AES Indiana Attachment AKH-6(C)
Page 29 of 49

Cause No. 38703 FAC 133S1 AES Indiana Attachment AKH-6(C) Page 31 of 49

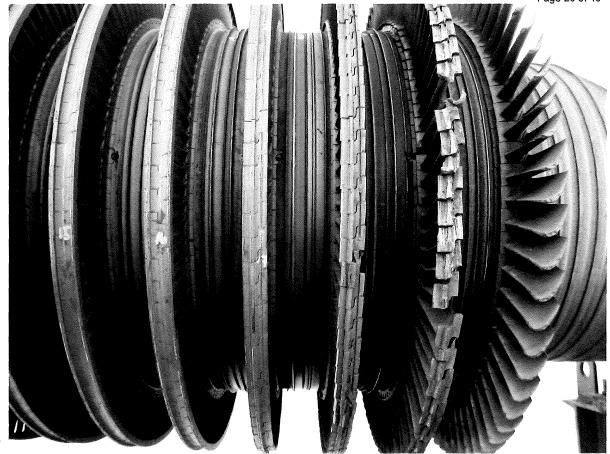
Photograph 5, Damaged STG Turbine (HP section)

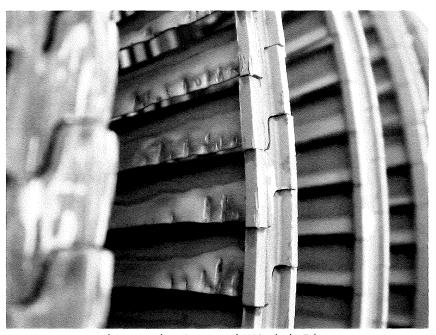
Photograph 6, Damaged STG Blade Edges

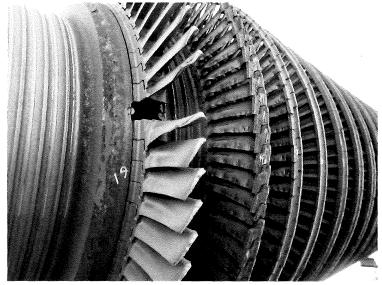
Photograph 7, Missing Blade STG HP Section

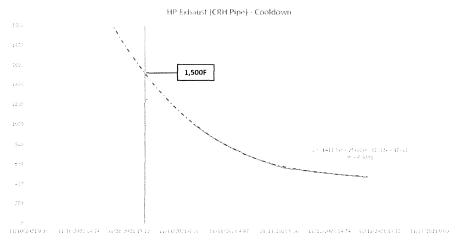
Figure 1, Regression analysis of HP Exhaust Temperature cooling curve

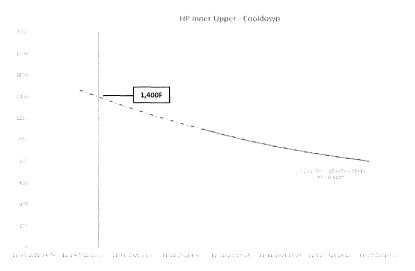
Figure 2, Regression analysis of HP Inner Upper Casing cooling curve
