# PROJECT EVANSVILLE WATER PLANT ADVANCED FACILITY PLAN

# **IMMEDIATE NEEDS MEMORANDUM: TREATMENT EQUIPMENT INFRASTRUCTURE**

**WATER TREATMENT PLANT  
ADVANCED FACILITY PLAN**

# **IMMEDIATE NEEDS MEMORANDUM: ELECTRICAL INFRASTRUCTURE**

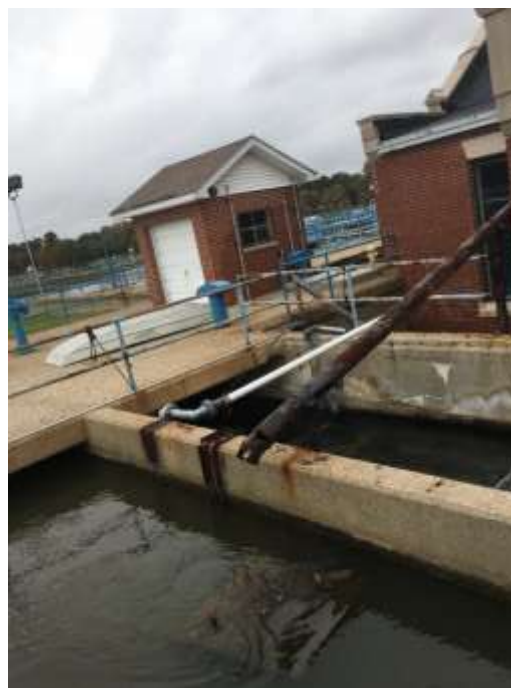
**FIGURE 2-4**  
**Corroded Roof Drain Downspout**

Due to age, material, and exposure to the elements, the roof drains discharging into the raw water flume, shown in **Figure 2-4**, are heavily corroded. Staff mentioned the corrosion of the downspouts and potential replacement should be considered to avoid a possible overhead safety issue. Handrails and walkways are also showing signs of heavy corrosion and should be inspected and recoated or replaced with new to extend their useful life.

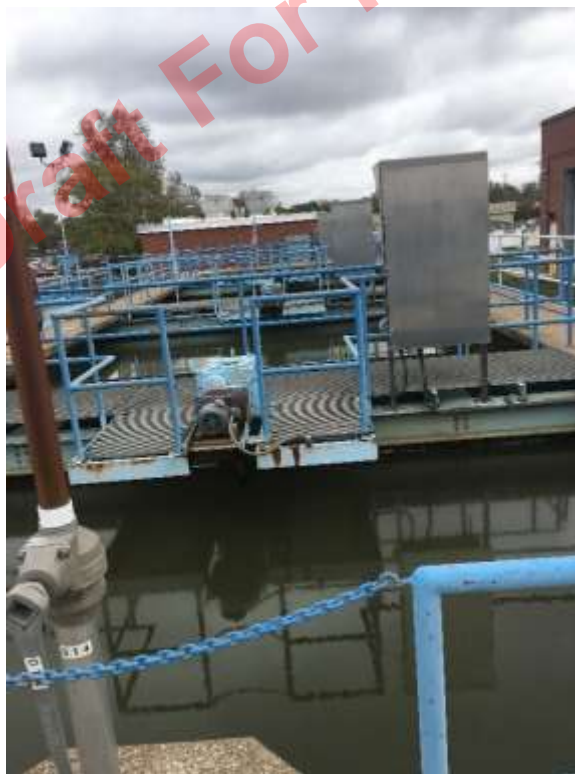
**FIGURE 2-5**  
**Flocculation Basins**

The North Plant flocculation basin tank walls, shown in **Figure 2-5**, are showing signs of concrete surface deterioration. It is recommended to clean the tanks, perform a structural inspection, and apply a protective coating to the concrete walls to mitigate chemical attack and extend the life of the structure. The bridges and submerged support structures are also showing signs of corrosion. Following inspection, rehabilitation and coating of these items should be completed to extend their useful life. Two (2) of the drives were replaced in 2015. The remaining four (4) flocculator drives were included within the master plan to be replaced in the 2022-2026 timeframe, beyond the five (5) year outlook.

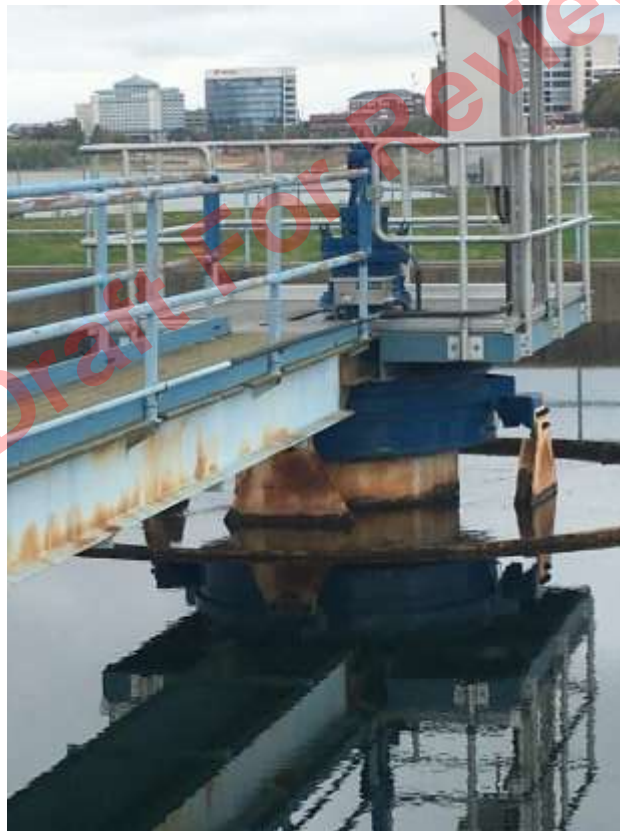
**FIGURE 2-8**  
**Support Column and Bridge Corrosion**

The center support column and other submerged ferrous components in Basin No. 2 should be replaced similar to the work completed for Basin No. 1. The concrete tank walls are showing signs of concrete surface deterioration. Previous concrete patches are also shown in **Figure 2-7**. To mitigate the risk of structural issues, the concrete structures should be drained, cleaned and inspected for structural integrity with corrective action taken if needed. The bridge within Basin No. 2 is showing signs of corrosion as shown in **Figure 2-8** and should be inspected, repaired, and recoated.

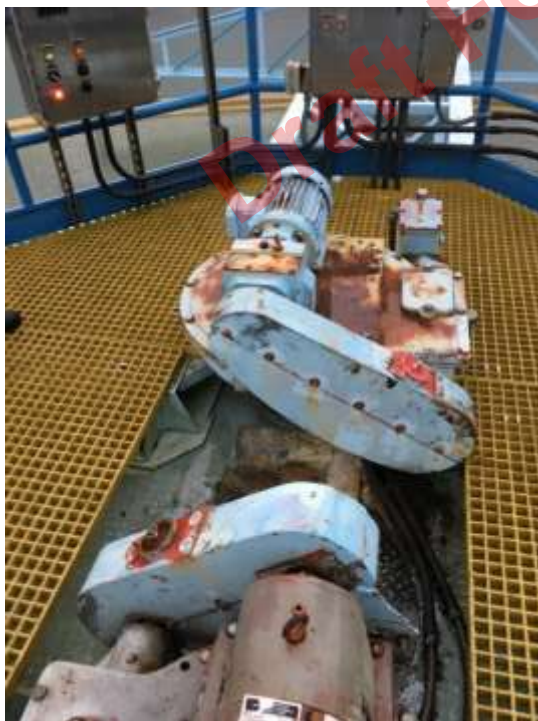
**FIGURE 2-10**  
**Primary Clarifier Flocculator Drive**

As shown in **Figure 2-10**, the flocculator drives and motors are in poor condition and should be replaced. Additionally, the concrete walls of the settling basins shown in **Figure 2-11** should be inspected for structural integrity. The basins should be drained, cleaned, and submerged ferrous structural and mechanical equipment should be inspected for damage.

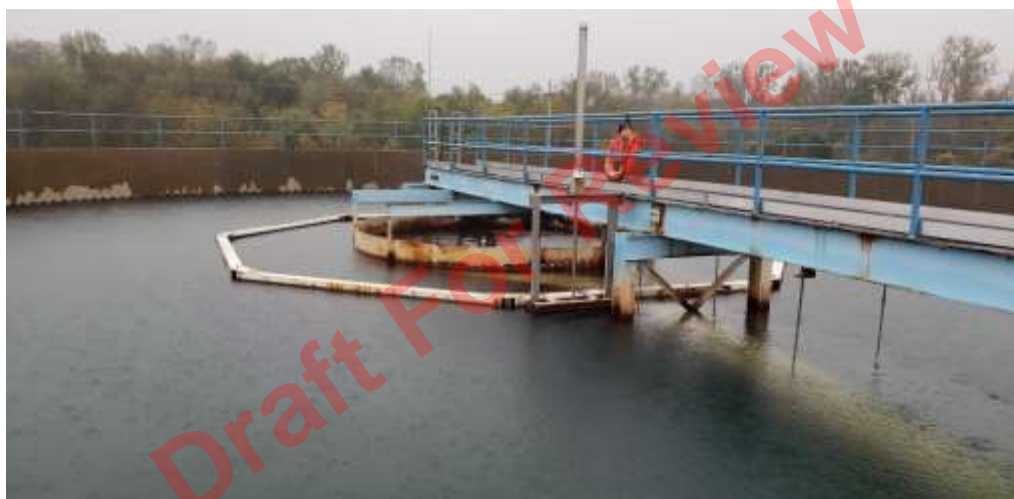
**FIGURE 2-12**  
**South Plant Secondary Clarifier**

The concrete basins are generally in good condition. It is recommended to drain the tanks and inspect the submerged metal walkway supports, center support column, and steel baffles and if required, repair and recoat to extend life of the assets.

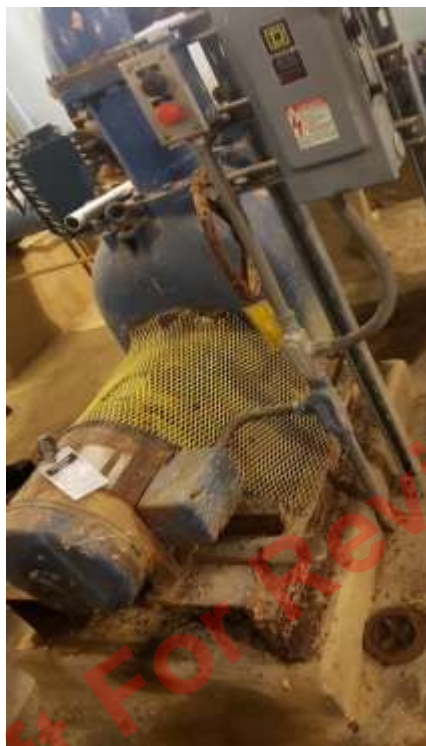
**FIGURE 2-13**  
**South Sludge Pump Station Pump Corrosion**

10 years, it is recommended to replace the second pump and associated electrical controls. The existing condition of the sludge pump is shown in **Figure 2-13**. It is also recommended to structurally inspect, clean and recoat (replace if necessary) corroded piping and ferrous metal stairs, handrail, hatches, supports and similar within the building.

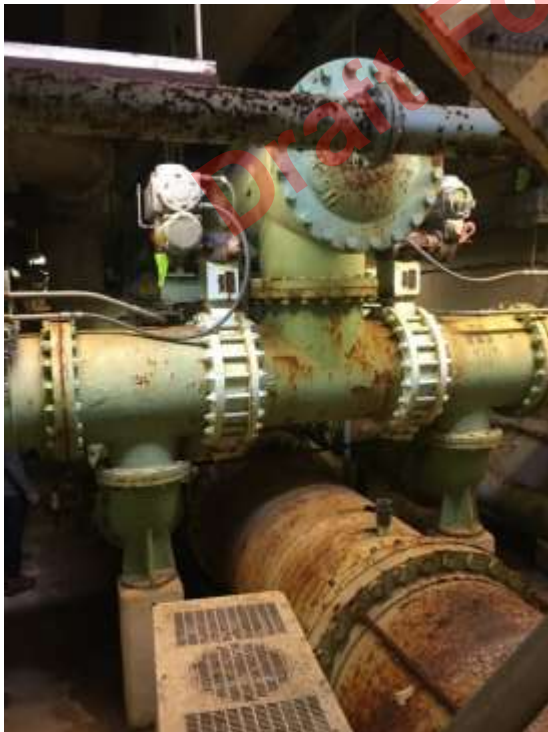
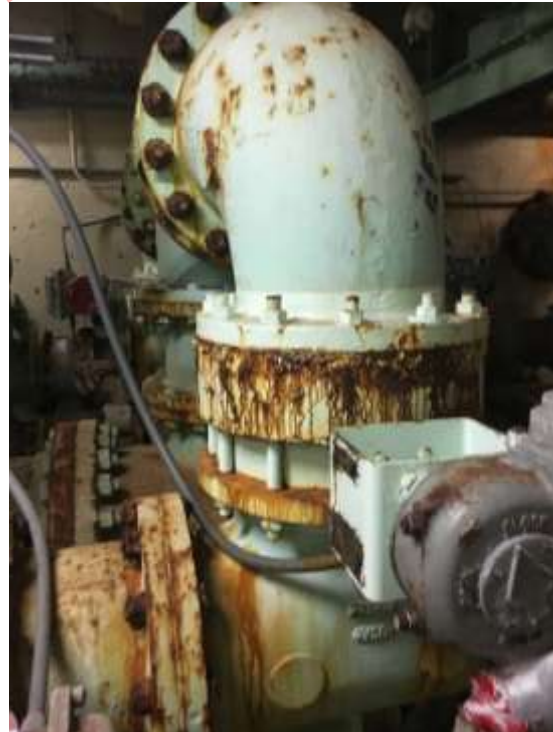
Filters 33-36 are relatively new and require no major repairs within the next five (5) years, however, each of the respective piping galleries associated with filters 13-32 exhibit similar repair needs associated with excessive corrosion of filter gallery piping, actuators, and miscellaneous metals as shown on **Figures 2-14 through 2-16.** The extent of corrosion in each of the galleries is largely a result of inadequate ventilation and humidity control. Additionally, in filters 13-20, there is a cross-connection associated with the vent for the adjacent 1.5 MG clearwell that vents directly into this pipe gallery, contributing to the excessive moisture and chlorine levels in the pipe gallery. Recent air monitoring by staff have shown low available oxygen levels in the pipe gallery of 13-20. For each of the 13-32 filter galleries, dehumidification improvements are recommended to be included as part of the filter gallery upgrade. Piping and equipment showing significant corrosion (in some cases the entire gallery) should be blasted and recoated to extend service life and prevent possible failure.

**FIGURE 2-15**  
**Corrosion in Pipe Gallery**

**FIGURE 2-16**  
**Corrosion in Pipe Gallery**

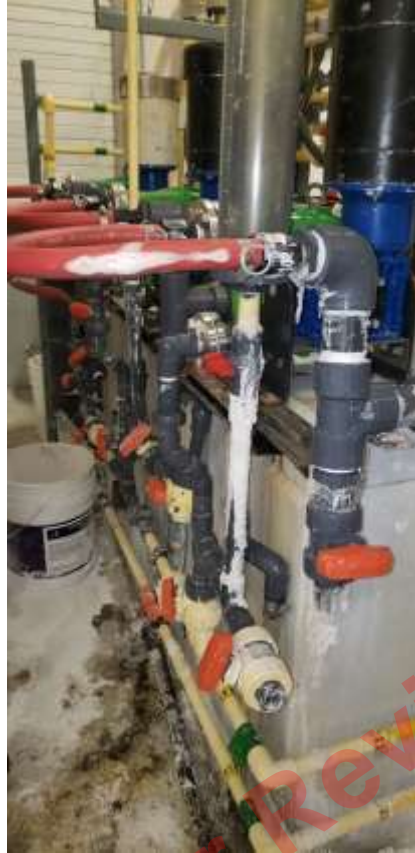
**FIGURE 2-19**  
**Leaking Caustic Chemical Feed System**

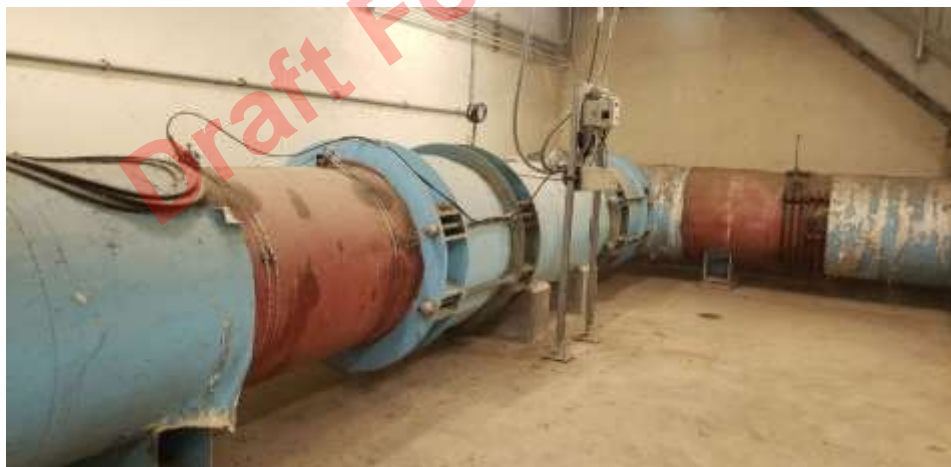
**FIGURE 2-29**  
**Effluent Piping in High Service Pump Station No. 3**

Additional improvements to HSPS No. 3 include recoating of the corroded process piping, and equipment as needed, recoating the stairs and handrails, and upgrading or replacing the flow meters on the discharge piping.

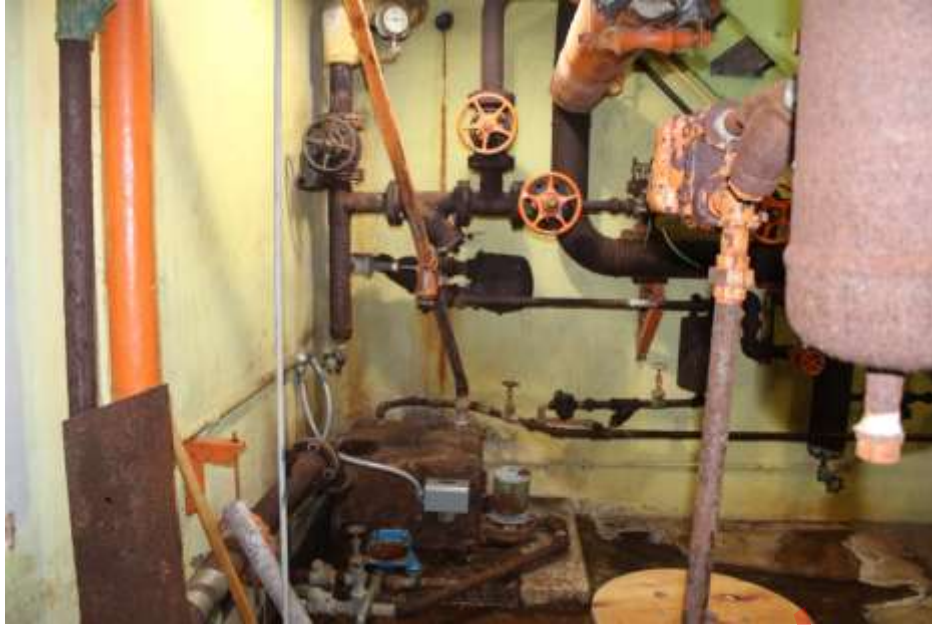
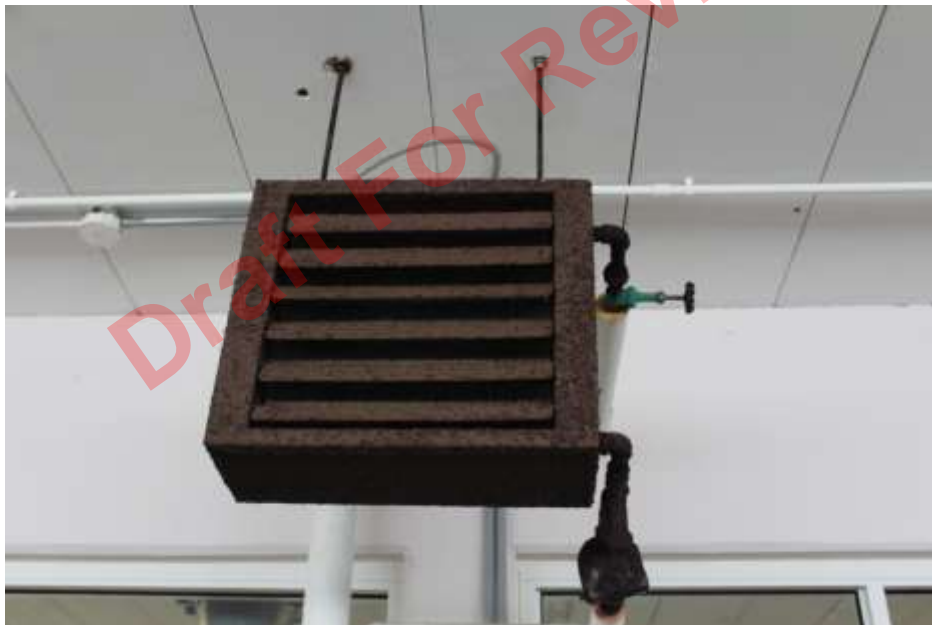
Many of the components of this system are beyond the intended useful life but are readily available if replacements are needed. The boiler is serviced annually and in general working order. The boiler manufactured in 1963 has been decommissioned. Although no recommendations are proposed to replace the boiler in the next five (5) years, it is recommended to replace the aged and corroded piping and unit heaters shown in **Figures 2-31 and 2-32**.

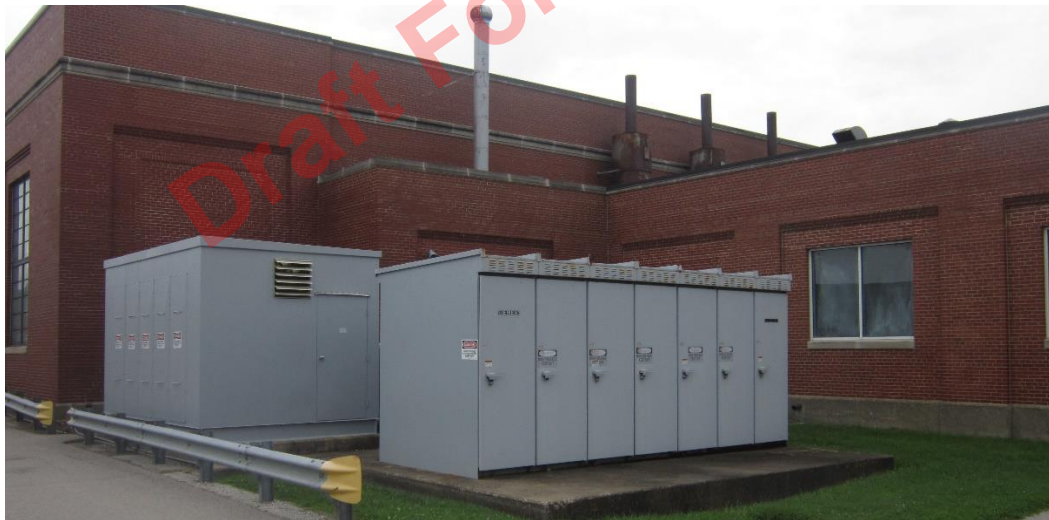
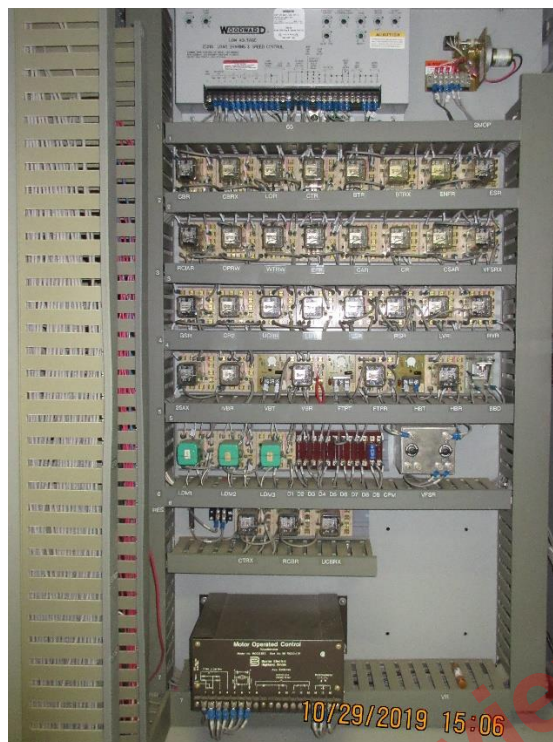
During a planned Vectren Energy WTP power outage in October 2019, it was discovered the automated power transfer equipment, shown in **Figures 2-1 and 2-2** was inoperable. Due to the age of this equipment and its critical function, this equipment is recommended to be serviced every two (2) years or replaced with more reliable equipment. It is also recommended to purchase or rent a load bank to provide staff with the means to test the functionality of the generator equipment.

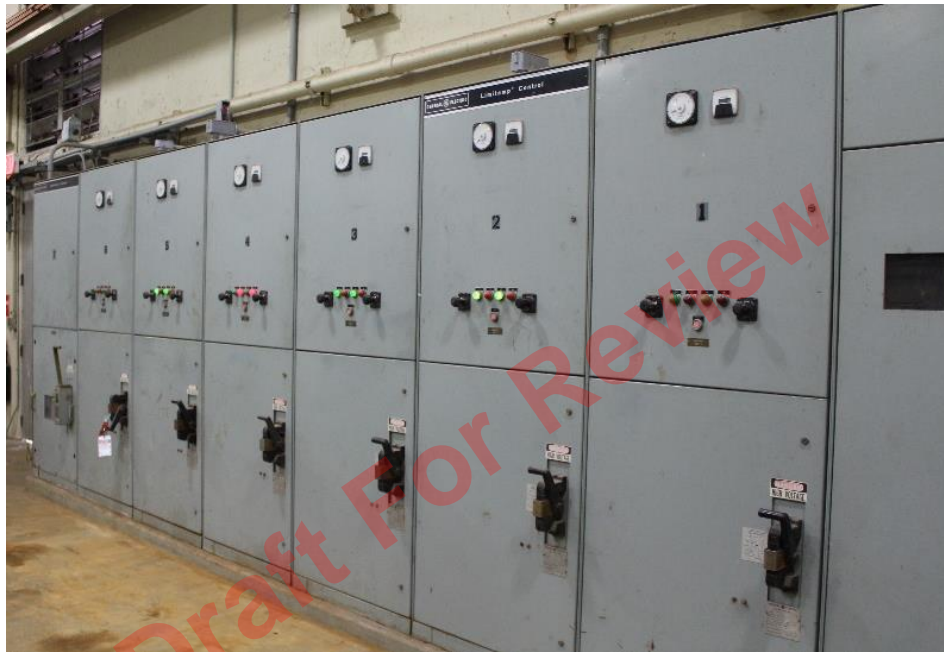
**FIGURE 2-5**  
**Low Service Pump Station Switchgear**

The LSPS switchgear shown in **Figure 2-5**, referenced on **Figure 1-1, Area 11** is utilized both to deenergize electrical equipment for maintenance and to clear downstream faults. The Low Service switchgear feeding the switchboard transformer, Tag No. XFMR MCC-LS, is damaged and in need of repair. Furthermore, the switchgear in this area is not shielded from intrusion of water leaks as shown in **Figure 2-6**. Intrusion of water inside the 4,160-volt switchgear can generate an arc flash capable of extreme injury.

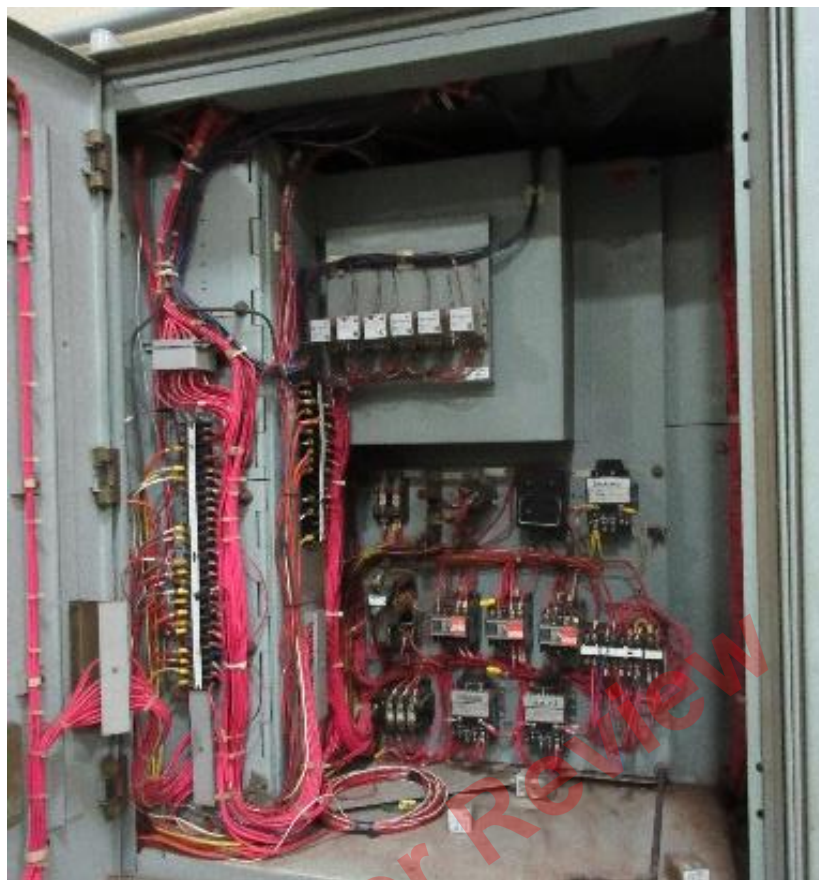
**FIGURE 2-7**  
**Low Service Pump Controls**

The pump controls system in the LSPS are over 30 years old and the parts are obsolete and difficult to source. The pump controls are shown in Figure 2-7. Due to parts being difficult to source if a part fails, this will leave the station with inoperable controls for extended periods of time. The control system is critical for plant operation and extended failure could directly impact the plant's water production potential.

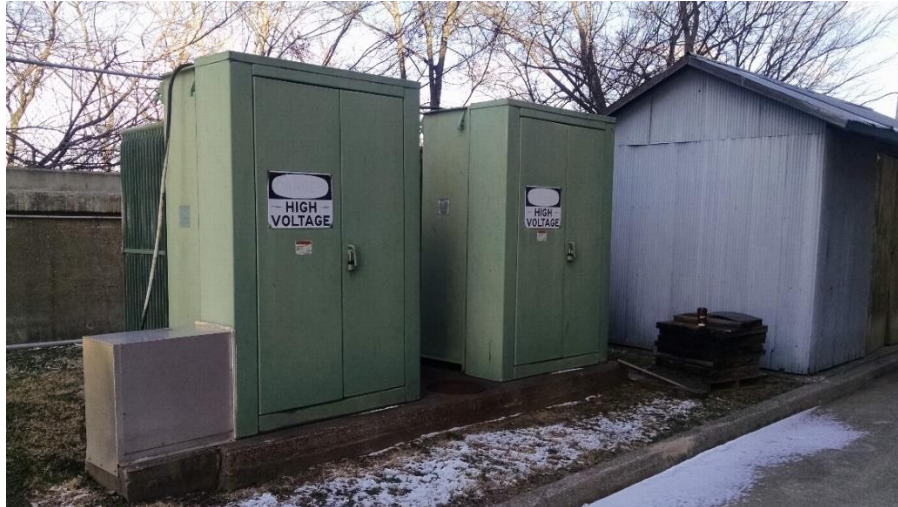
**FIGURE 2-8  
LSPS Transformer**

During a recent inspection, the northern transformer shown in **Figure 2-8** was noticeably warmer to the touch than the other transformer. The temperature difference could be as simple as a low oil level or as severe as a transformer failure. Both transformers should be further evaluated and serviced as required. Additionally, to improve equipment reliability, switchboards 2A and 2B located within HSPS No. 1 should have the equipment replaced with modern components.

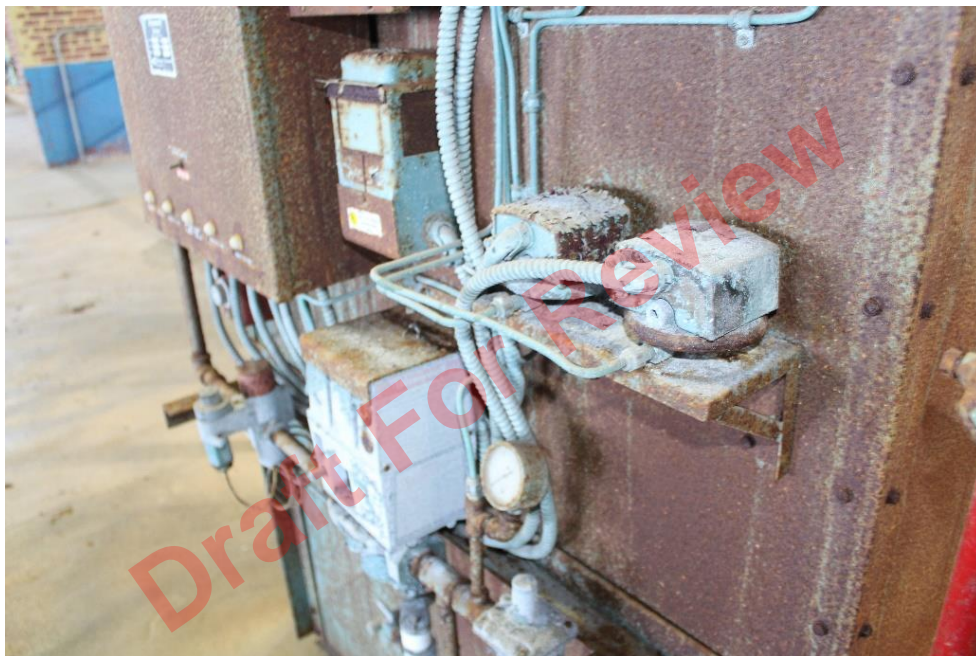
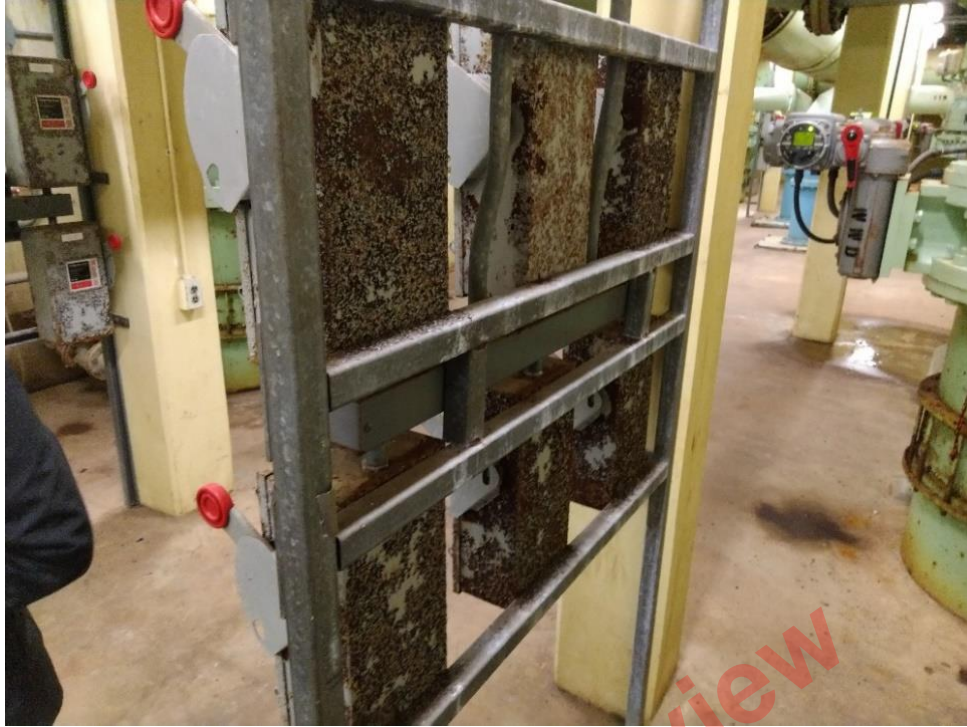
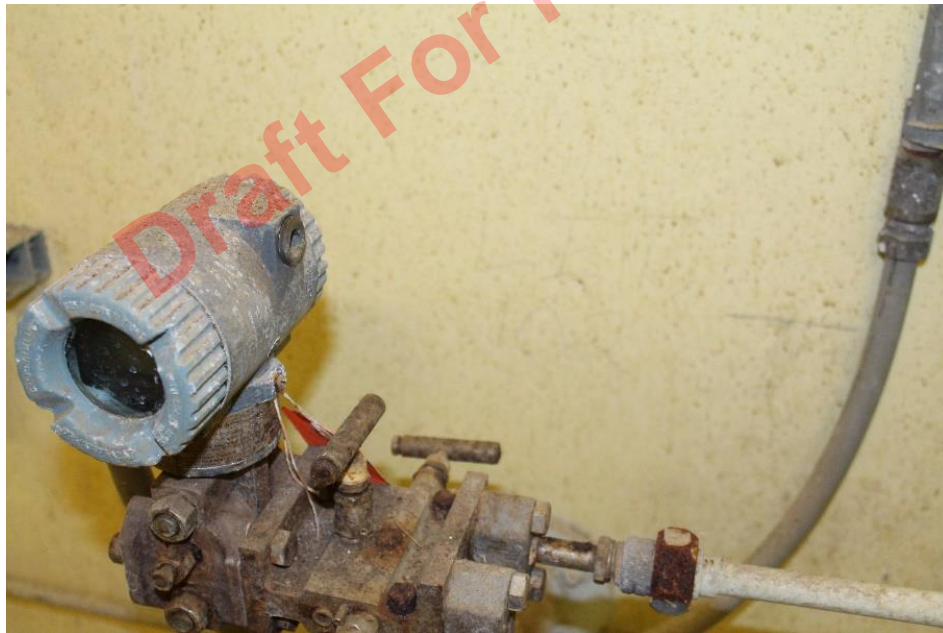
There are 36 filter beds within the treatment plant, 16 of which are active in the North Plant and eight (8) that are active in the South Plant. The North Plant filters include filters 13-20, filters 29-32, and filters 33-36 shown on **Figure 1-1, Areas 6,7, and 10**. Filters 1-12 shown on **Figure 1-1, Area 23**, have been taken out of service. The remaining filters 21-28 shown on **Figure 1-1, Area 19**, serve the South Plant. For the filters, the majority of the electrical and I&C equipment is located within the filter pipe galleries and is extremely critical to the plant in providing SCADA data and monitoring plant operation. Much of this equipment is corroded due to poor ventilation and dehumidification as shown in **Figures 2-9 through 2-11**.

**FIGURE 2-9**  
**Exposed Electrical Equipment Corrosion**

**FIGURE 2-10**  
**Electrical Enclosure Corrosion**

**FIGURE 2-11**  
**Pipe Gallery Controls Corrosion**

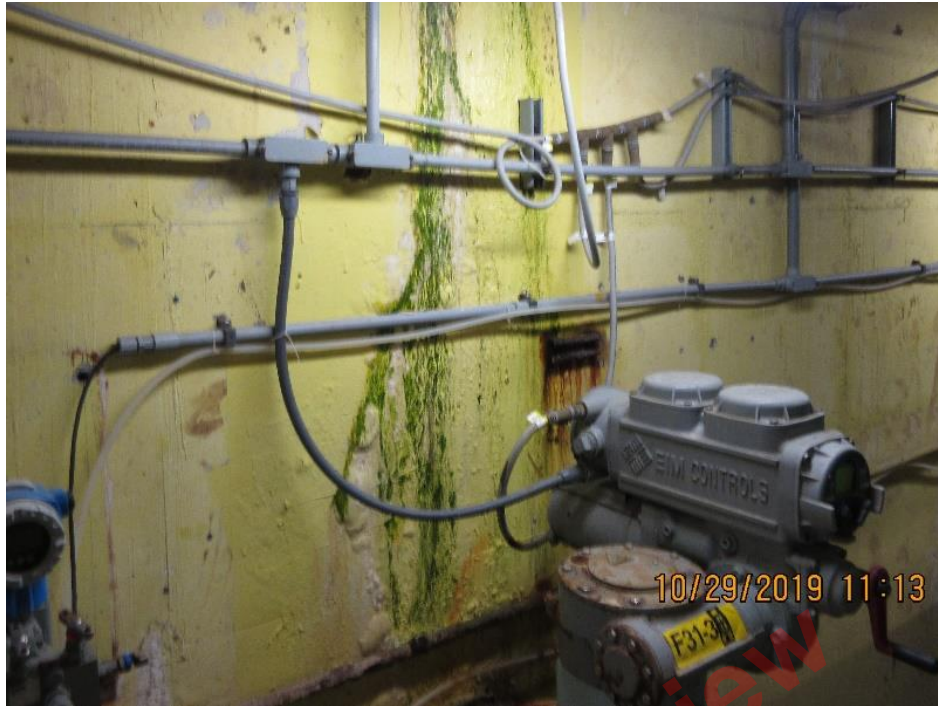
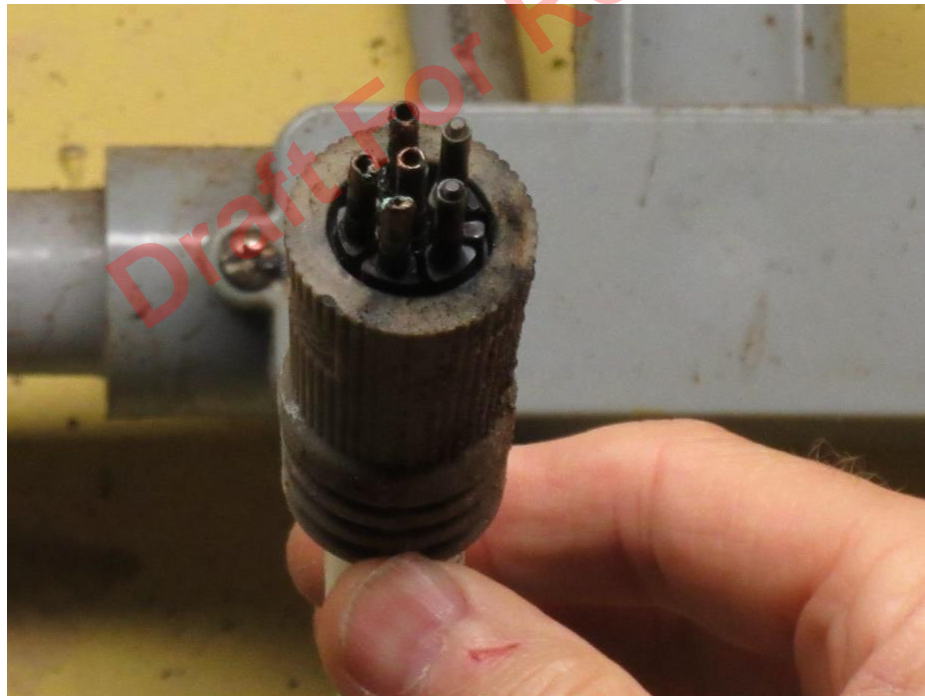
It was noted that the actuator power supply cables located in the filter galleries do not comply with the NEC Section 400.7 for Flexible Cords and Cables. The supply cables are shown in **Figure 2-12**. Staff have indicated that the power supply cables have failed in the past, likely due to the excessively moist condition of the area. Refer to **Figure 2-13** for an example of one of the cables that have failed.

**FIGURE 2-12**  
**Flexible Cables**

**FIGURE 2-13**  
**Flexible Cable Failure**

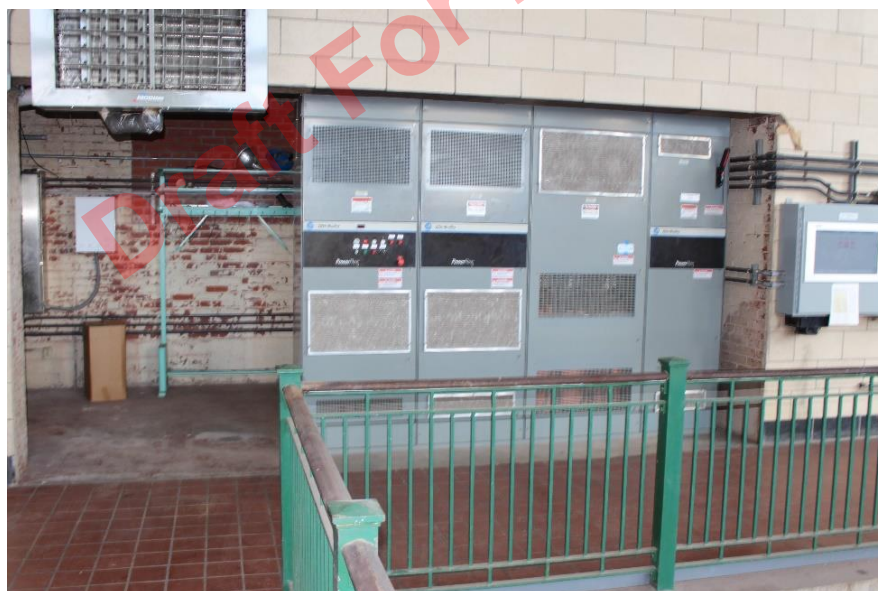
**FIGURE 2-14**  
**VFD for HSP No. 5**

The electrical equipment within HSPS No. 2 shown on **Figure 1-1, Area 14** is exposed to the extreme temperature fluctuations throughout the year. These temperature fluctuations and lack of dehumidification have likely shortened the life of the electrical equipment in the area. Specifically, the variable frequency drive (VFD) for High Service Pump (HSP) No. 5 shown in **Figure 2-14** is beyond its useful life due to the extreme environment in which it resides. The VFDs for HSP Nos. 6 and 7 were installed during the 2014 pump rebuild project.

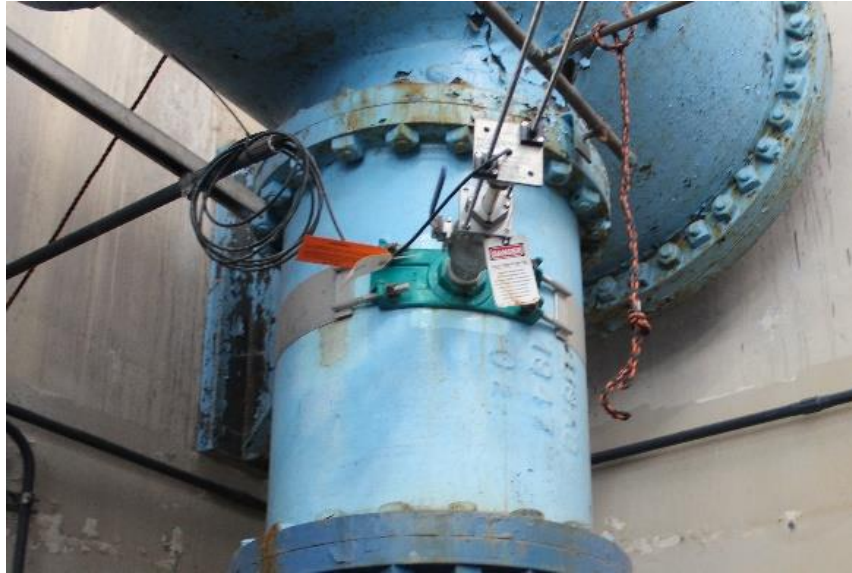
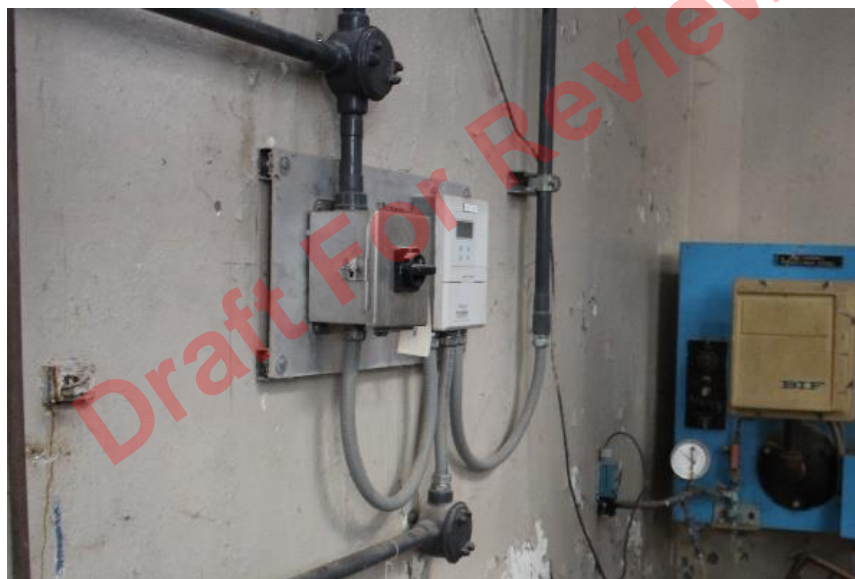
The pump flow meters shown in **Figures 2-15 and 2-16** are malfunctioning and are unreliable. Staff does not trust the accuracy of the data provided leading to uncertainty in plant production.

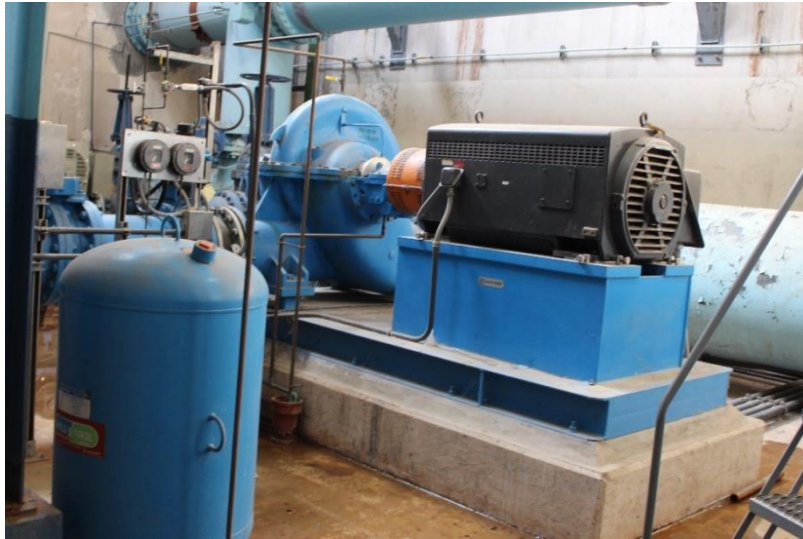
**FIGURE 2-17**  
**Emergency Valve Closure System Water Storage Tanks**

The existing HSP emergency discharge valve closure system shown in **Figure 2-17** is hydraulically operated with an open/close function only. This system has internal leaks and is beyond its useful life. Currently, staff do not have visual confirmation of open/close status for each pump discharge valve to ensure proper operation. The open/close status of the HSP discharge valves is critical to know to avoid prematurely opening valves causing pump wear and system faults. Discharge valves not closing completely can cause the pump to spin backward which may cause pump overload failures or broken input shaft couplers.

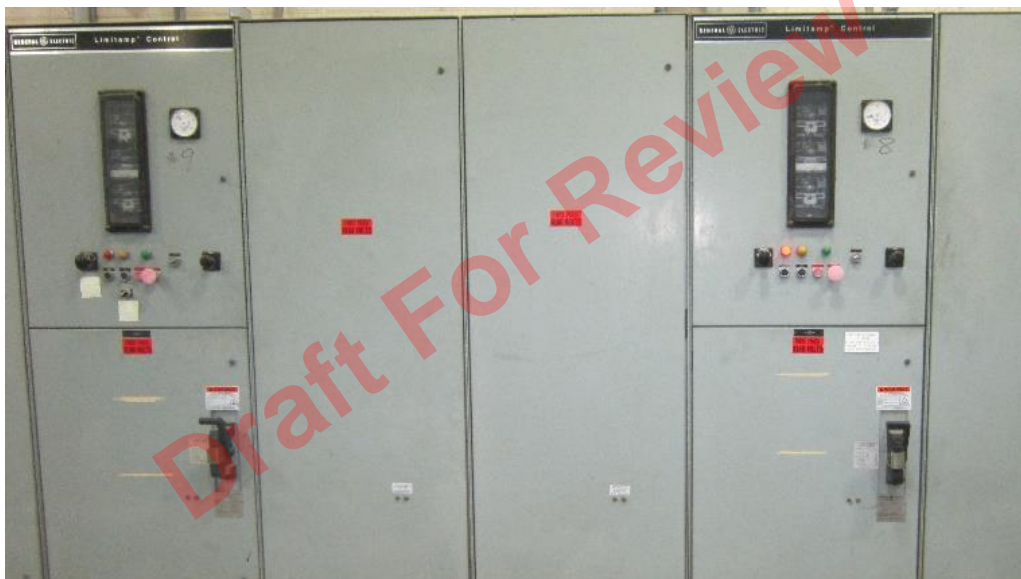
**FIGURE 2-18**  
**HSPS No. 3 Switchgear**

The electrical equipment located in HSPS No. 3 shown on **Figure 1-1, Area 4** is located primarily on the upper level of the station. The General Electric Limitamp Model switchgear shown in **Figure 2-18** has exceeded its life and is now obsolete. The main power equipment, Tag No. MVB, is a lineup of medium voltage, 4160 volts, switchgear/MCC units. The switchgear was last shut down for cleaning and maintenance, recommended every 3 to 5 years by the manufacturer. Despite the maintenance performed, staff indicated that the switchgear has cabinet safety interlock issues that should be resolved. Similarly to the LSPS switchgear, the switchgear located within HSPS No. 3 is not shielded from water spray presenting risks of arc flash.

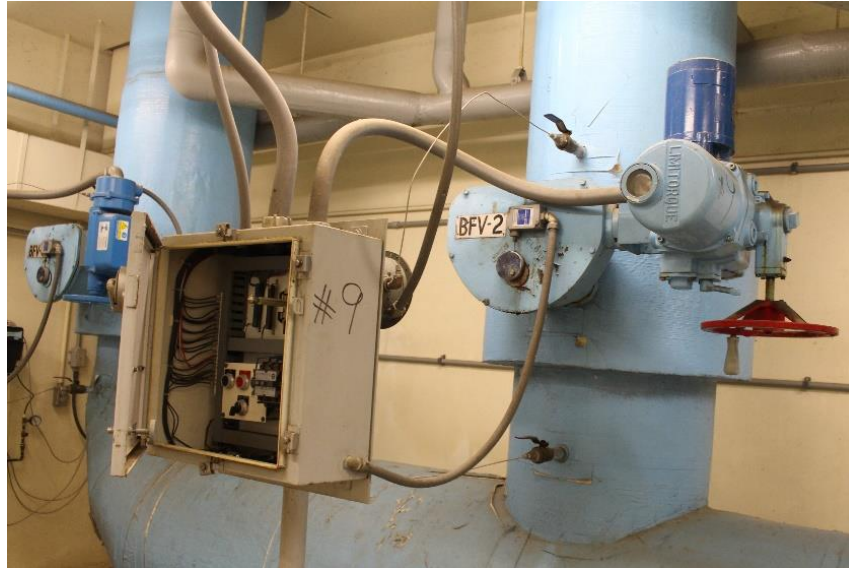
**FIGURE 2-19**  
**HSPS No. 3 Discharge Valve Actuators**

HSPS No. 3's emergency discharge valve closure systems have exceeded their anticipated useful life. The uninterruptable power supply system is no longer functional. The electric actuators have several issues including being mismatched, limit torque trip issues, and they are heavily worn. Similarly to HSPS No. 2, the pump discharge valve actuators, shown in **Figure 2-19**, do not have a clear indication of valve position to indicate proper valve operability outside of a valve fault.

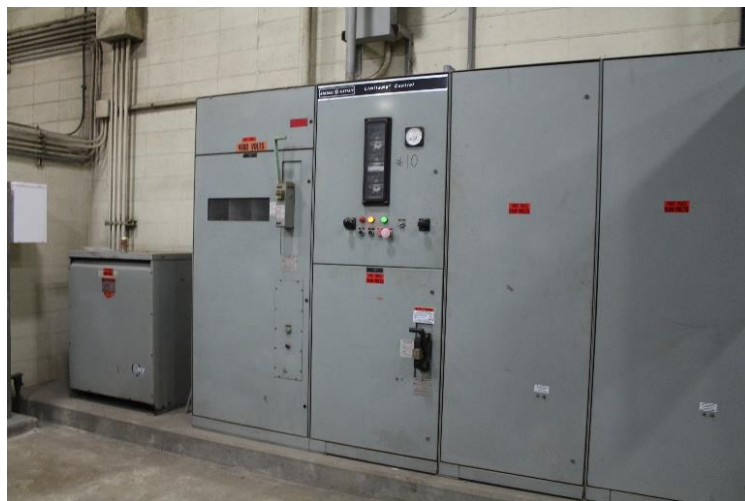
**FIGURE 2-20**  
**HSPS No. 3 Pump Controls**

The MCC shown in **Figure 2-20** is obsolete and staff deem unreliable. Parts for this MCC are difficult to source and could leave the station with inoperable control systems for extended periods of time. An example of one of the recent failures of this system is in 2018 a timer relay failure on HSP No. 10 rendering the pump inoperable until parts could be sourced to replace the broken equipment.
