CERTIFICATE OF SERVICE

**TESTIMONY OF OUCC WITNESS JAMES T. PARKS
CAUSE NO. 45132-U
HILLVIEW ESTATES SUBDIVISION UTILITIES, INC.**

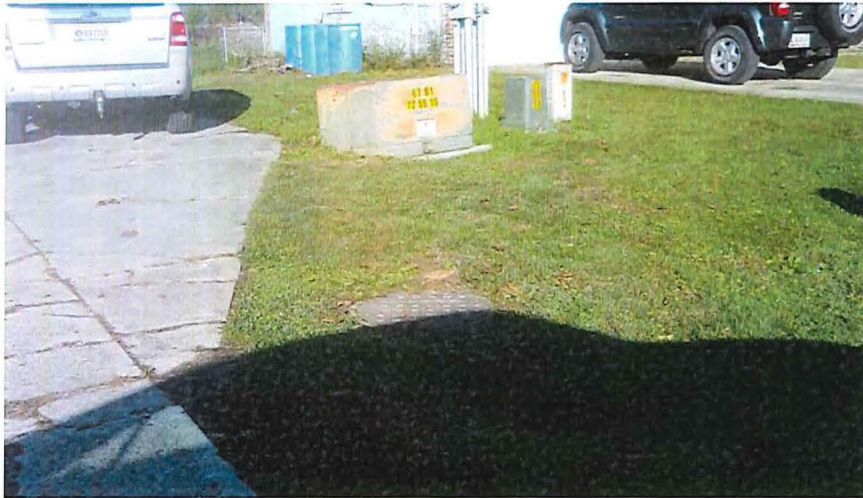
Fig. 1 Manhole on South Hillview Drive.

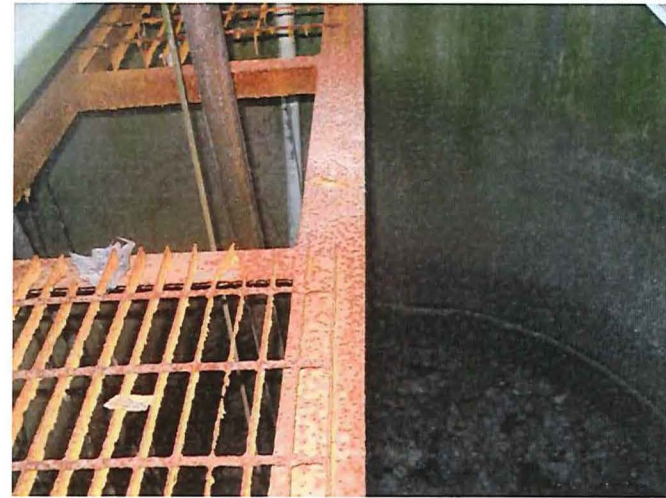
Fig. 2 Inside of Raw Sewage Pump Station showing rusted steel.

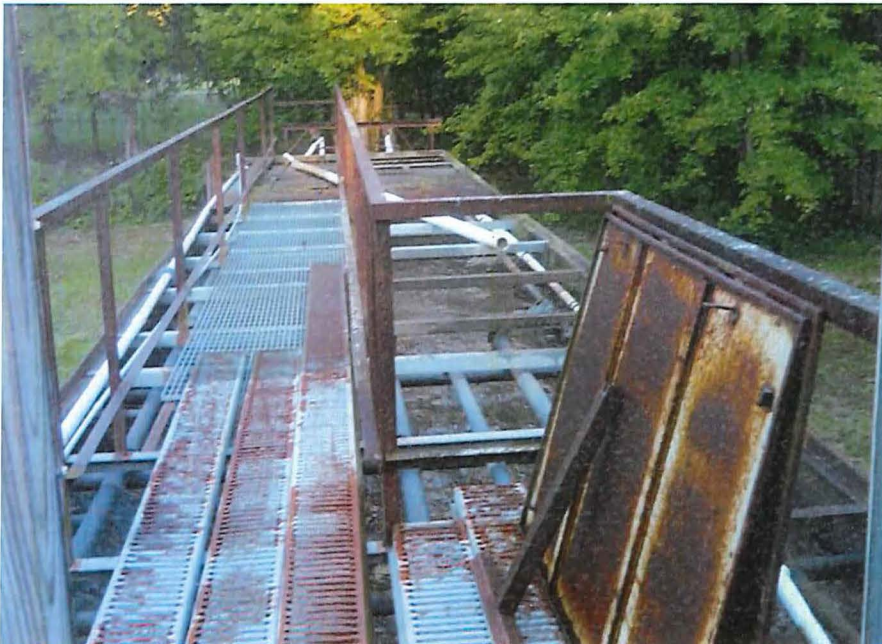
Fig. 3 View west of top of the aeration tank and sludge digester.

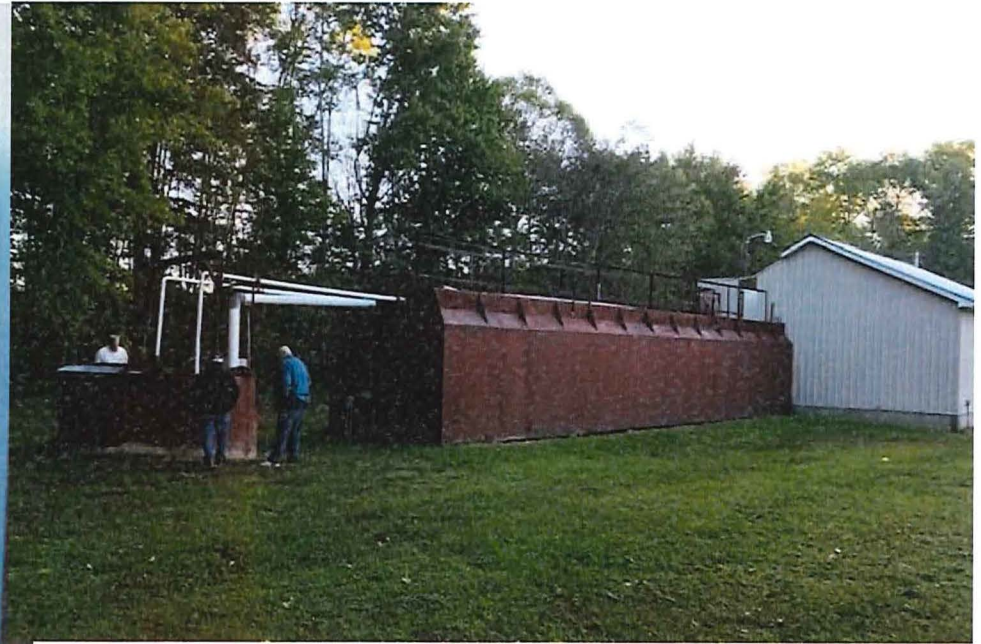
Fig. 4 View of Raw Sewage Pump Station (left), Sludge Digester and Aeration Basin (large brown tank), and Control Building (right).

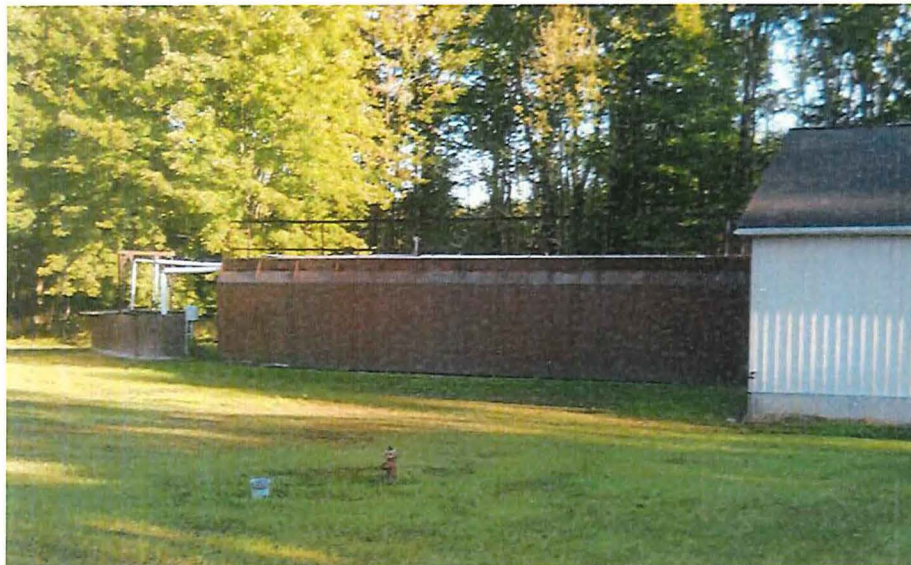
Fig. 5 View of Hillview Estates steel package treatment plant.

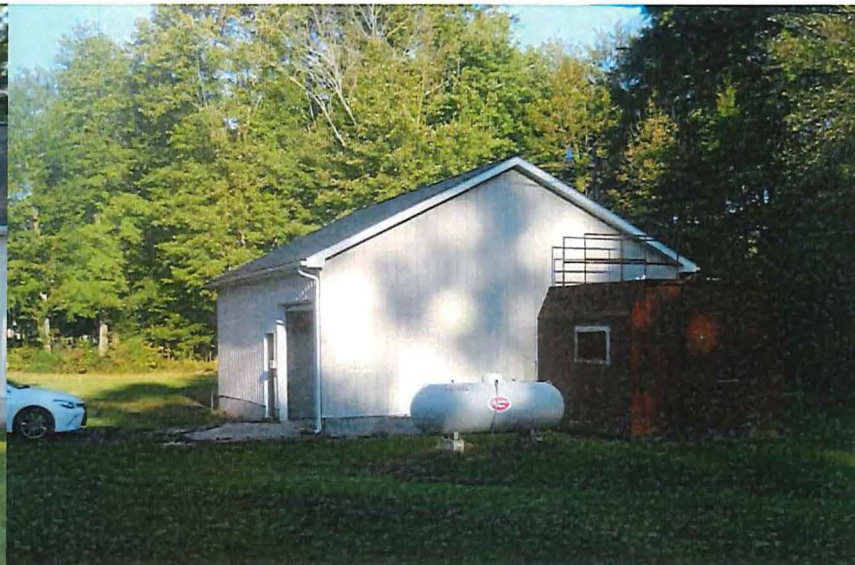
Fig. 6 View west of Control Building and out of service filter tank.

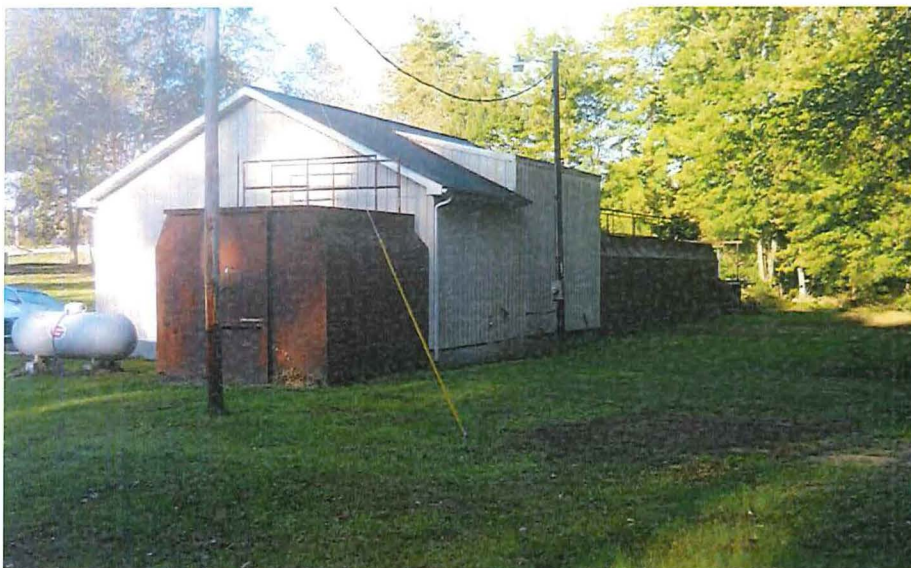
Fig. 7 View of out of service filter tank (brown), Control Building, and Aeration Tank (in background).

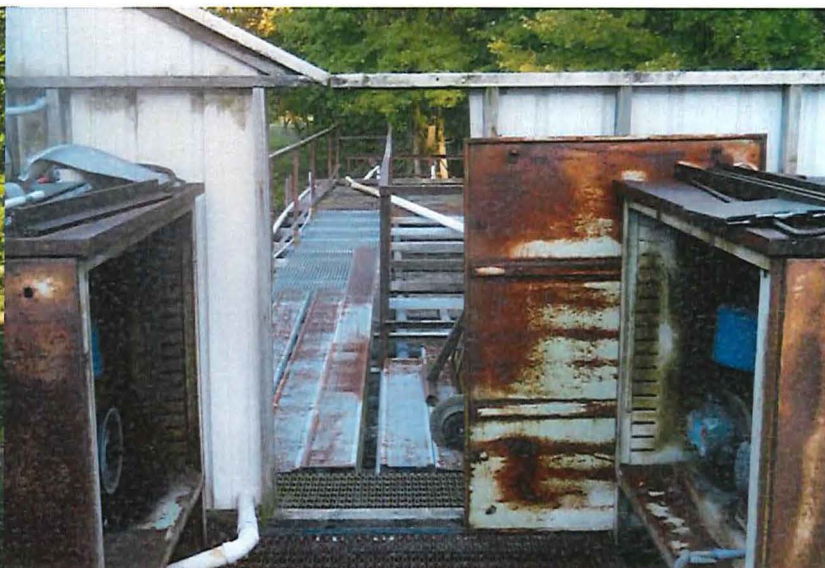
Fig. 8 View west on top of tanks showing blowers (in foreground).

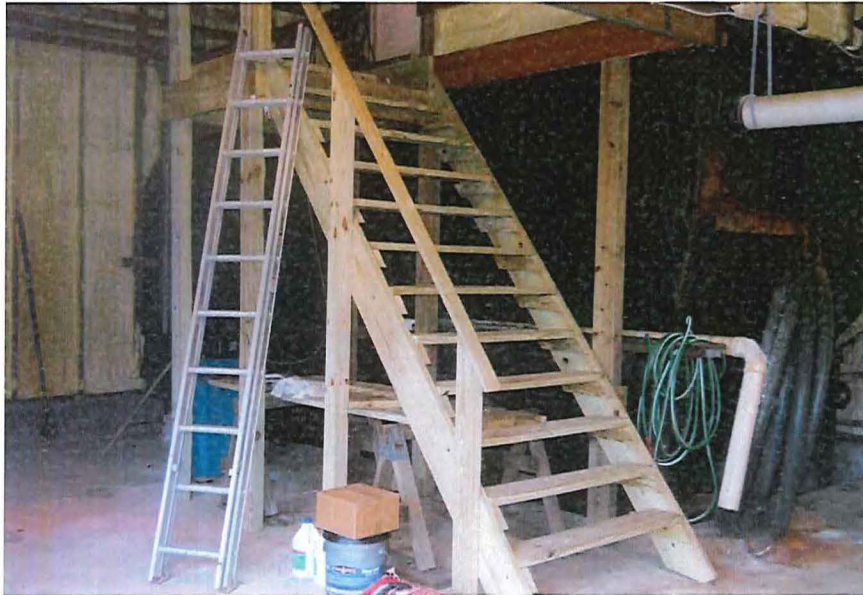
Fig. 9 View of new access stairs inside Control Bldg. (to top of tanks)

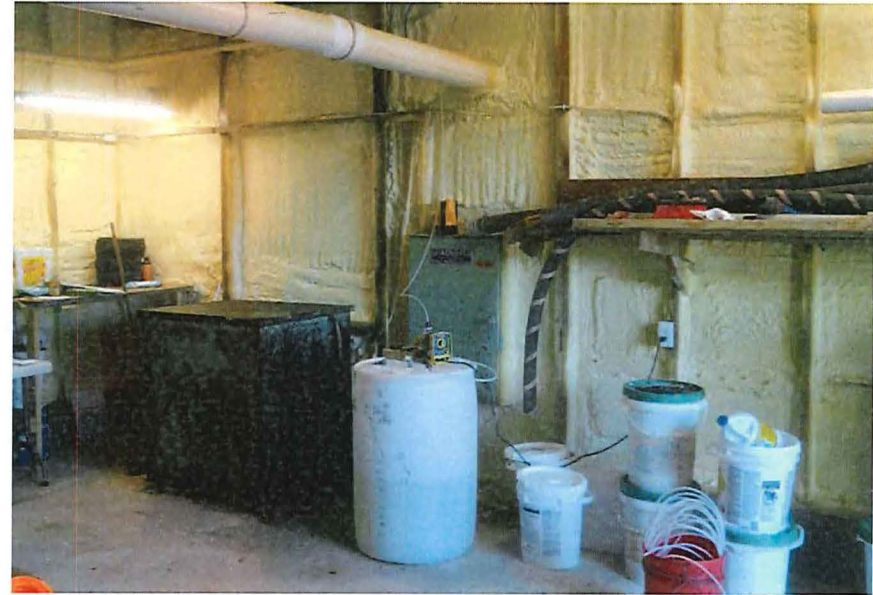
Fig. 10 Chemical feed system for effluent disinfection.

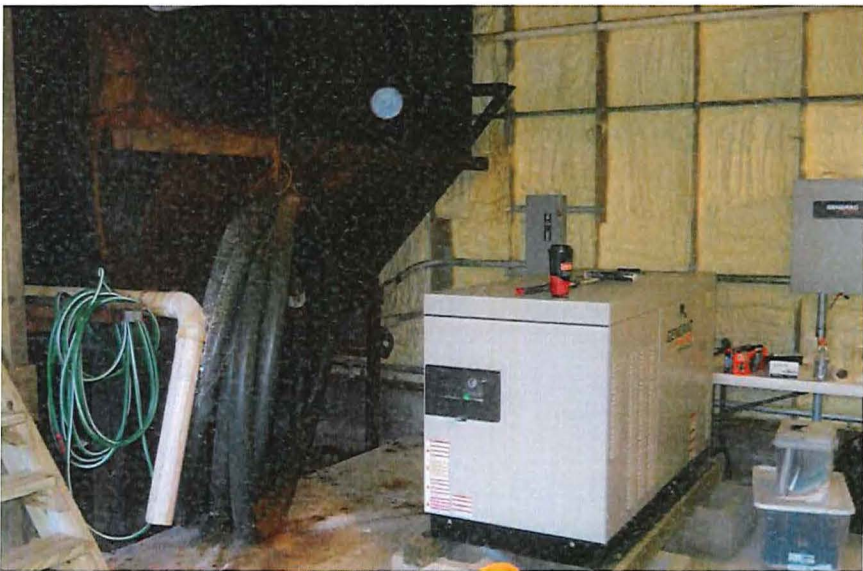
Fig. 11 View of clarifier (left) and new standby power generator.

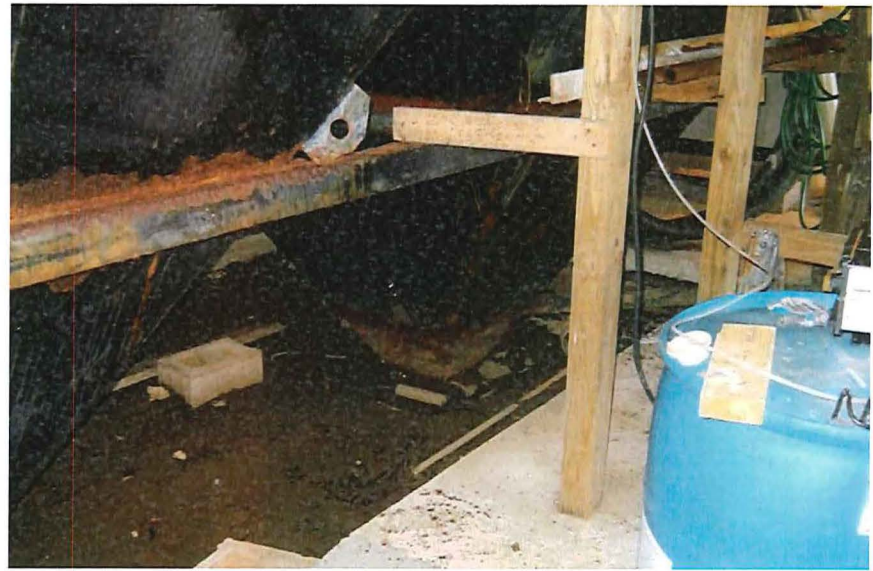
Fig. 12 View of steel condition of the clarifier hopper bottoms.

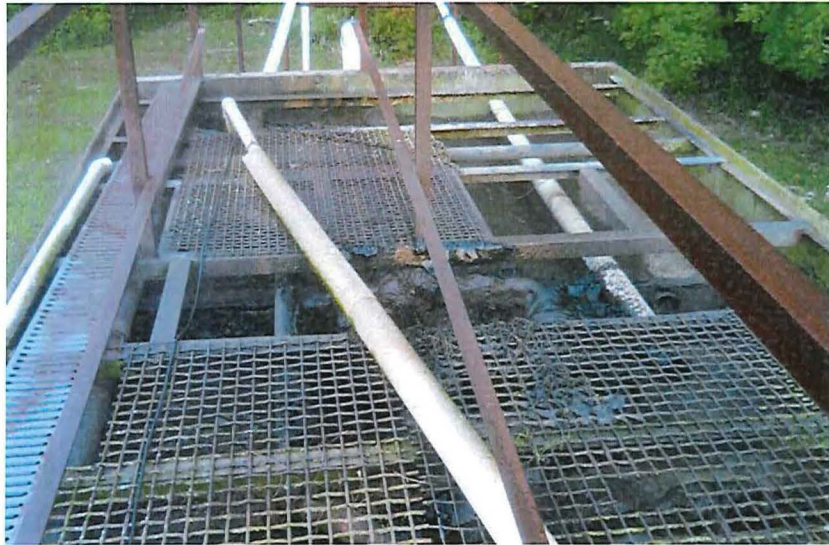
Fig. 13 View of aerobic sludge digester and holding tank section.

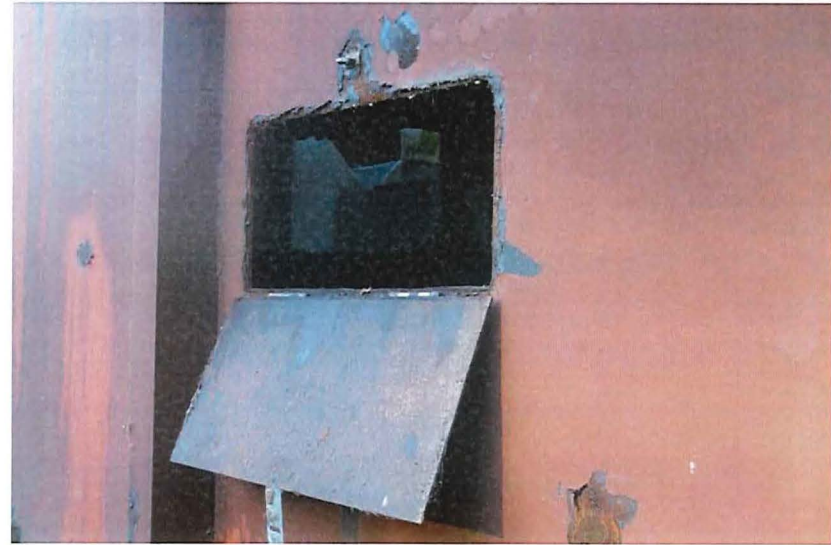
Fig. 14 V-notched weir for flow measuring inside old filter tank.

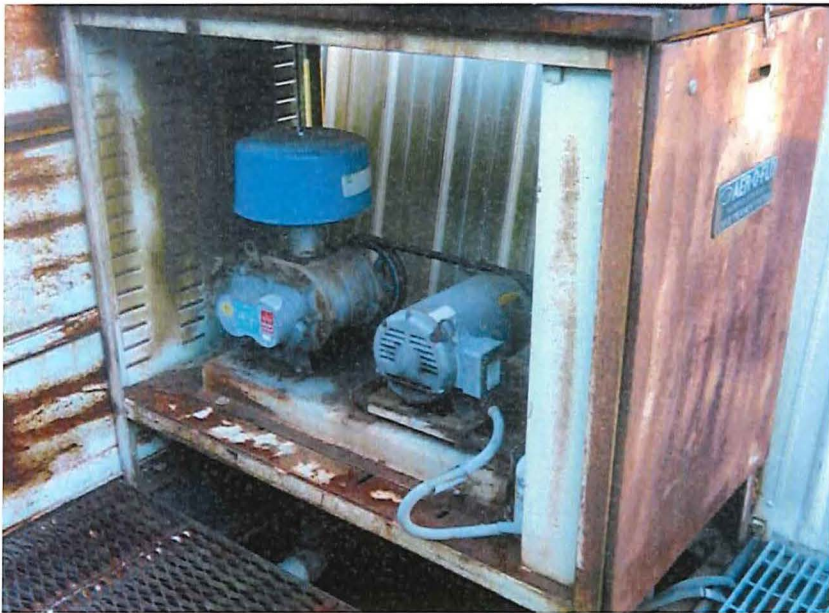
Fig. 15 View of aeration blower (one of two blowers).

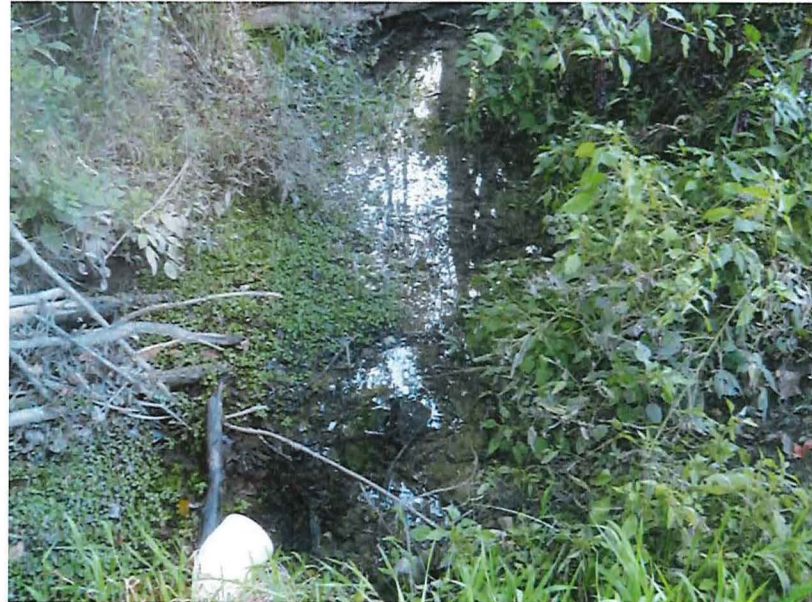
Fig. 16 View of Outfall 001 discharging to unnamed tributary.

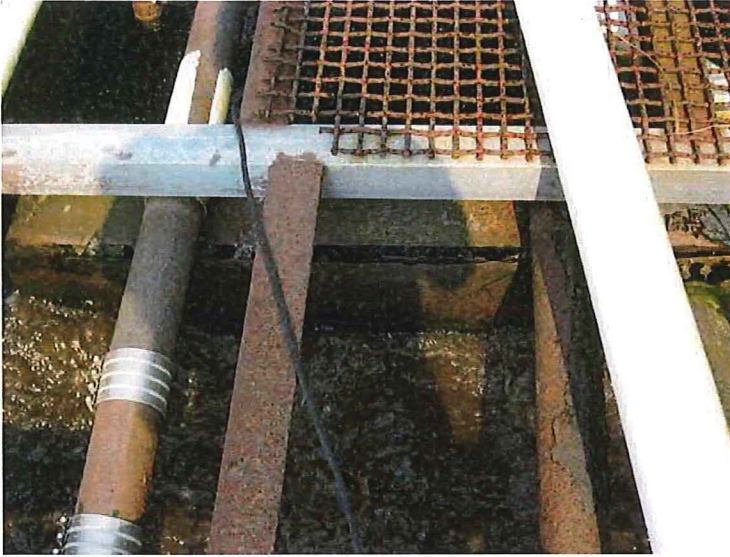
Facility: Hillview Estates Subdivision
Photographer: Kevin Hotz
Date: 6/30/2015 Time:
Others Present:
Location/Description: Rust damage on supports and walls,

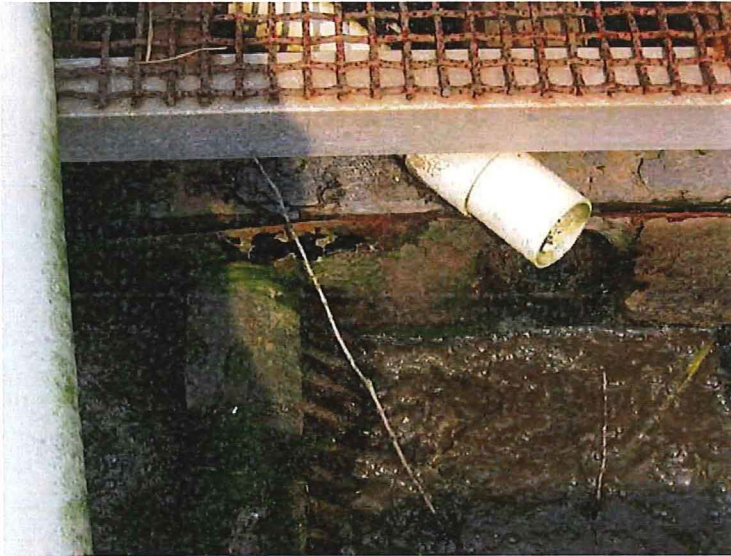
Facility: Hillview Estates Subdivision
Photographer: Kevin Hotz
Date: 6/30/2015 Time:
Others Present:
Location/Description: Perforated tank wall

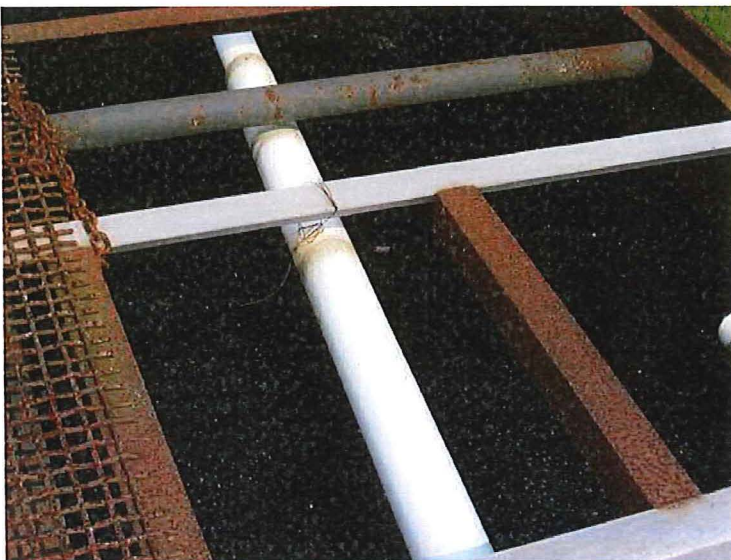
Facility: Hillview Estates Subdivision
Photographer: Kevin Hotz
Date: 6/30/2015 Time:
Others Present:
Location/Description: Full digester and missing grates.

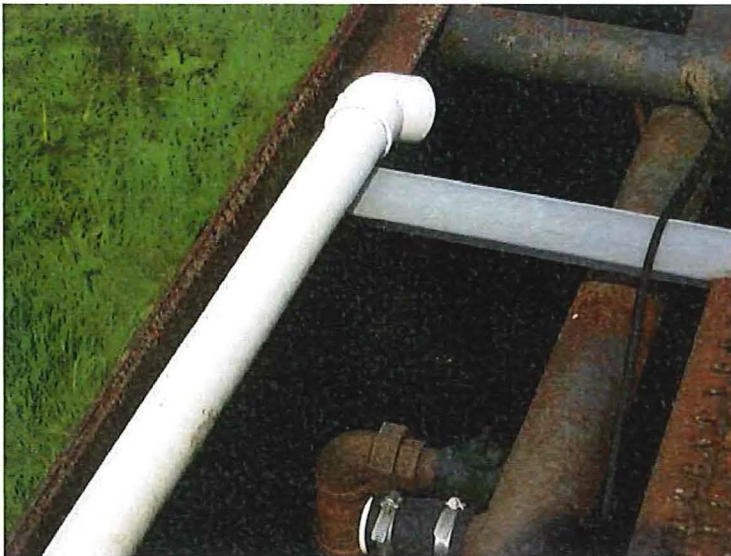
Facility:	
Hillview Estates Subdivision	
Photographer:	
Kevin Hotz	
Date: 6/30/2015	Time:
Others Present:	
Location/Description: Rust damage on tank wall

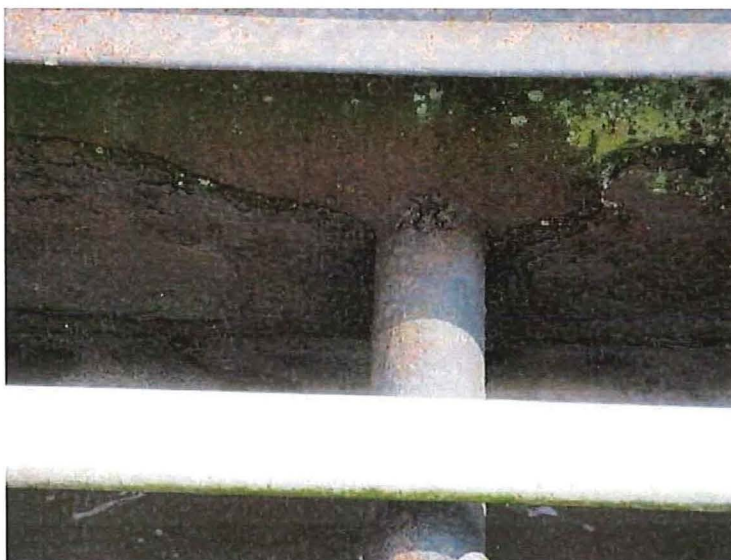
Facility:	
Hillview Estates Subdivision	
Photographer:	
Kevin Hotz	
Date: 6/30/2015	Time:
Others Present:	
Location/Description: Clear influent wastewater

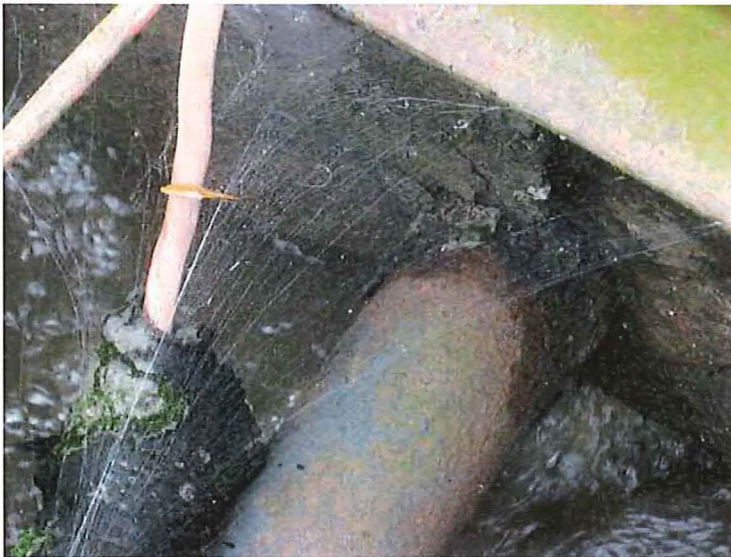
Facility: Hillview Estates Subdivision
Photographer: Kevin Hotz
Date: 6/30/2015 Time:
Others Present:
Location/Description: Rust damage

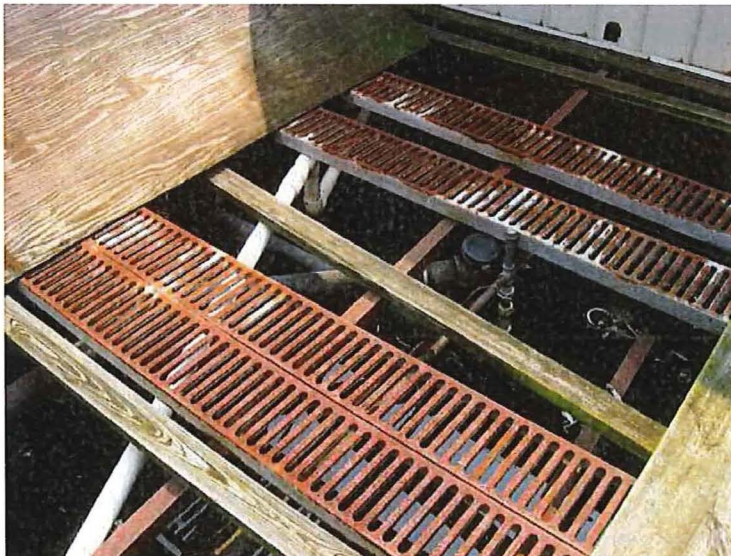
Facility: Hillview Estates Subdivision
Photographer: Kevin Hotz
Date: Time:
Others Present:
Location/Description: Missing grating at clarifier and wooden walkways

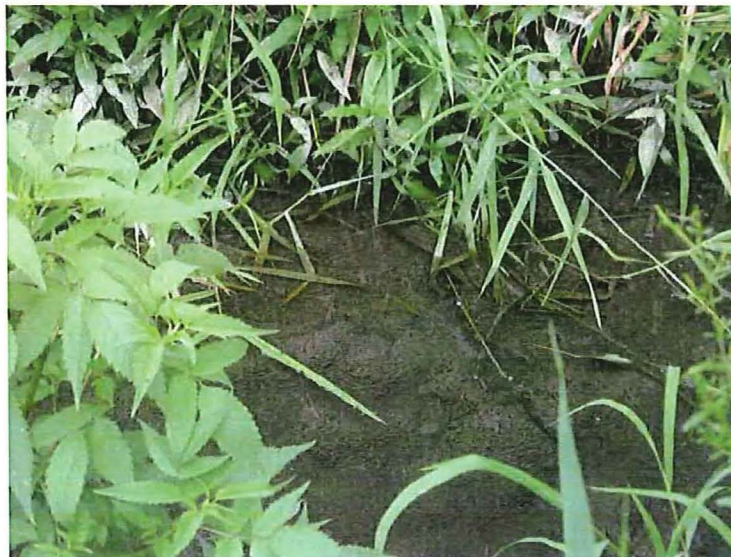
Facility: Hillview Estates Subdivision
Photographer: Kevin Hotz
Date: 6/30/2015 Time:
Others Present:
Location/Description: Sludge build up in channel next to creek

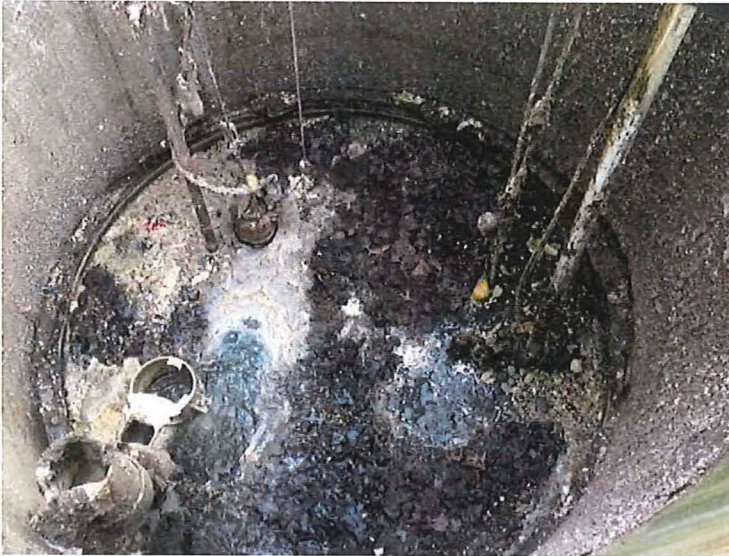
Facility: Hillview Estates Subdivision
Photographer: David Denman
Date: 1/4/2016 Time:
Others Present: Kevin Hotz
Location/Description: Grease and trash in wet well

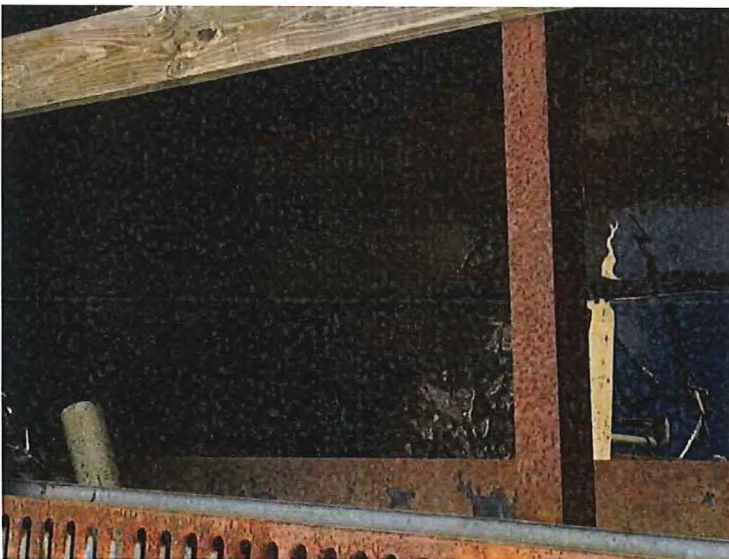
Facility: Hillview Estates Subdivision
Photographer: David Denman
Date: 1/4/2016 Time:
Others Present: Kevin Hotz
Location/Description: Floating sludge in clarifier

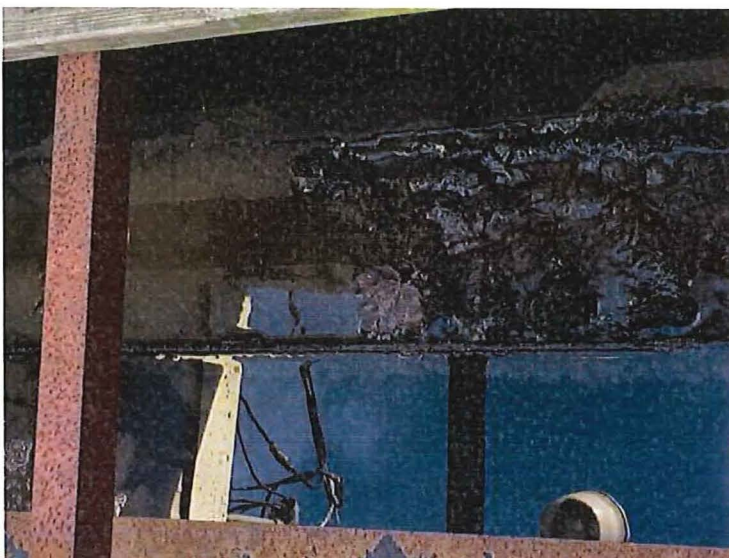
Facility: Hillview Estates Subdivision
Photographer: David Denman
Date: 1/4/2016 Time:
Others Present: Kevin Hotz
Location/Description: Sludge in weir trough

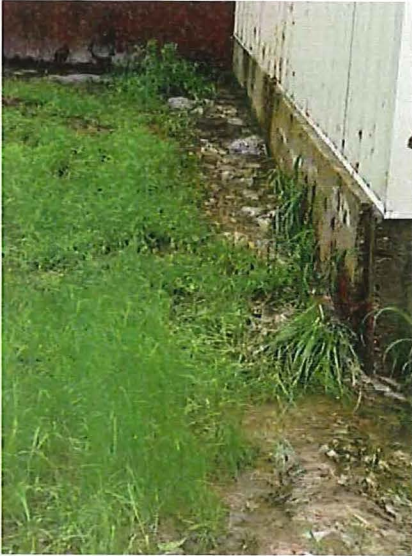
Facility: Hillview Estates Subdivision
Photographer: Kevin Hotz
Date: 8/16/2016 Time:
Others Present: Andrew Naumann
Location/Description: Sewage coming out of the ground near the garage door.

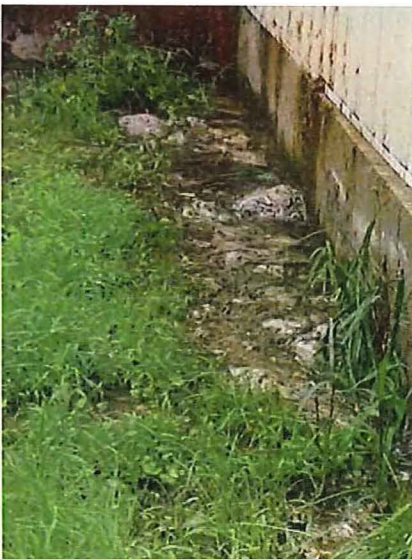
Facility: Hillview Estates Subdivision
Photographer: Kevin Hotz
Date: 8/16/2016 Time:
Others Present: Andrew Naumann
Location/Description: Sewage coming out of the overflow pipe near the garage door.

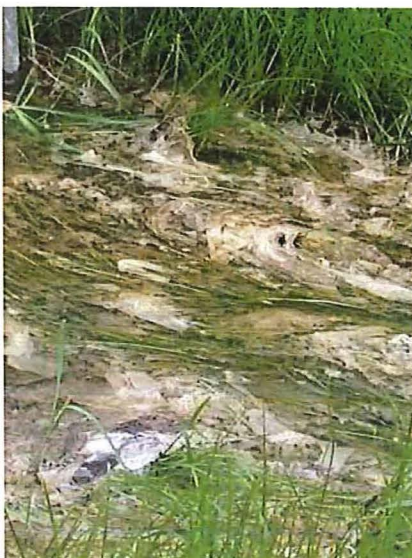
Facility: Hillview Estates Subdivision
Photographer: Kevin Hotz
Date: 8/16/2016 Time:
Others Present: Andrew Naumann
Location/Description: Sewage solids on ground flowing into ditch.
