To identify the root causes of the STG-1 generator failure to synchronize with grid and the damage to the generator field at the Eagle Valley power plant facility. This includes identifying deficiencies in, or lack of, management systems and oversight. Appropriate recommendations for root causes will be communicated to management for rapid resolution.

Event Date: November 10, 2021

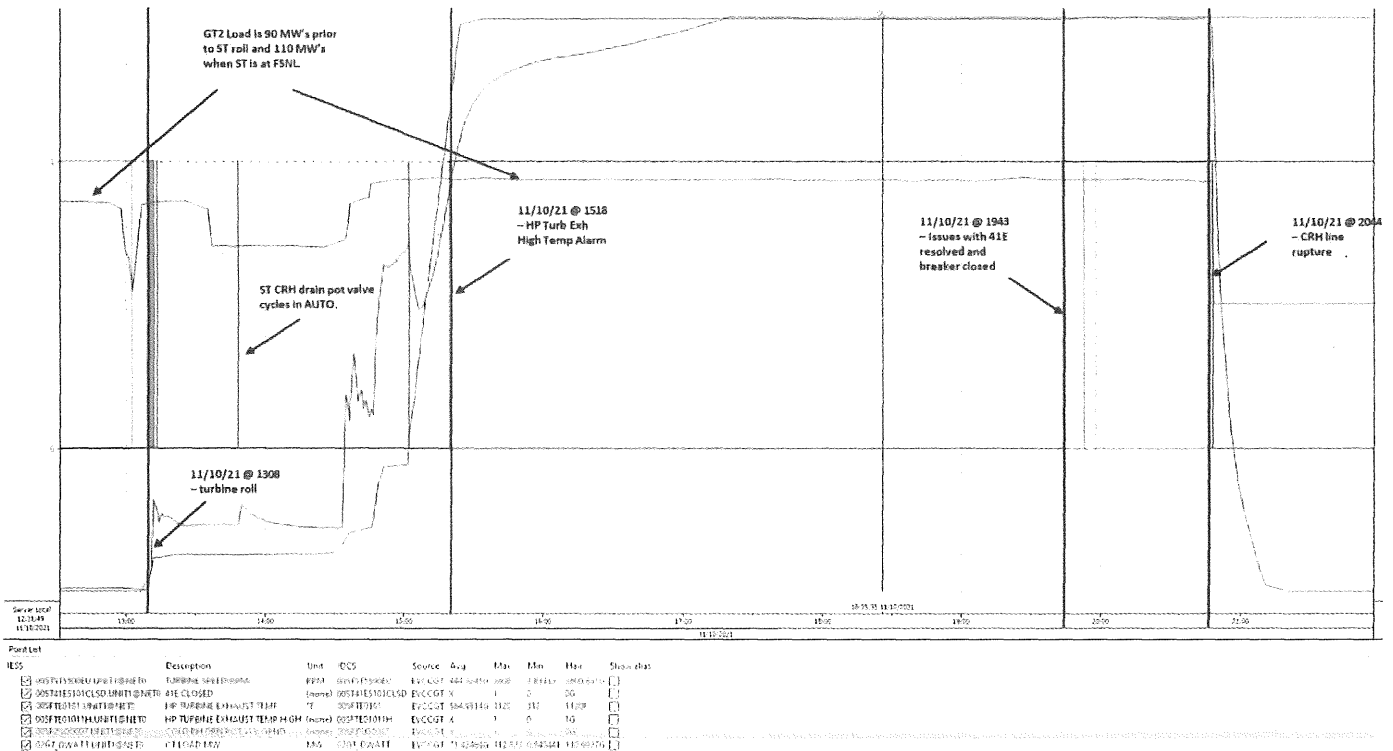
Figure 11, Effect of CRH drain valve on November 10, 2021, STG Startup

13:21	GT2 Synch - MW setting adjusted from 25 to 16	
	13:24	GT2 - Temp Matching Mode Enabled	
	13:30	CRH condensate drain valve set in Auto mode	
	14:27	GT2 - Temp Matching Mode Disabled	Deviation from startup procedure. Not documented in log book or in the startup procedure record. Plant leadership wanted to lower emissions.

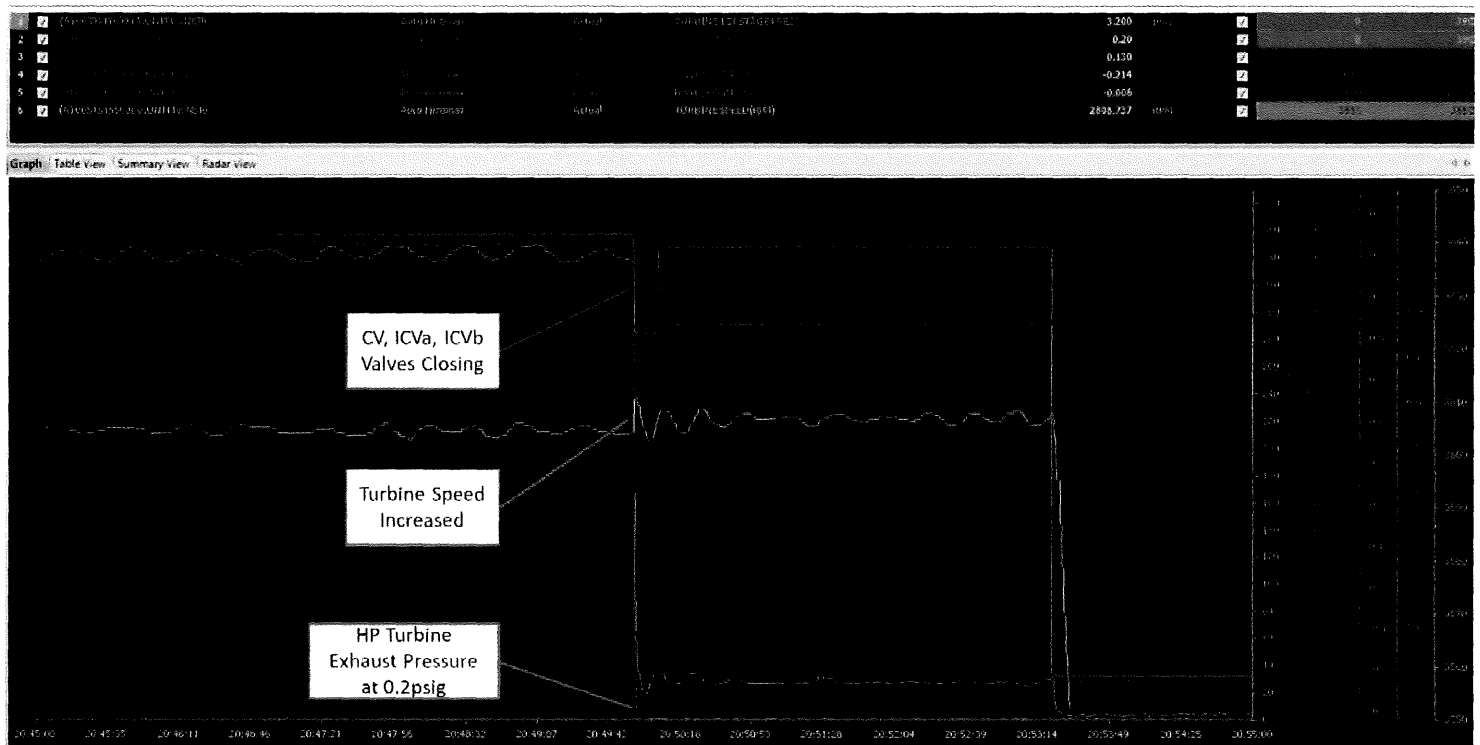
Figure 12, STG Trend data of at time of pipe rupture

19:54	STG - 52G Breaker Fails to Close	Troubleshooting began
	20:44	STG - CRH pipe ruptures	
	20:47	STG - Manually Tripped	
	20:47	GT2 - Manually Tripped

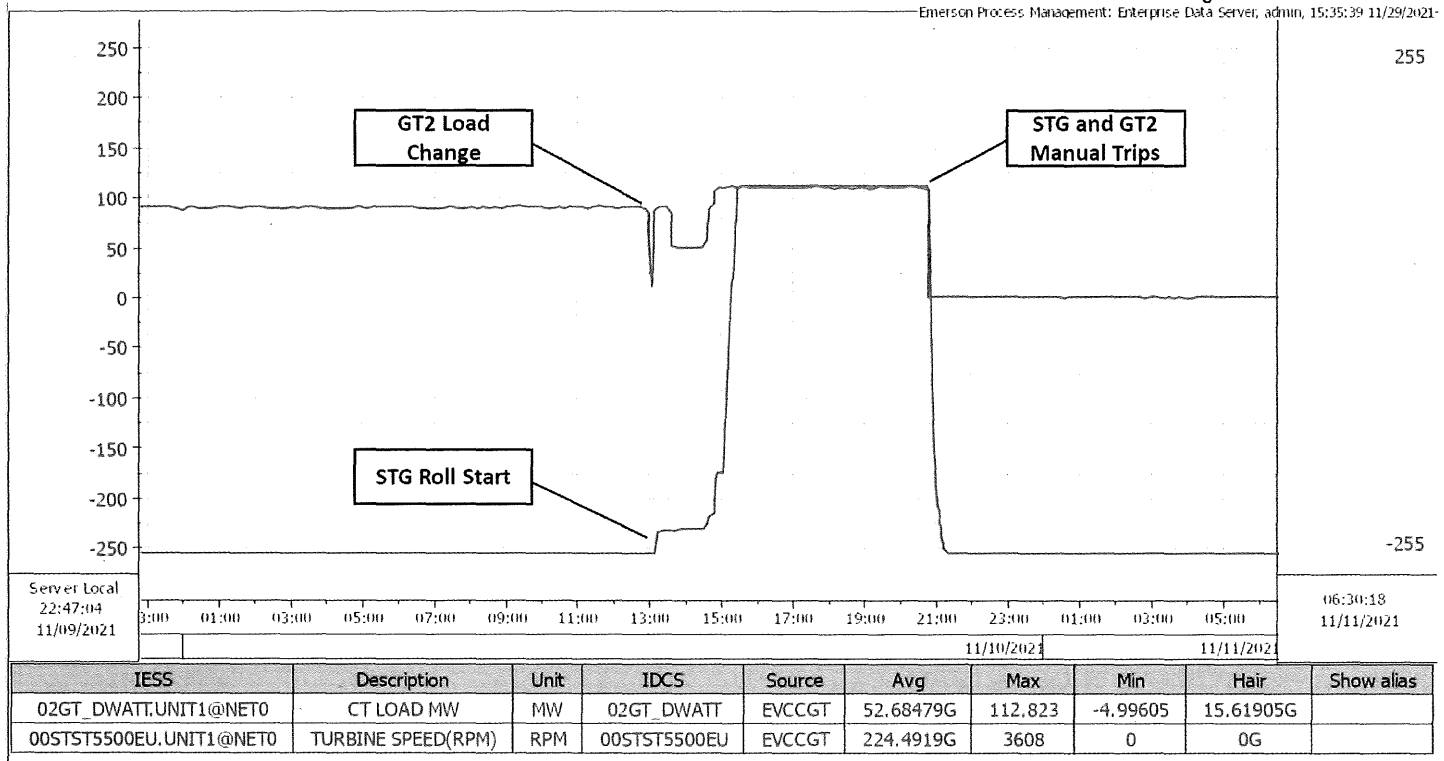
Figure 15, Trend data of GT2 Load and STG Turbine Speed (November 10th STG startup)

Sequence of Events	Observations
11/10/2021	13:08	GT2 - MW setpoint increased from 15MW to 90MW	Operator was instructed by the Operations Manager to raise the MW back up to get into DLN emissions mode

13:40	GT2 - MW setpoint decreased from 90MW to 50MW	Unclear why the changes in GT MW setpoint
	14:40	GT2 - MW setpoint increased from 50MW to 90MW	Unclear why the changes in GT MW setpoint

14:50	GT2 - MW setpoint increased from 90MW to 110MW	Unclear why the changes in GT MW setpoint
	14:58	Main Steam (1,042F @ 1,500psi)	Design is [REDACTED]
