**REBUTTAL TESTIMONY OF RONALD A. HALPERN
PRESIDENT, GENERATOR CONSULTING SERVICES, INC.
ON BEHALF OF DUKE ENERGY INDIANA, INC.
CAUSE NO. 38707FAC76-S1 BEFORE THE
INDIANA UTILITY REGULATORY COMMISSION**

**INDIANA UTILITY
REGULATORY COMMISSION**

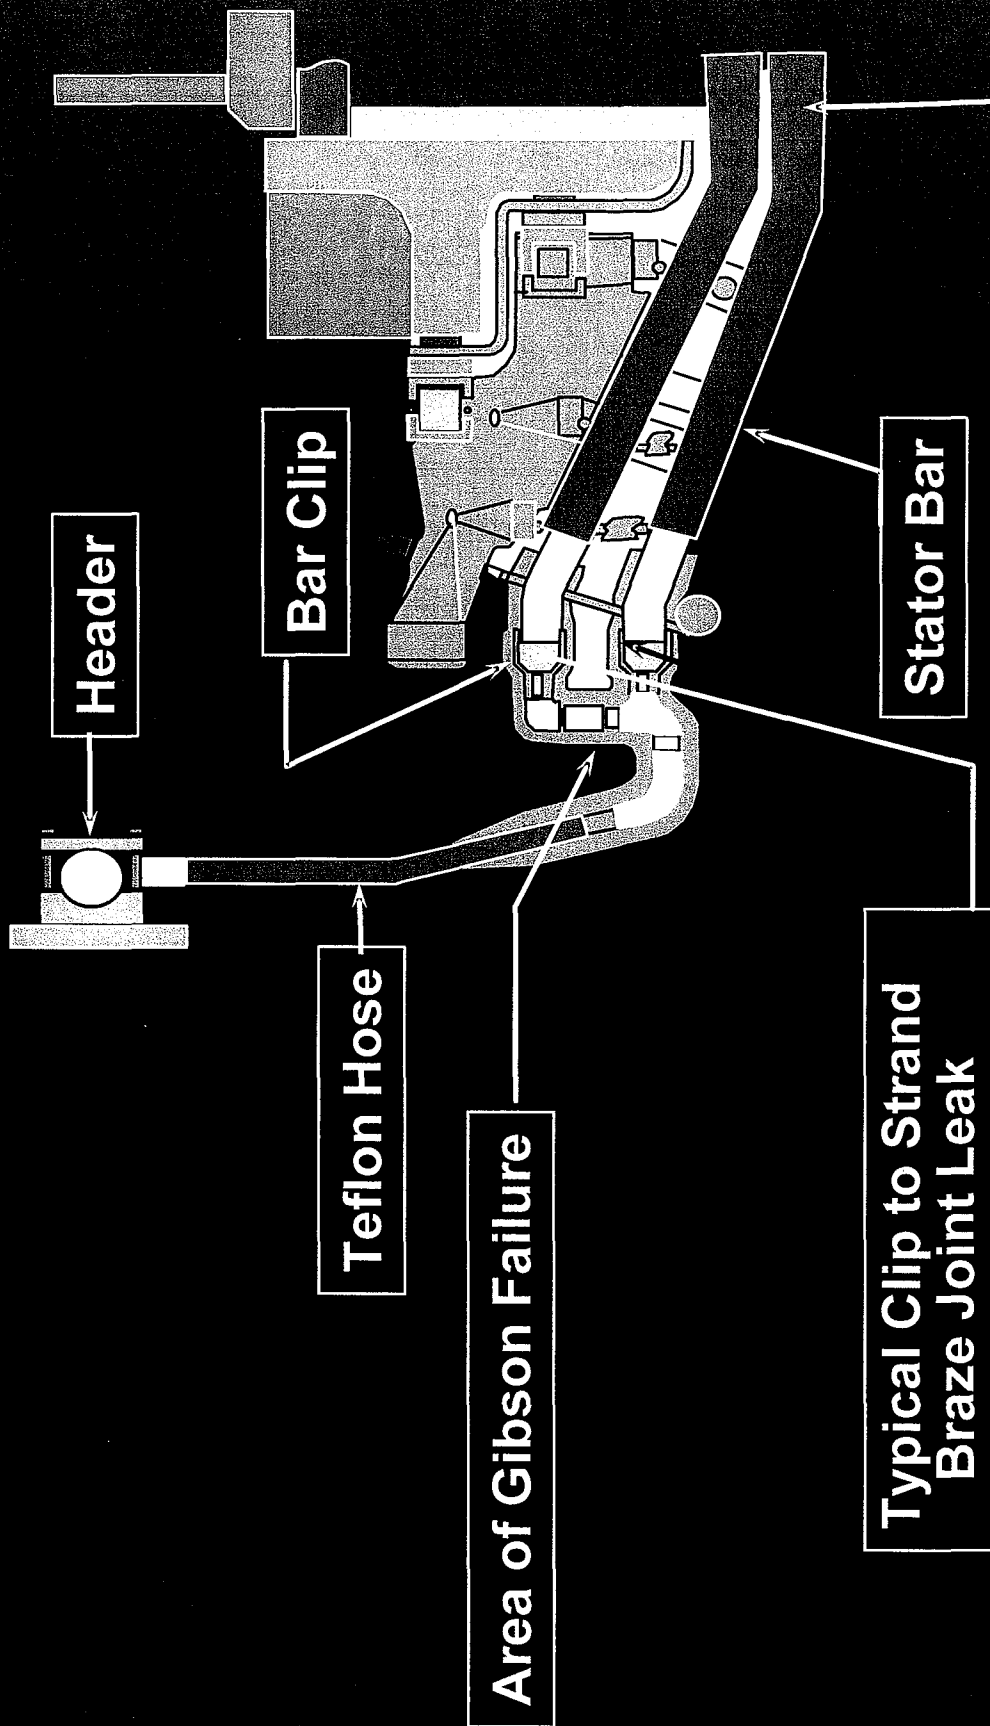
Typical Leak Locations vs. Gibson Failure Location

17 A. No. The failure at Gibson Unit 4 was at the connections, not at the end of the
18 core. Attached is Exhibit G-2, which are diagrams and pictures that show the
19 location of typical stator bar leaks and the location of the failure that occurred on
20 Gibson Unit 4. I have also attached pictures, attached as Exhibit G-3, taken as the
21 Gibson Unit 4 generator was being disassembled which reinforces my conclusion
22 that the failure was at the connections and not at the end of the core. This type of
23 failure is very unusual and, in my opinion, means that the cause of the failure was

Typical Failure location

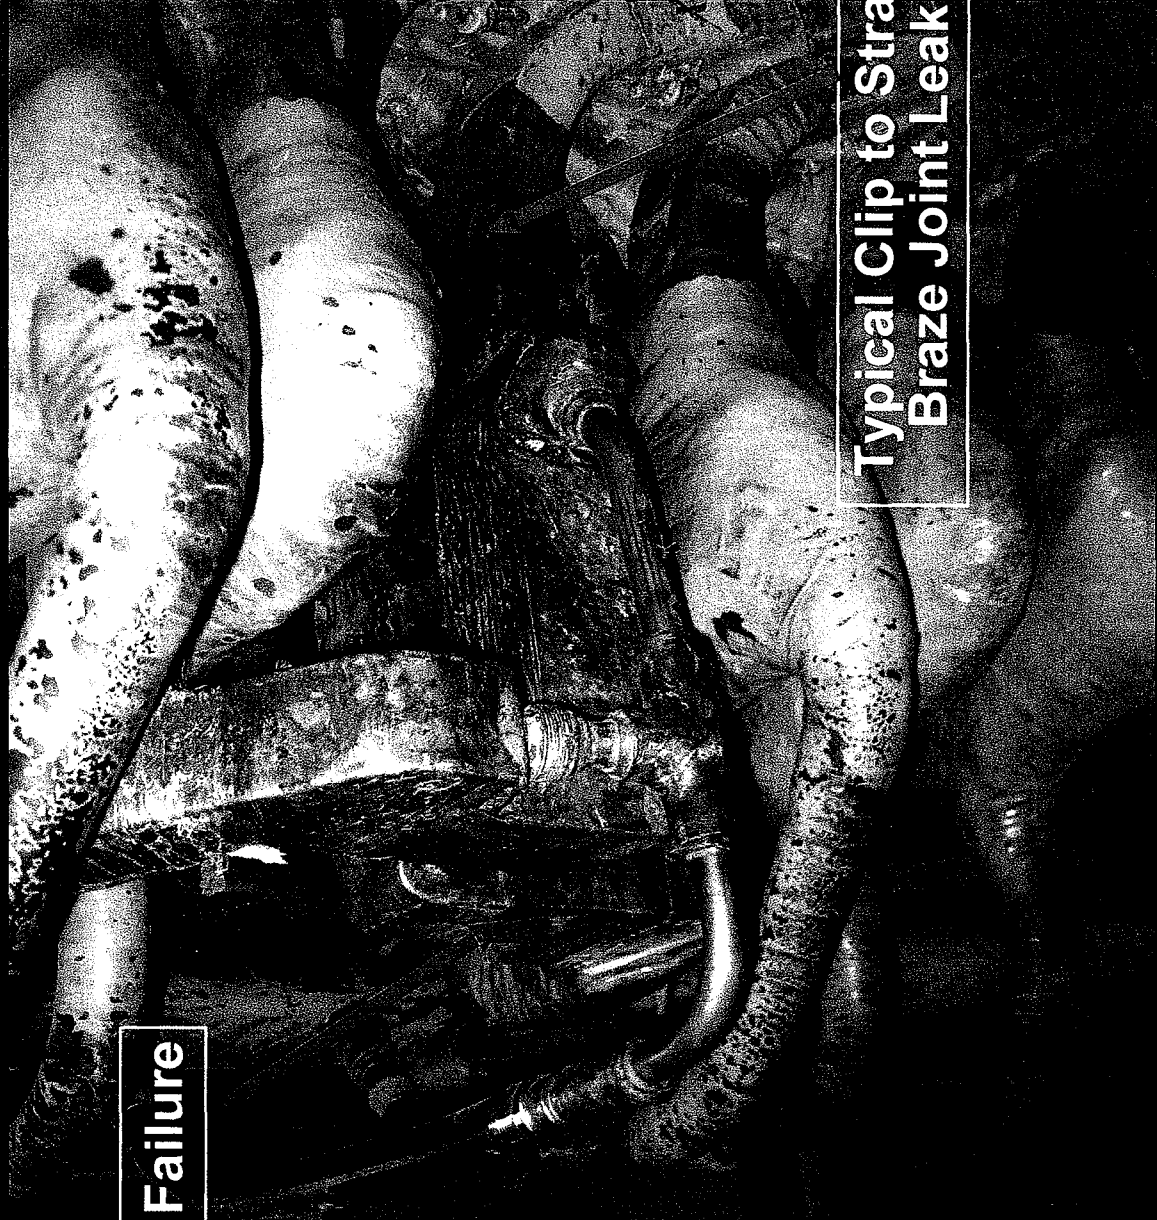
Typical Leak Locations vs. Gibson Failure Location

Area of Gibson Failure

Typical Clip to Strand
Brazed Joint Leak

Area of Gibson failure at connections

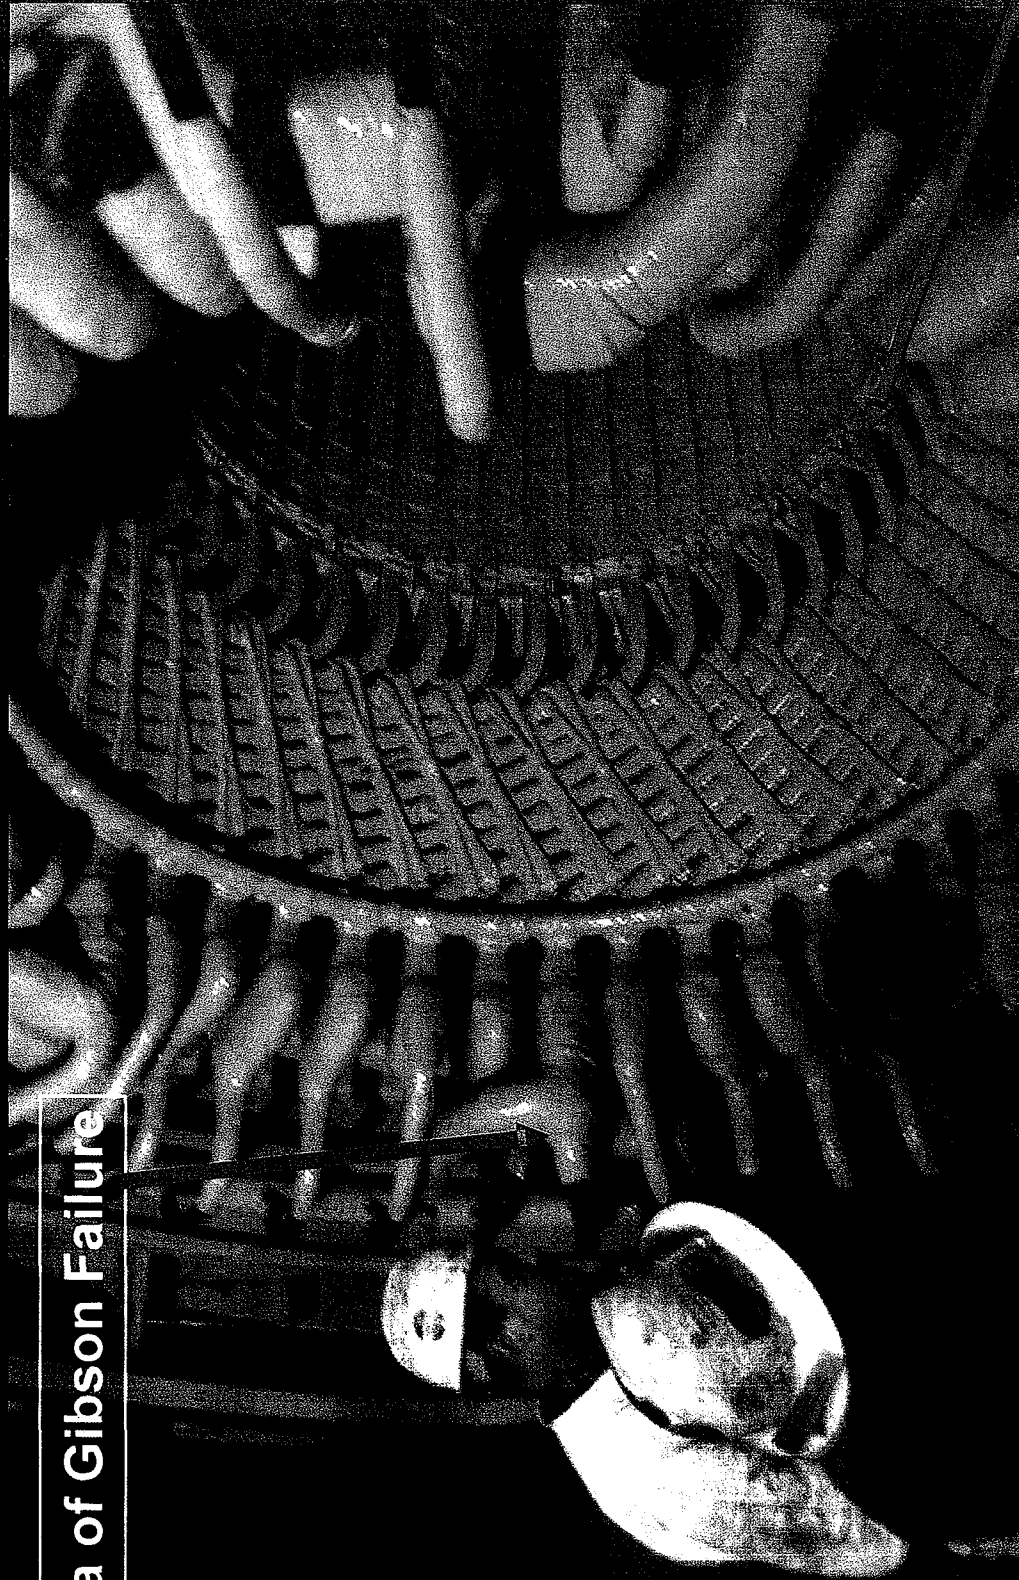
Area of Gibson Failure

Typical failure location

Area of Gibson failure at connections

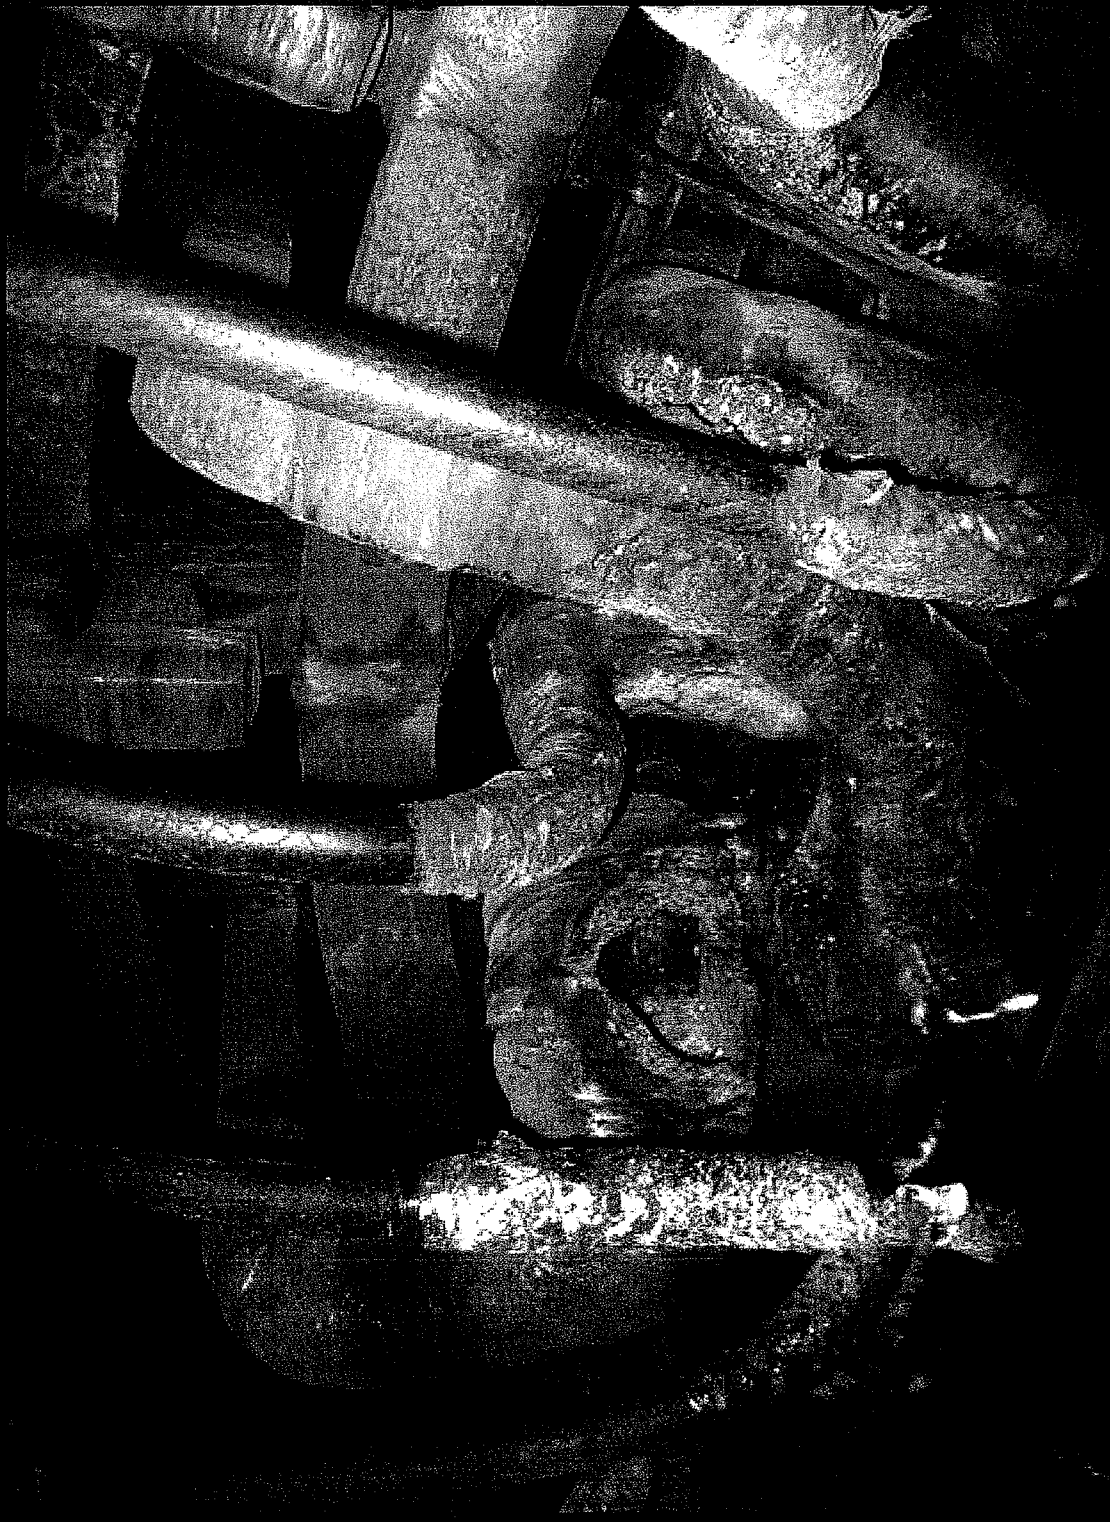
Area of Gibson failure at connections-as found condition
