Insufficient flow of steam through the HP section

Insufficient notification and response to high HP Turbine Exhaust temperature

The steam turbine operated outside parameters for an extended time with no load (FSNL)

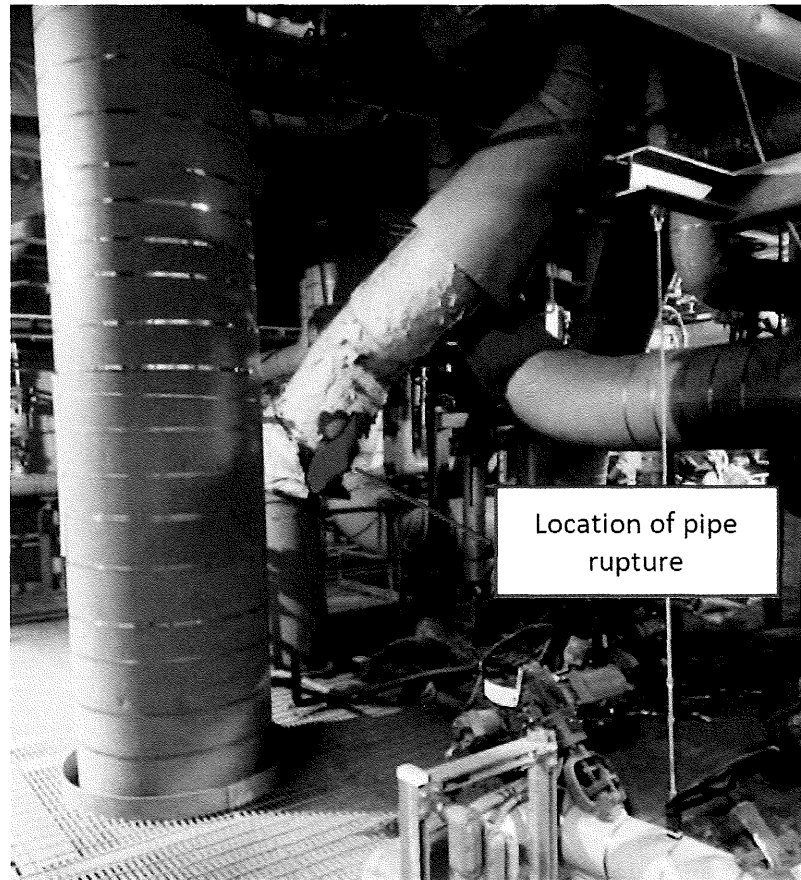
Photograph 1, HP Turbine Exhaust pipe (8 minutes after rupture)

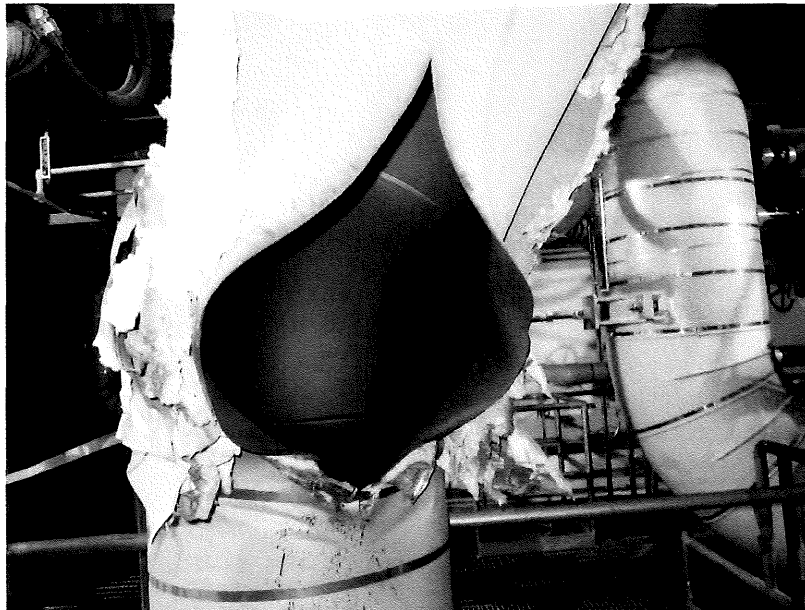
Photograph 2, Ruptured HP Turbine Exhaust pipe (South Leg)

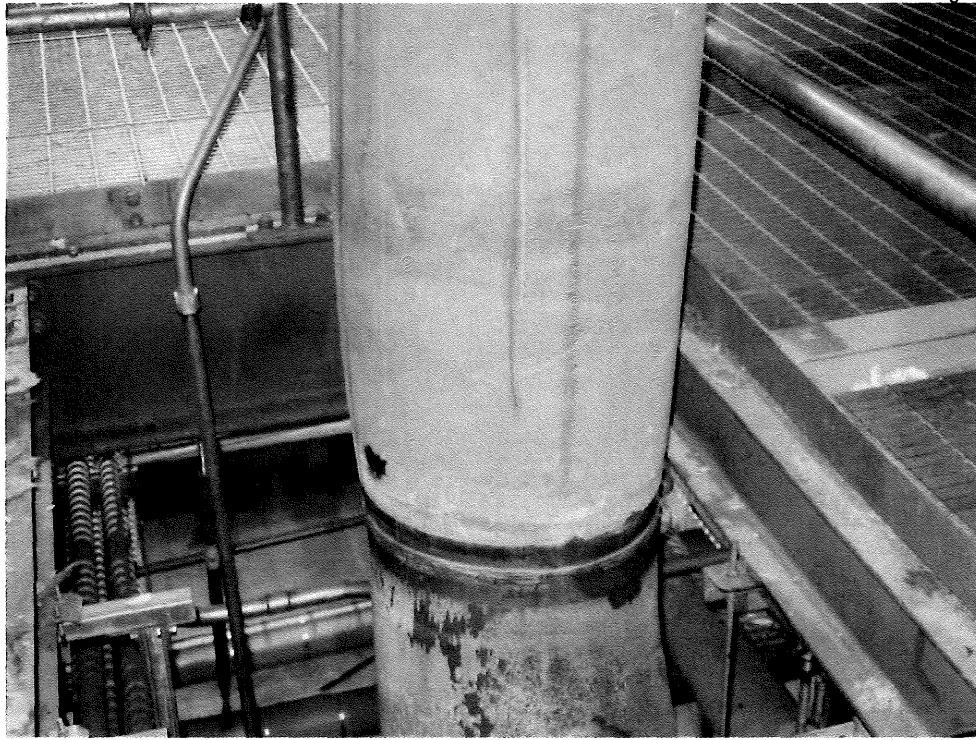
Photograph 3, Bulging HP Exhaust Pipe (North Leg with insulation removed)
