INDIANA UTILITY REGULATORY COMMISSION

CAUSE NO. 45342

REDACTED SUPPLEMENTAL TESTIMONY

REDACTED SUPPLEMENTAL TESTIMONY OF OUCC WITNESS
JAMES T. PARKS
CAUSE NO. 45342
COMMUNITY UTILITIES OF INDIANA, INC.

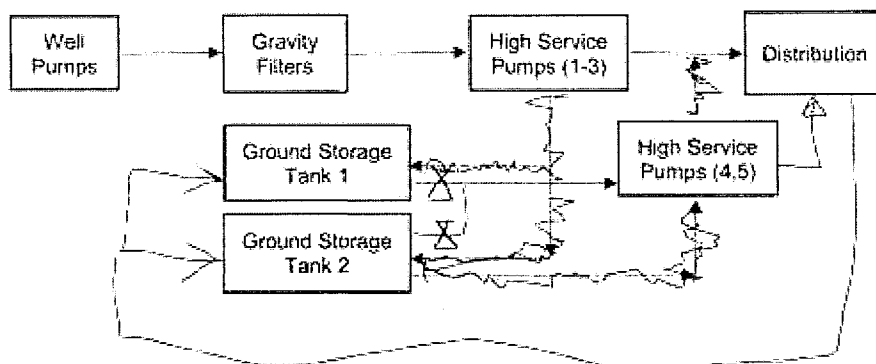
Figure 1. Current Water Treatment/Storage/Pumping Schematic

The existing condition flow paths are not accurate. The actual situation is like this. The GSTs float off the distribution system. The blue valves, as shown, allow each tank to be isolated before the tee connection.
