INDIANA UTILITY REGULATORY COMMISSION

CAUSE NO. 44976

TESTIMONY OF
JAMES T. PARKS – PUBLIC’S EXHIBIT NO. 4
ON BEHALF OF THE
INDIANA OFFICE OF UTILITY CONSUMER COUNSELOR
NOVEMBER 2, 2017

TESTIMONY OF OUCC WITNESS JAMES T. PARKS, P.E.
CAUSE NO. 44976
INDIANA AMERICAN WATER COMPANY, INC.
AND THE CITY OF CHARLESTOWN, INDIANA

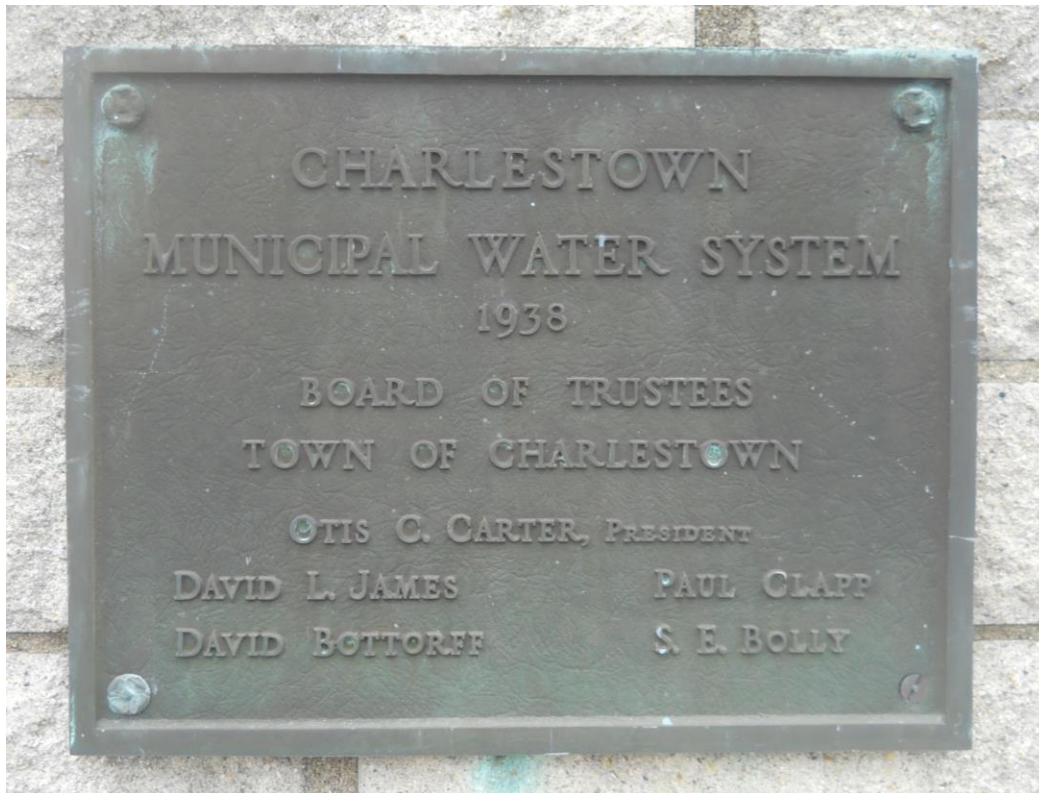
Figure 1 – Charlestown Water System 1938 Dedication Plaque on Pump Building

3 A: Yes. Two bronze plaques at the Pump Building doorway, document that
4 Charlestown's Water System was dedicated in 1938 and gives 1963 as the date of
5 the Water Improvement Program referenced above. (*See Attachment JTP-4 for*
6 *photos of the two dedication plaques.*) Also, in 1977 the Commission found that
7 the existing storage tanks were in a state of disrepair and noted "the City proposes
8 to remedy the existing conditions by the ... renovation of ground and elevated
9 storage tanks."¹² This 1977 finding further supports that the tank was actually
10 constructed in 1963 and not 1975. It is unlikely that a tank coating would have
11 failed after only two years.

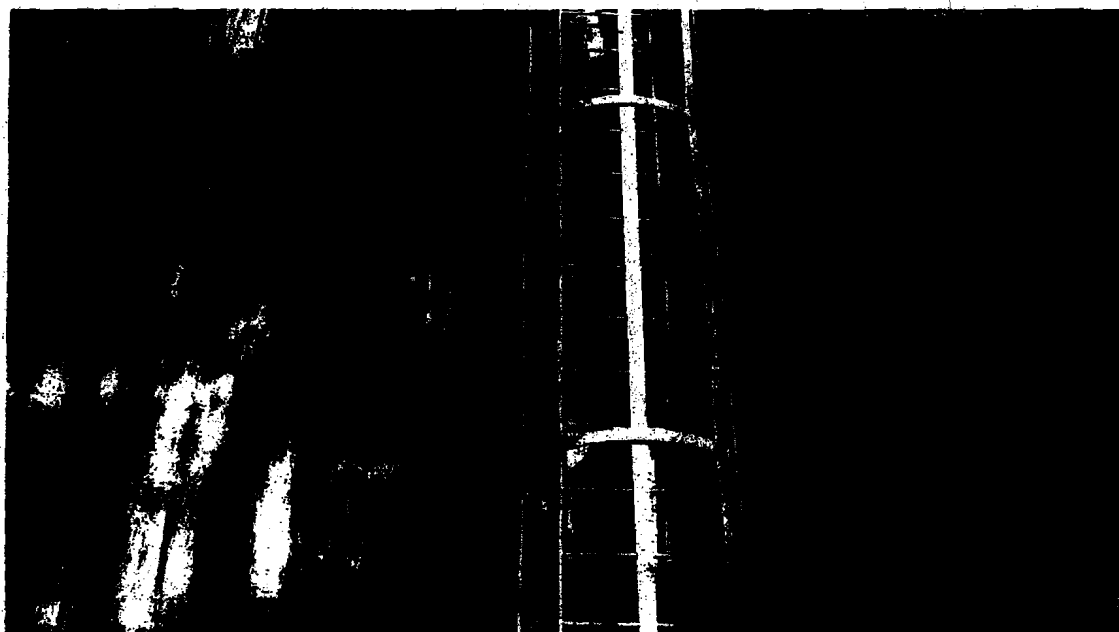
Shell ladder in above photo is not in compliance with OSHA and AWWA D100-96, Section 7.4: Ladders, 7.4.1: Outside tank ladder, regulations. We recommend replacement of the ladder for the following reasons:

*Recommendation
* Notch rail or cable grab system*

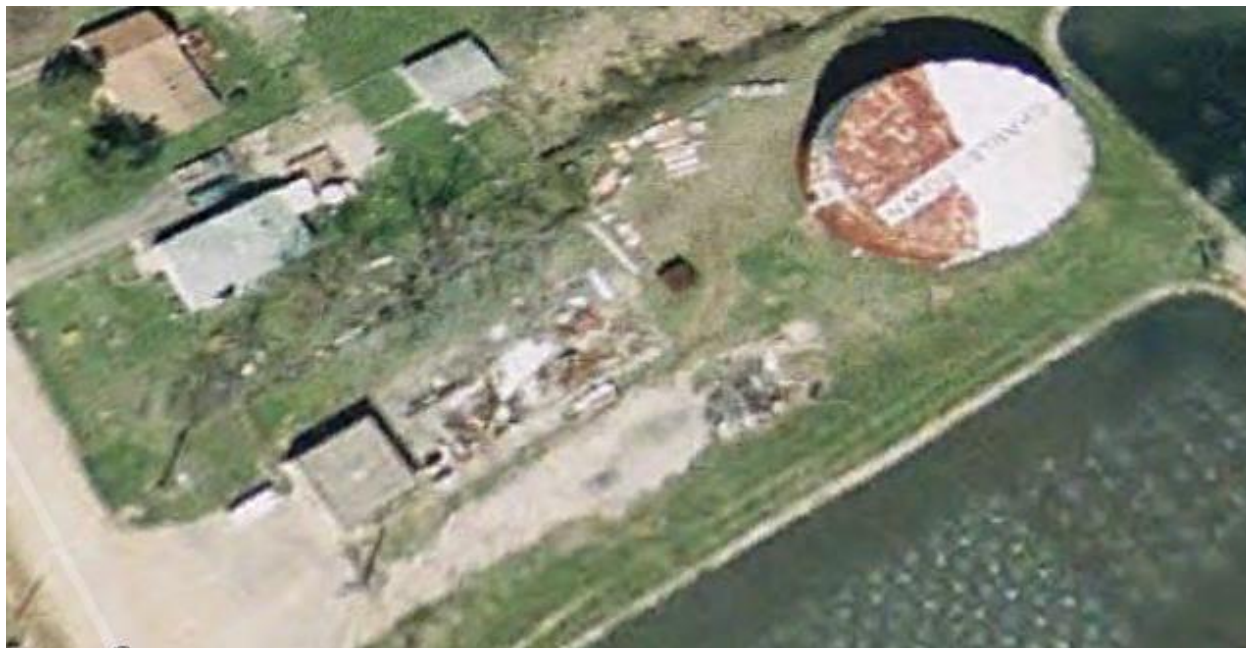
Figure 1 - December 2002 – Aerial of Charlestown’s 1.5 MG Ground Storage Tank showing extensive rusting of the roof and west half of the tank steel. Also shown is the Pump Building.

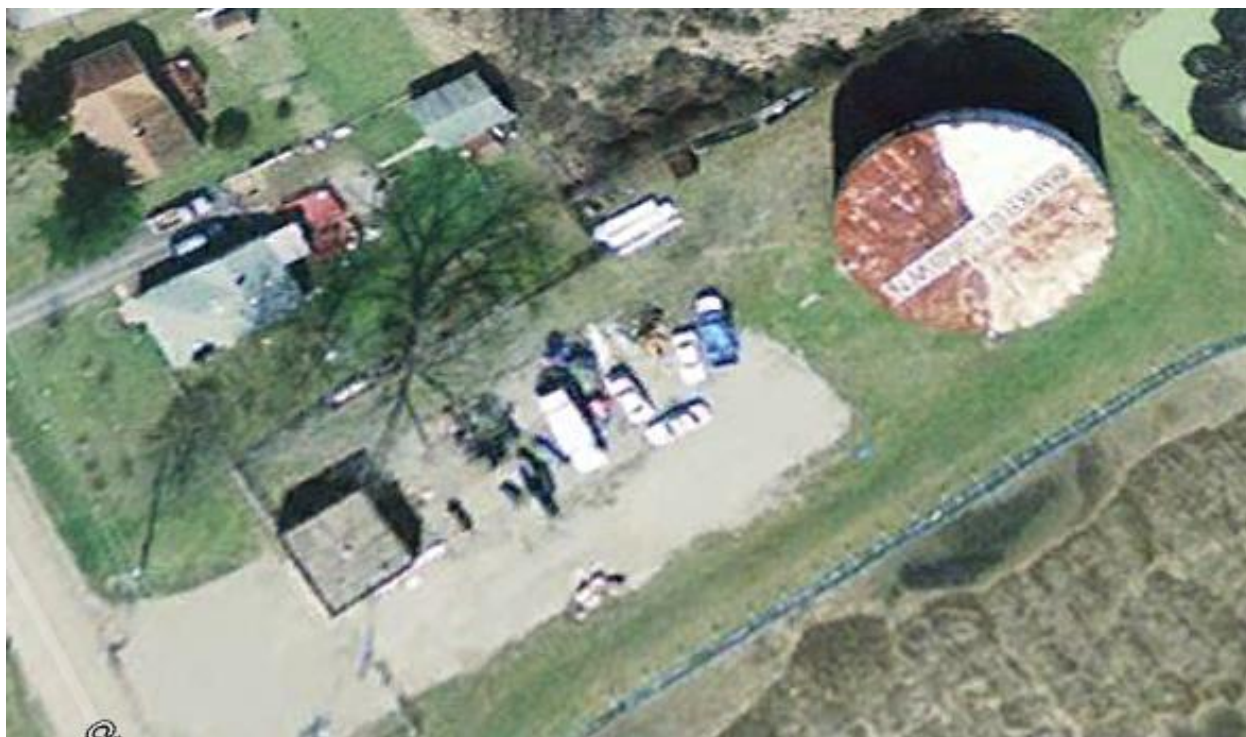
Figure 2 - March 2005 – Aerial of Charlestown’s 1.5 MG Ground Storage Tank showing extensive rusting of the roof steel.

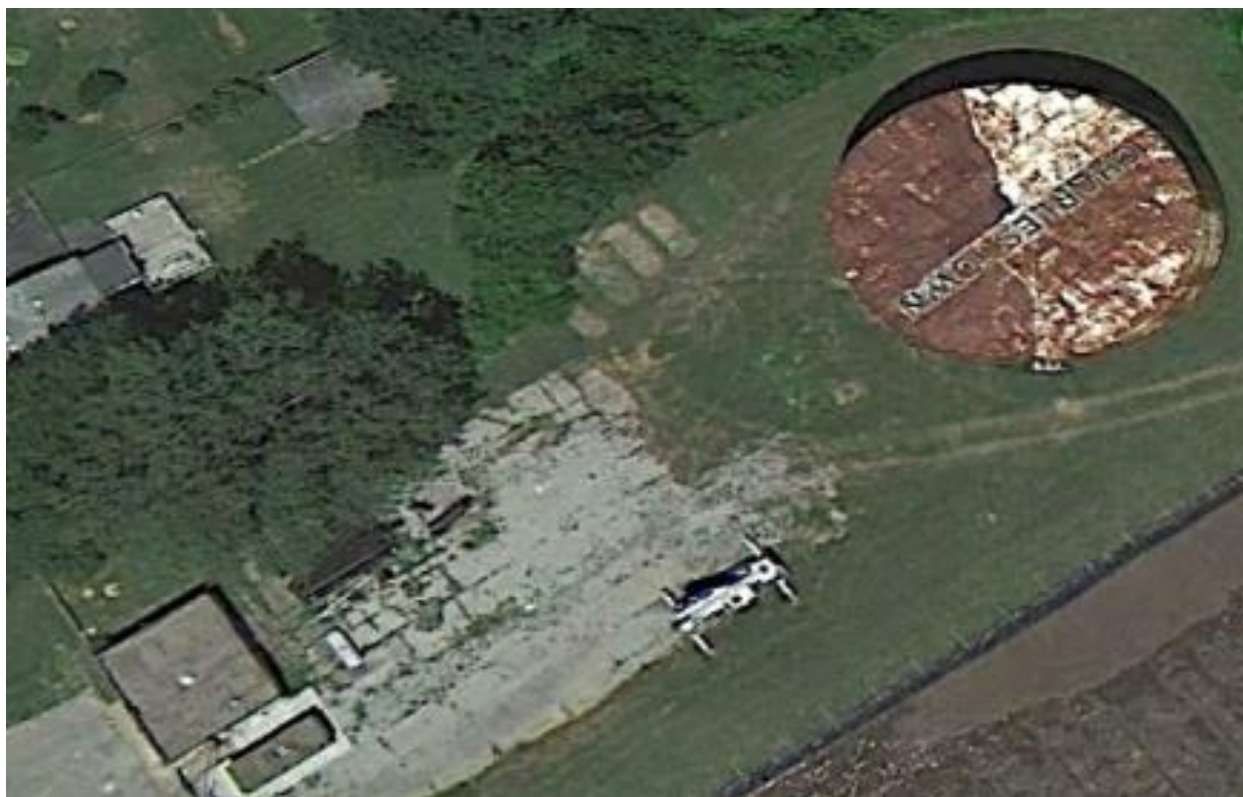
Figure 3 – June 2010 – Aerial of Charlestown’s 1.5 MG Ground Storage Tank showing the progression of roof rusting. Note the standby generator south of the Pump Building (lower left).

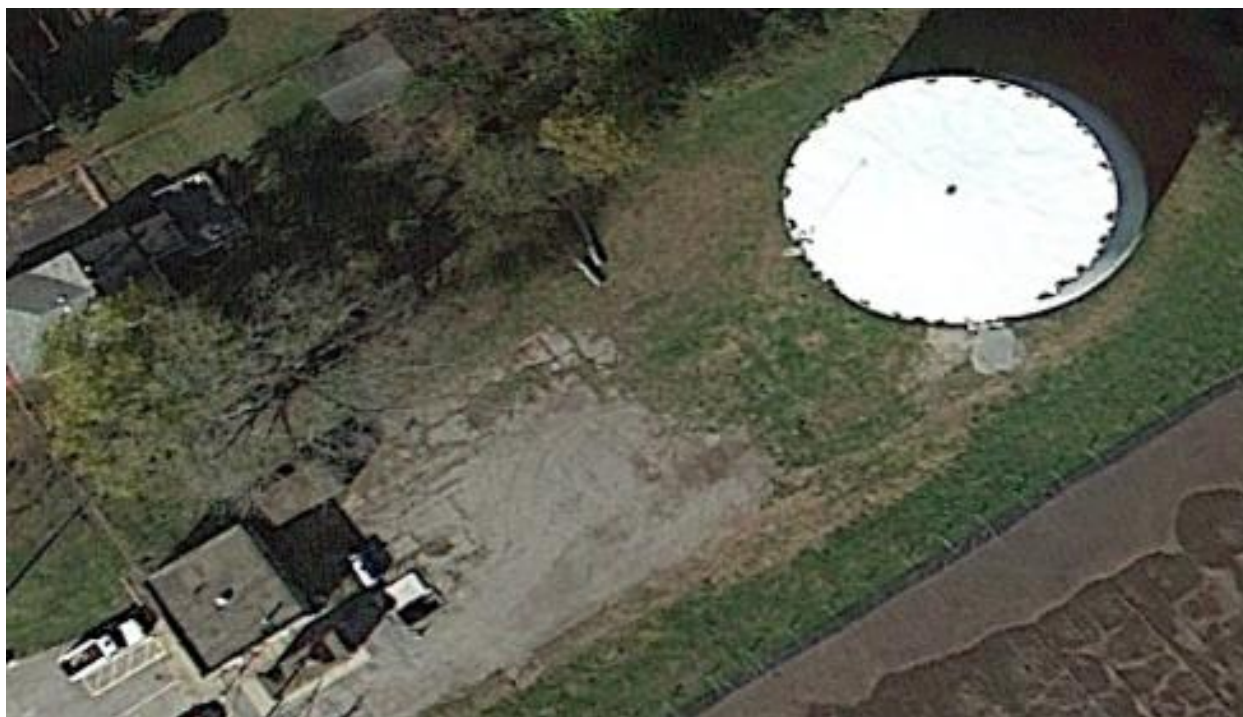
Figure 4 – November 2013 – Aerial of Charlestown’s 1.5 MG Ground Storage Tank showing the tank has been repainted. Note that the roof shows rust pockets at the roof-wall interface.

14 A: Yes. The tank exterior has been repainted, but it is beginning to exhibit rust on the
15 walls. I did not inspect the interior and cannot report on its condition. In 2016, the
16 appraisers viewed the tank exterior. From 2013 and 2016 aerial photos, I identified
17 underlying rust areas at the roof/wall interface. These areas appear to currently
18 have a failed coating that should be promptly inspected and addressed. *See*
19 *Attachment JTP-7* for aerial photos and GST photos taken in 2005 and 2017.

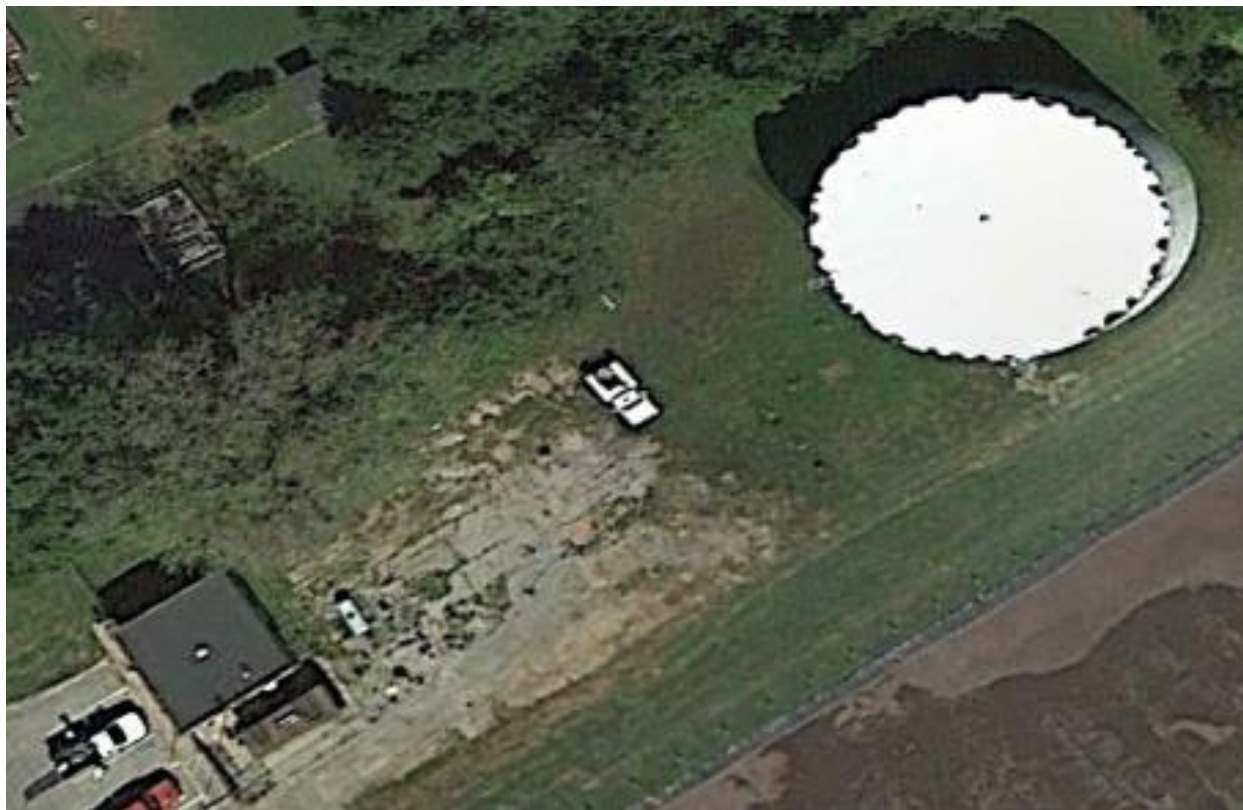
Figure 5 – September 2013 – Aerial of Charlestown’s Pump Building and 1.5 MG Ground Storage Tank showing the tank roof rust pockets at the roof-wall interface.

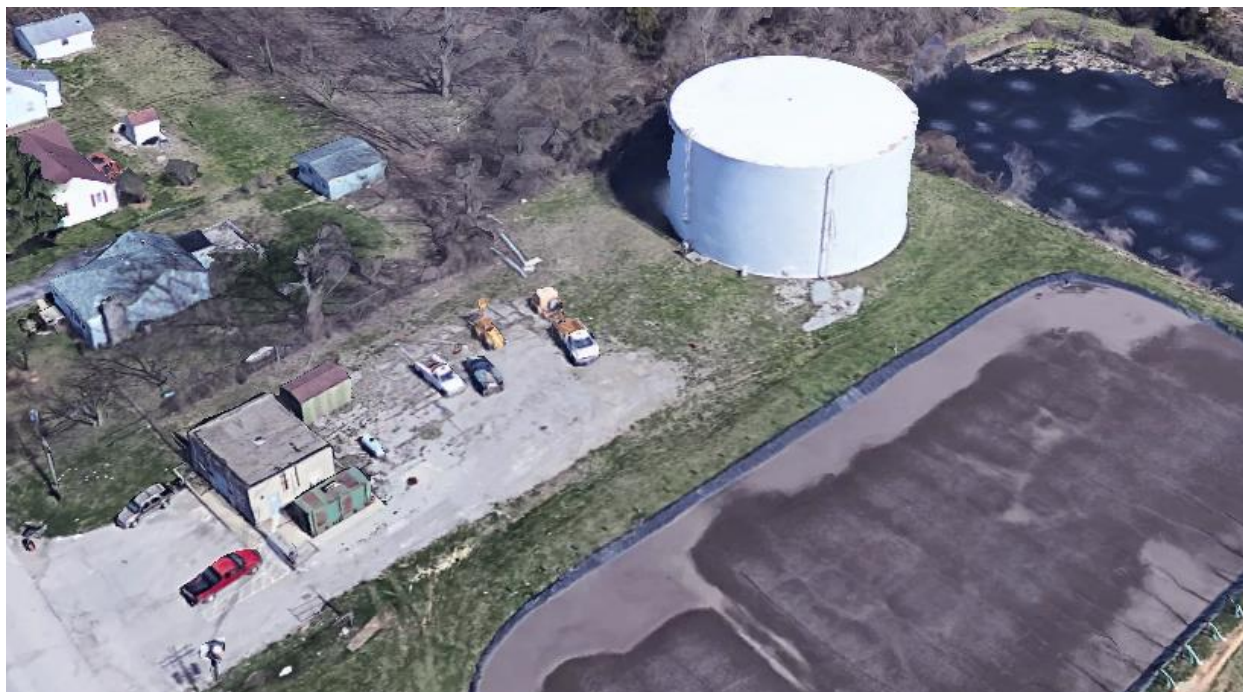
Figure 6 - September 2016 – Oblique view of Charlestown’s 1.5 MG Ground Storage Tank showing the repainted tank, Pump Building, and standby (nonfunctioning) generator (lower left).

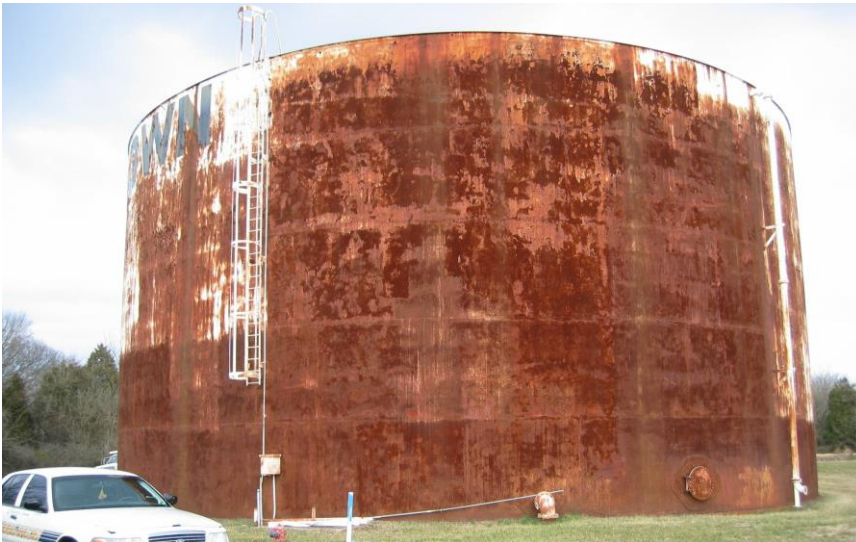
Figure 9 – 1.5 MG GST showing extensive rust. Photo taken in 2005.

13 A: The condition is poor. Based on my observations, the tank's steel exterior shows
14 uniform pit corrosion indicating the protective tank coating has been neglected. At
15 first look, I thought the tank had a textured coating but then realized that the
16 underlying steel surface was pitted. Such pitting is caused by rust that results when
17 repainting is not done in a timely manner. The lack of tank maintenance is
18 confirmed by previous OUCC testimony. In Charlestown's 2006 rate case, the
19 OUCC noted the ground storage tank's poor condition:

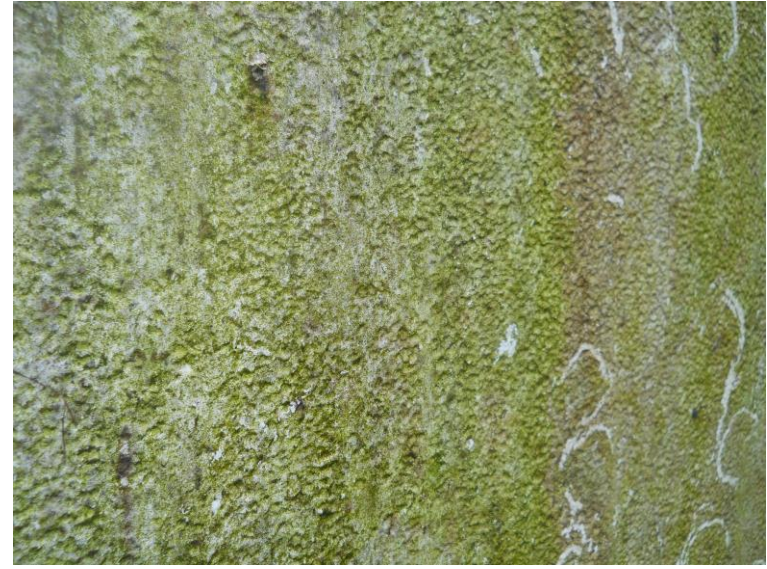
Figure 12 – Photo of corrosion pitting. Oct. 12, 2017

8 A: Based on my observations at the site visit, the delay likely caused progression of
9 corrosion beyond surface rust to include pitting of exterior steel. The inspection
10 conducted in 2004, after iron and manganese sediments had been partially removed,
11 indicated interior steel rusting and pitting.¹⁶ This would have also progressed
12 causing deeper pits and steel loss.

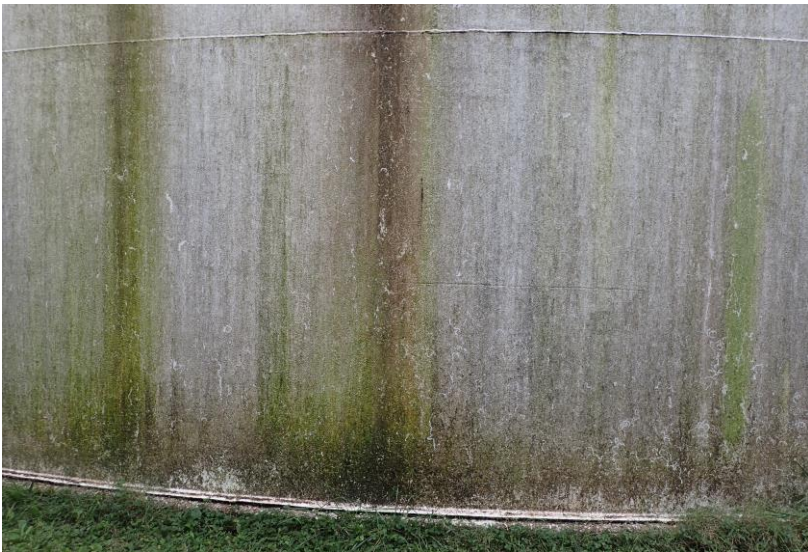
Figure 13 – 1.5 MG GST showing rust streaks. Oct. 12, 2017

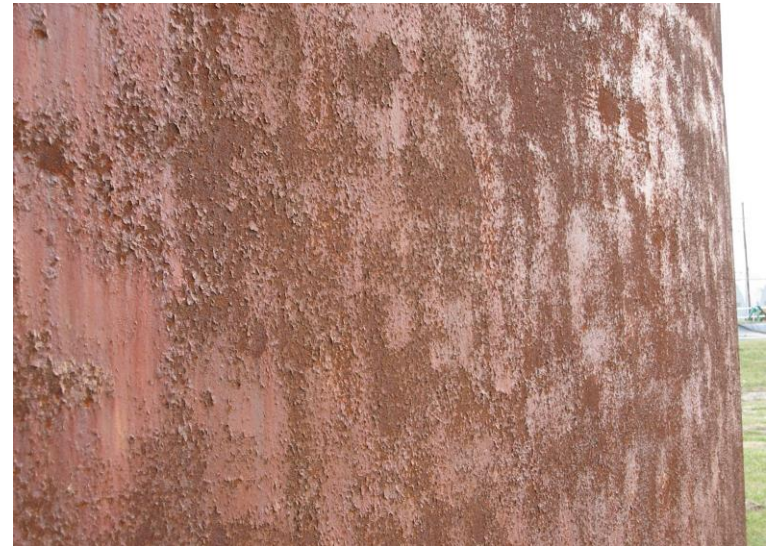
Figure 14 – 1.5 MG GST showing rust streaks. Photo taken in 2005.

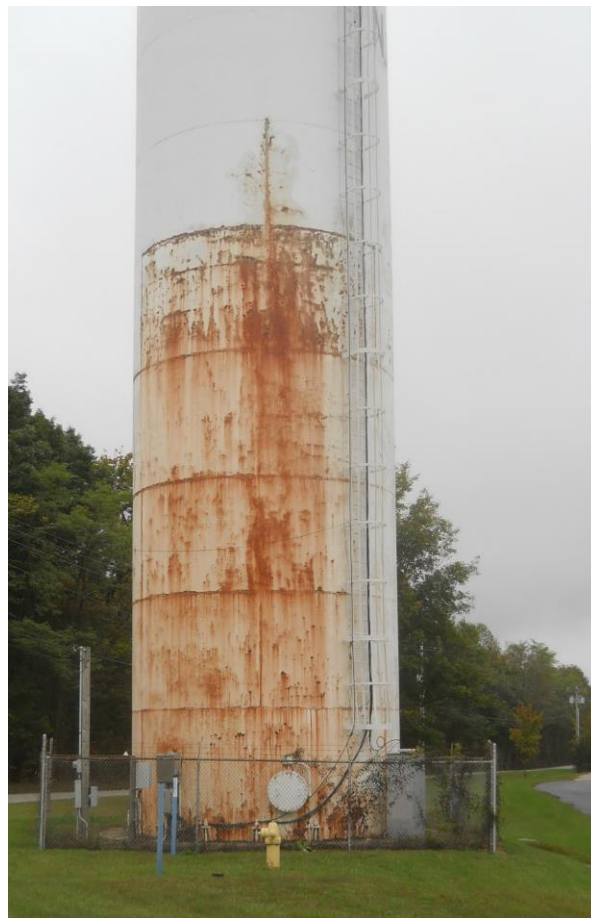
Figure 2 Standpipe rust and coating failure

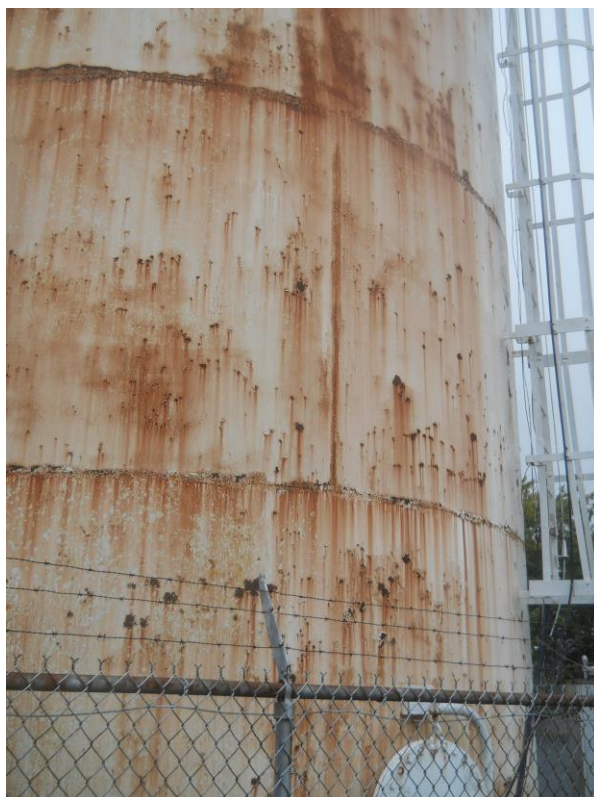
Figure 3 Standpipe rust.

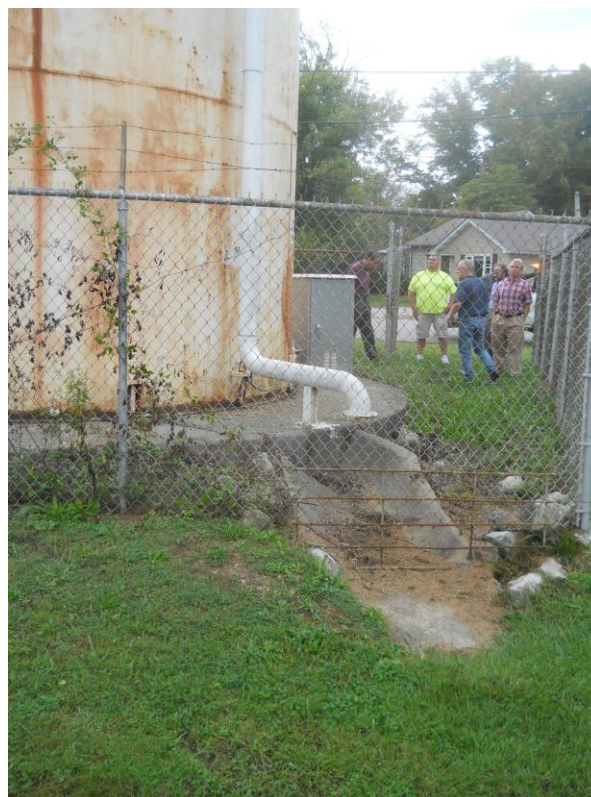
Figure 4 Standpipe overflow pipe.

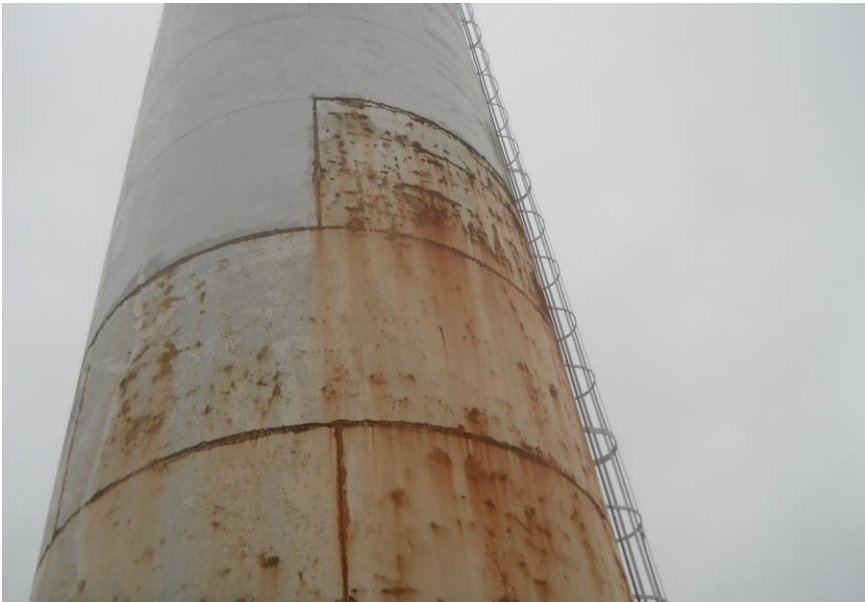
Figure 5 Rusty welds and plate steel (10/12/17 photos)

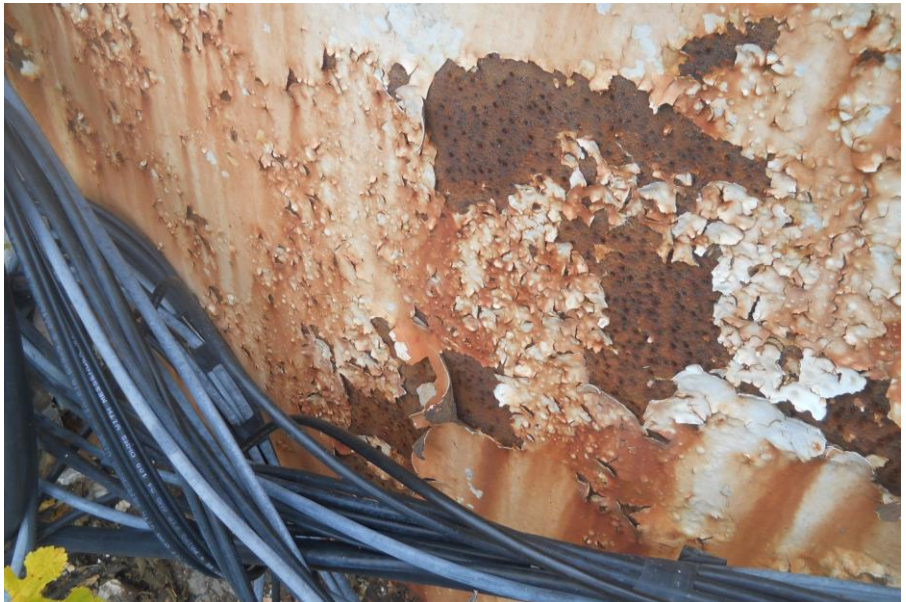
Figure 7 Standpipe lower section with coating failure and corrosion.

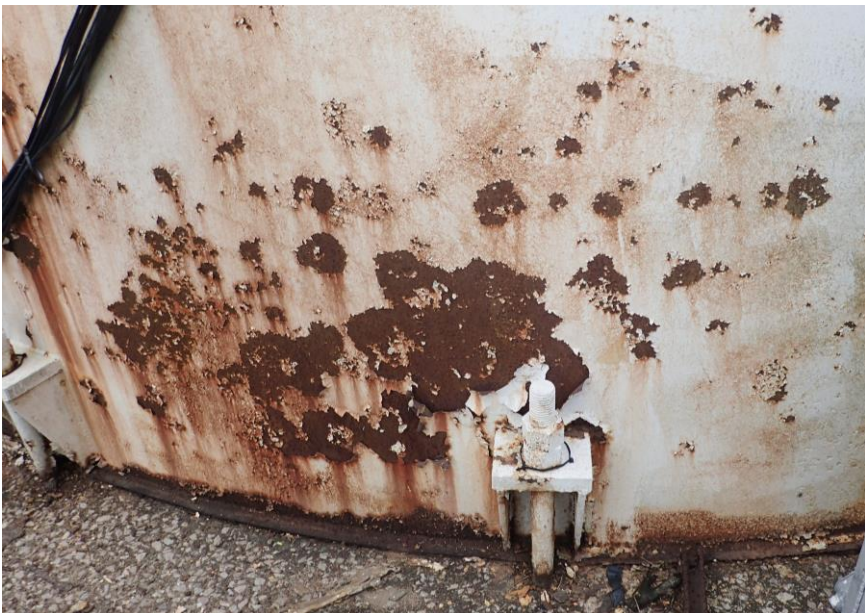
Figure 6 Surface rust and pitting including chine corrosion (bottom).

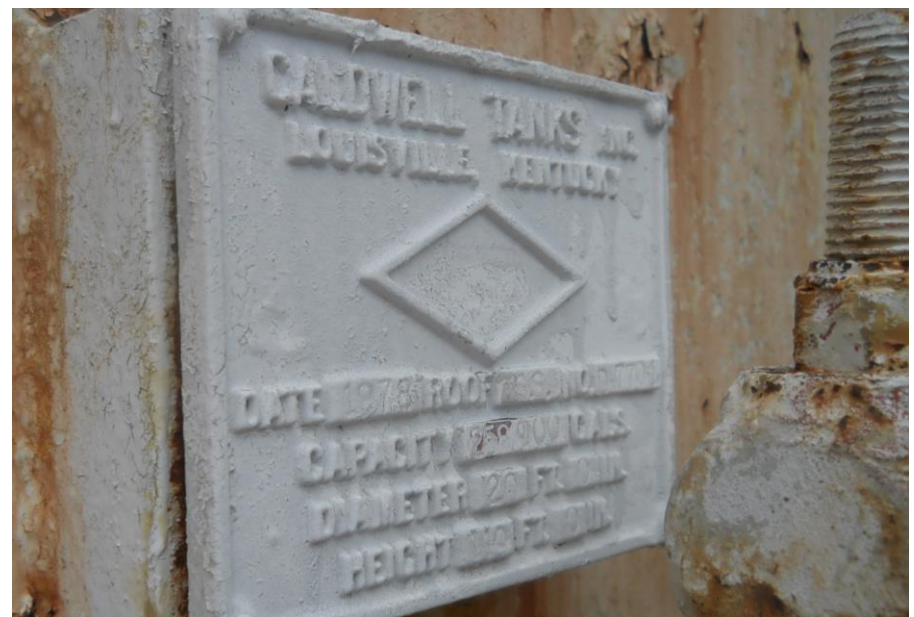
Figure 8 1978 Manufacturer plate – Caldwell Tanks, Louisville, KY
