INDIANA UTILITY REGULATORY COMMISSION

PETITION OF THE CITY OF ANDERSON, )  
INDIANA, FOR AUTHORITY TO: (1) ISSUE )  
LONG TERM DEBT TO FINANCE WATER ) CAUSE NO. 46171  
SYSTEM IMPROVEMENTS; AND (2) )  
ADJUST ITS RATES AND CHARGES )

TESTIMONY OF CARL N. SEALS

THE INDIANA OFFICE OF UTILITY CONSUMER COUNSELOR

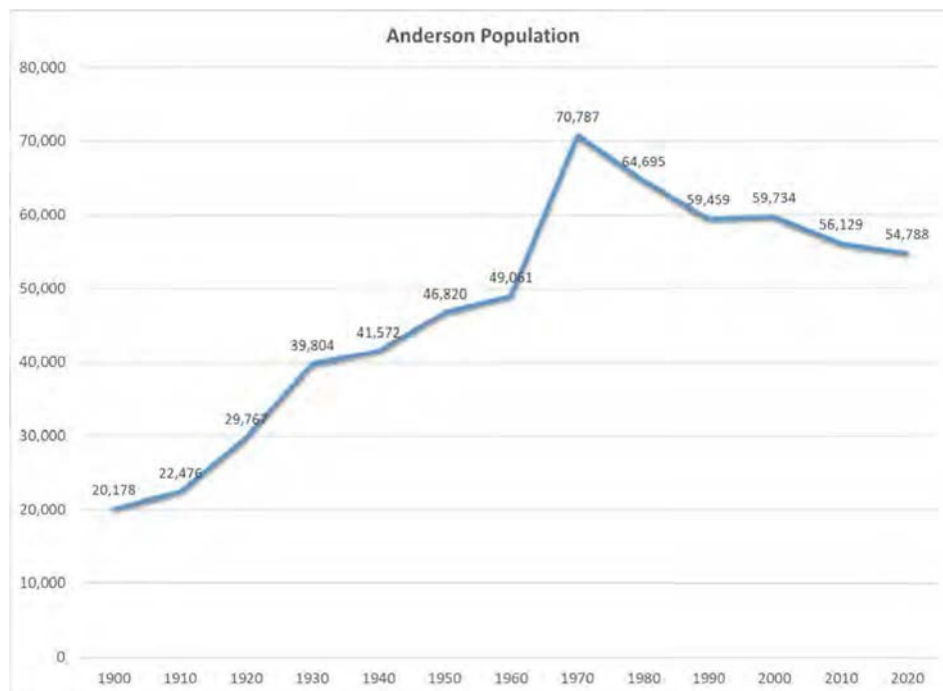
1 will continue to decline to 49,272 by 2050, a decrease of another 5,516 people. This  
2 is shown in the following chart. It is logical, therefore, to assume that the combined  
3 pressures of 1) a declining population, 2) decreasing use per customer and 3) actual,  
4 experienced declines in sales volumes (as shown above) will cause Anderson to see  
5 continued decreasing usage, absent growth in the population or number of  
6 customers served.

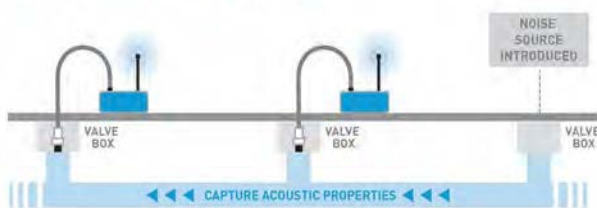
FIGURE 3: EPULSE® FOR DISTRIBUTION & TRANSMISSION MAINS ABOVE ILLUSTRATES THE TYPICAL FIELD SETUP FOR AN EPULSE FIELD MEASUREMENT.

The field team measures the distance between the two sensors and proprietary software calculates the time taken for the acoustic signal to propagate between the two sensors. The wall stiffness is determined using the measured sound wave propagation speed through the pipe and comparing that value to the wave speed of a new perfect condition concrete pipe. This calculation takes into account the pipe and water properties for the specific classes of concrete pipe tested. For this particular project, all pipe properties were determined from drawings provided by the City.

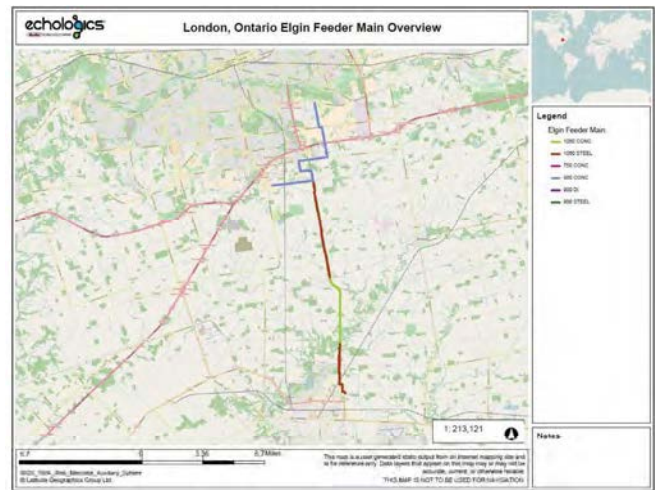
FIGURE 2: OVERVIEW OF LONDON, ONTARIO ELGIN FEEDER MAIN

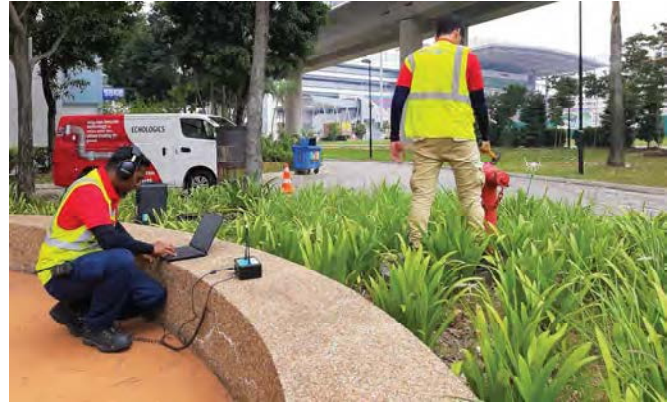
FIGURE 2: ECHOLOGICS FIELD SPECIALISTS GATHERING ACOUSTIC PROPERTIES OF A PIPE SEGMENT USING A LEAKFINDERST CORRELATOR

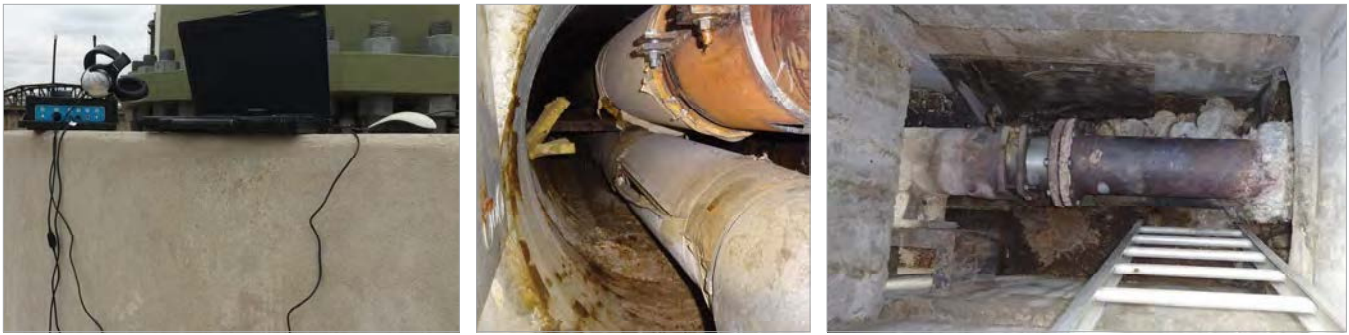
THE ECHOLOGICS FIELD TEAM LOCATED A LEAK ON THE WATER MAIN WHICH PROVIDED ADDITIONAL PROJECT VALUE.

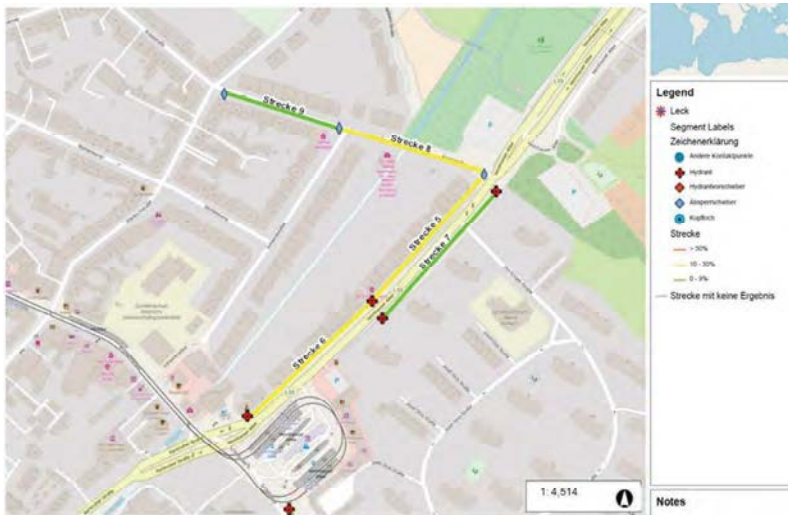
**Site plan indicating the pipe segments surveyed, which are color coded in three categories:**

green (**good**),  
yellow (**moderate**),  
red (**poor**).

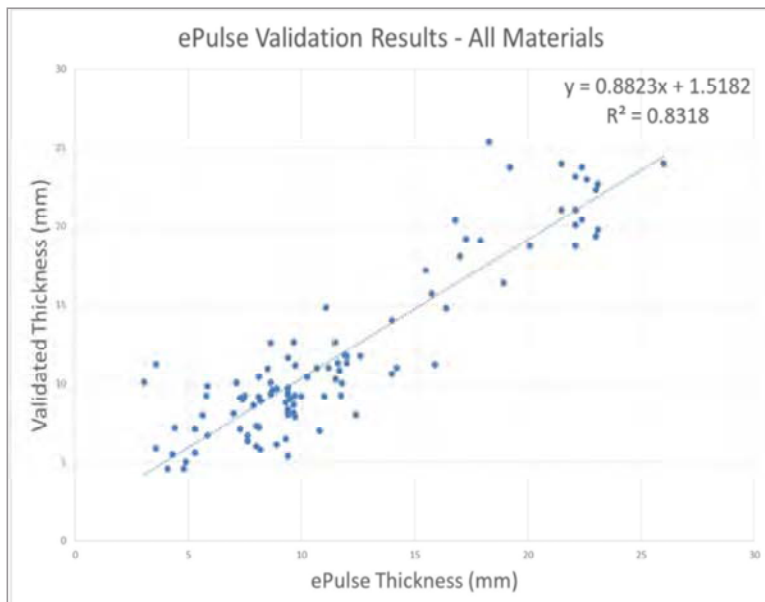
ePulse® validation results for all materials.

The minimal average remaining structural wall thickness calculation aligned with the pitting distribution and the minimal wall thickness values gathered through the BEM measurements, provided a useful dataset for NGD to make informed replacement decisions.
