IN THE MATTER OF THE PETITION OF LMH UTILITIES, INC. FOR A NEW SCHEDULE OF RATES AND CHARGES.

CAUSE NO. 45307-U

#### **PREFILED TESTIMONY**

#### TESTIMONY OF OUCC WITNESS JAMES T. PARKS CAUSE NO. 45307-U <u>LMH UTILITIES, INC.</u>

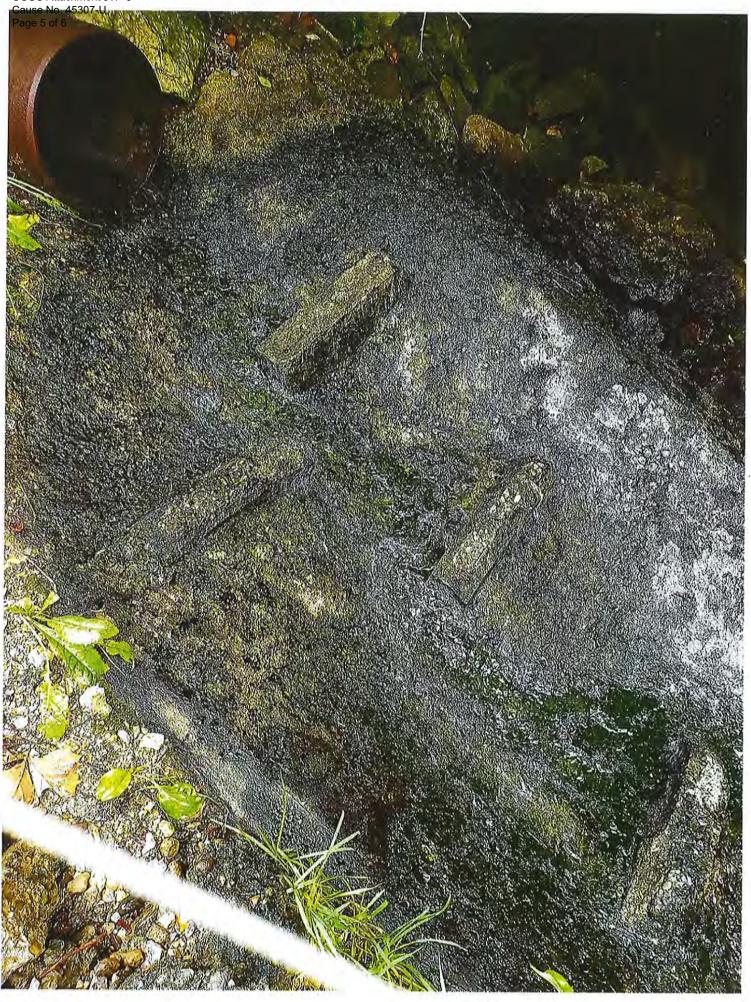
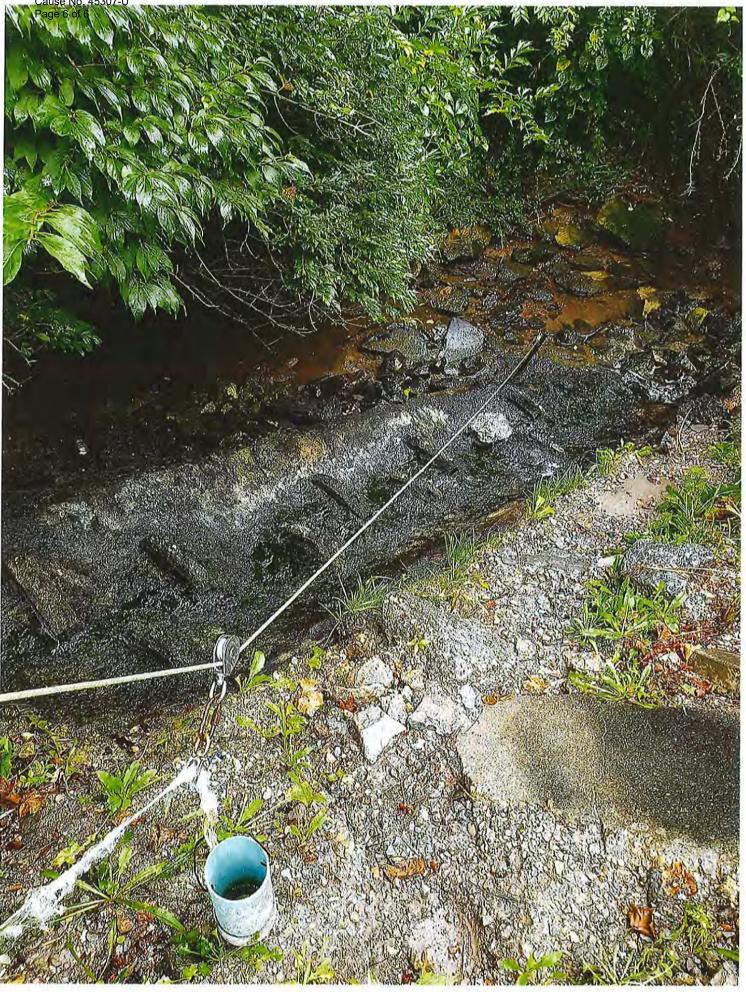
Facility:		
Picnic Woods Deve	lopme	ent WWTP
Photographer:		
Kevin Stark		
Date: 7/2/2019	Time:	11:07:00 AM
Others Present:		
Zach Tucker		
Location/Description: Outfall 001 of the Pic Development WWTF whitish substance de effluent caused from thiosulfate used in th process. The effluen clear at the time of th	P show posite the sc e dech nt was	ing a d from the dium norination clean and

Photographer:						
Kevin Stark						
Date: 7/2/2019	Time: 11:07:00 AM					
Others Present:						
Zach Tucker						
Location/Descripti	ion:					
Location/Description: Outfall 001 of the Picnic Woods Development WWTP post aeration steps showing the post aeration steps and a slight whitish substance deposited at the entry point of the creek.

- 6. We have reduced the dosage of sodium thiosulfate to address the residue left after dechlorination. We have also adjusted chemical intake valves to minimize sediment uptake from our bulk chemical totes. Rex Blanton from the Alliance of Indiana Rural Water has met with us at our facility to determine other methods of more effectively reducing residue from dechlorination on our outfall step aerator. Attached are pictures of the Outfall 001 step aerator approximately 6 days after implementation of stated residue reduction methods.
