# PROJECT EVANSVILLE WATER PLANT ADVANCED FACILITY PLAN

# **IMMEDIATE NEEDS MEMORANDUM: TREATMENT EQUIPMENT INFRASTRUCTURE**

**WATER TREATMENT PLANT  
ADVANCED FACILITY PLAN**

# **IMMEDIATE NEEDS MEMORANDUM: ELECTRICAL INFRASTRUCTURE**

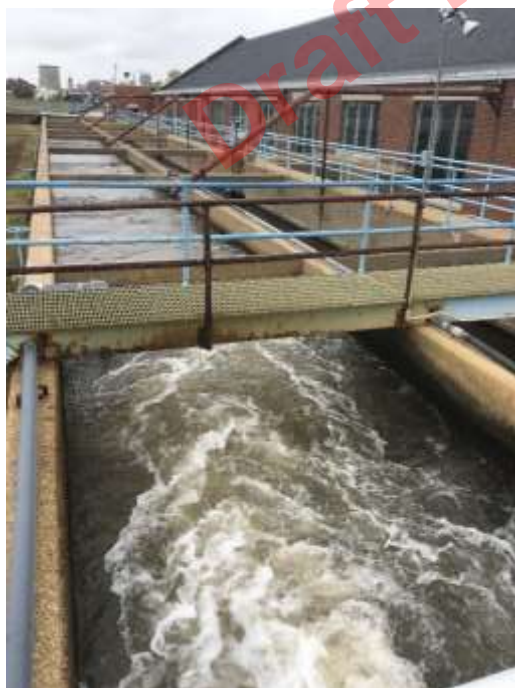
**FIGURE 2-3**  
**Raw Water Flume**

Due to age, material, and exposure to the elements, the roof drains discharging into the raw water flume, shown in **Figure 2-4**, are heavily corroded. Staff mentioned the corrosion of the downspouts and potential replacement should be considered to avoid a possible overhead safety issue. Handrails and walkways are also showing signs of heavy corrosion and should be inspected and recoated or replaced with new to extend their useful life.

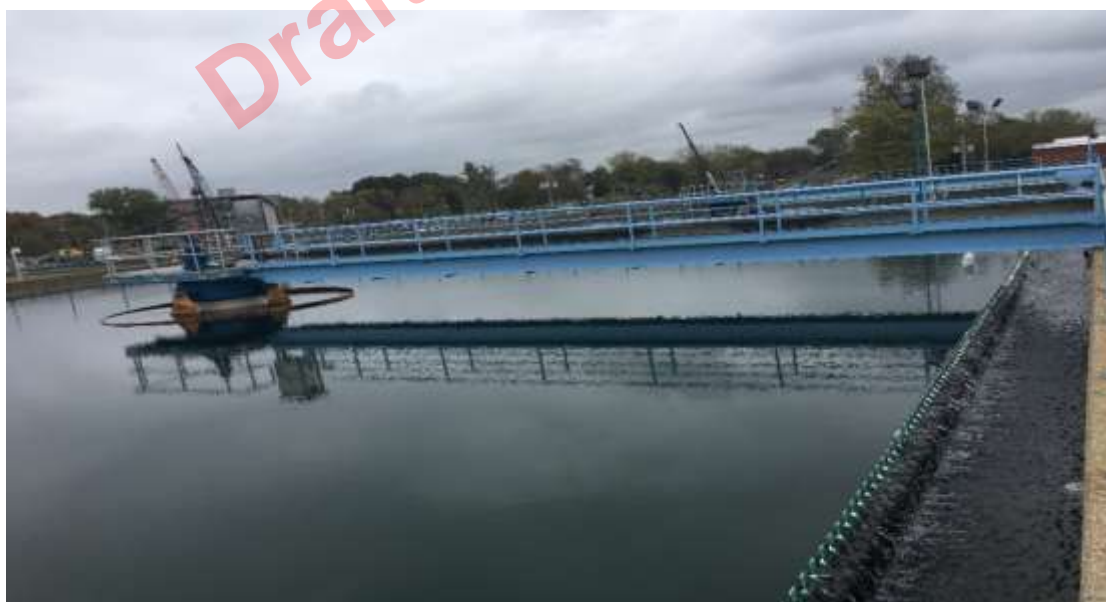
**FIGURE 2-6**  
**North Plant Primary Settling Basin**

Water from the flocculation basins travels to the Primary Sedimentation Basins shown on **Figure 1-1, Area 2** and shown in **Figure 2-6**. Within the primary sedimentation basins, the suspended material, or flocs, settle by gravity which is then removed from the basins by the sludge collector mechanisms and discharged to the Ohio River outfall by way of the North Plant sludge pumps. There are two (2) interconnected primary settling basins, both constructed in 1950's. V-notched weirs around the outside perimeter of the sedimentation basins control the flow of water out of the clarifier allowing the floc particles the proper settling time. The weirs were replaced in 2015 along with the clarifier center drive units in both basins. In early 2019, the support column of Basin No. 1, which was not replaced as part of the 2015 project, failed and caused the basin to be taken out of service. A replacement support column was fabricated and installed. It is likely that Basin No. 2 exhibits the same corrosion issues as Basin No. 1.

The center support column and other submerged ferrous components in Basin No. 2 should be replaced similar to the work completed for Basin No. 1. The concrete tank walls are showing signs of concrete surface deterioration. Previous concrete patches are also shown in **Figure 2-7**. To mitigate the risk of structural issues, the concrete structures should be drained, cleaned and inspected for structural integrity with corrective action taken if needed. The bridge within Basin No. 2 is showing signs of corrosion as shown in **Figure 2-8** and should be inspected, repaired, and recoated.

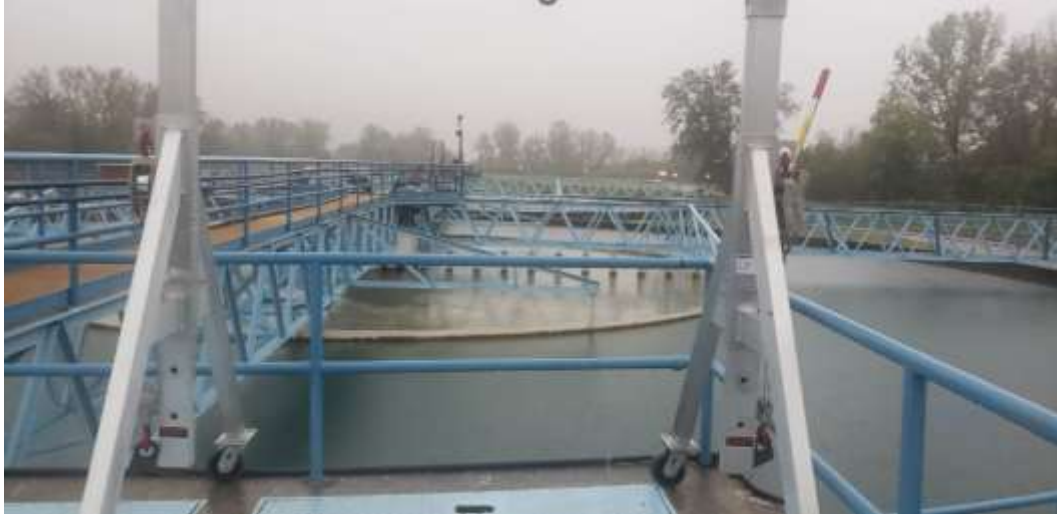
**FIGURE 2-9**  
**South Plant Primary Settling Basins**

Raw water is pumped from the LSPS to the South Plant as shown on **Figure 1-1, Area 20**. Raw water sent to the South Plant is distributed through a 42-inch pipe around the plant to the South Plant Primary Sedimentation Basins. Coagulant is added to the raw water prior to entering the primary clarifier and beginning the coagulation and flocculation process. The South Plant primary settling basins are shown in **Figure 2-9**. Unlike the North Plant, the coagulation and flocculation process are combined (picket fence style unit) in the sedimentation basin where flocculation is performed in the center of the basin and primary clarification occurs in the outer circle of the clarifier. **The units were constructed in the early 1970's. Minor structural** modifications to the center column supports, walkways, and ancillary equipment were replaced approximately 10 years ago; however, no work was completed on the mechanical drive unit or motor.

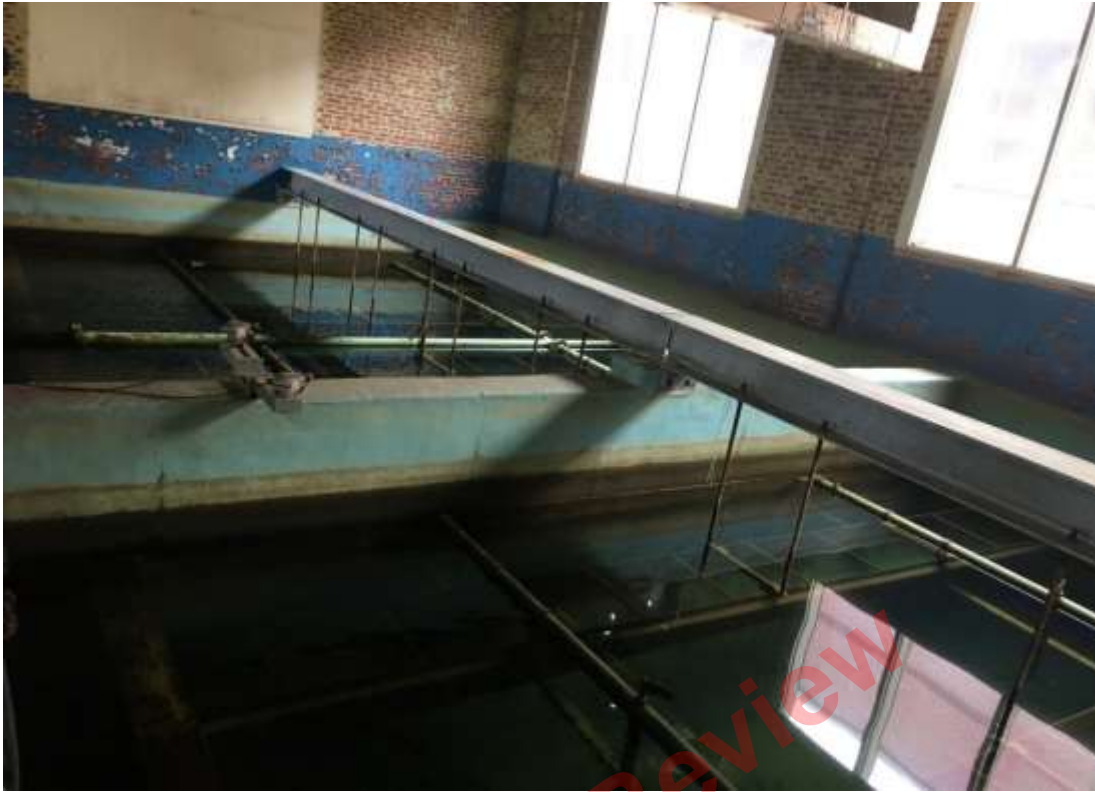
**FIGURE 2-14**  
**Filters 13-20**

Filters 33-36 are relatively new and require no major repairs within the next five (5) years, however, each of the respective piping galleries associated with filters 13-32 exhibit similar repair needs associated with excessive corrosion of filter gallery piping, actuators, and miscellaneous metals as shown on **Figures 2-14 through 2-16.** The extent of corrosion in each of the galleries is largely a result of inadequate ventilation and humidity control. Additionally, in filters 13-20, there is a cross-connection associated with the vent for the adjacent 1.5 MG clearwell that vents directly into this pipe gallery, contributing to the excessive moisture and chlorine levels in the pipe gallery. Recent air monitoring by staff have shown low available oxygen levels in the pipe gallery of 13-20. For each of the 13-32 filter galleries, dehumidification improvements are recommended to be included as part of the filter gallery upgrade. Piping and equipment showing significant corrosion (in some cases the entire gallery) should be blasted and recoated to extend service life and prevent possible failure.

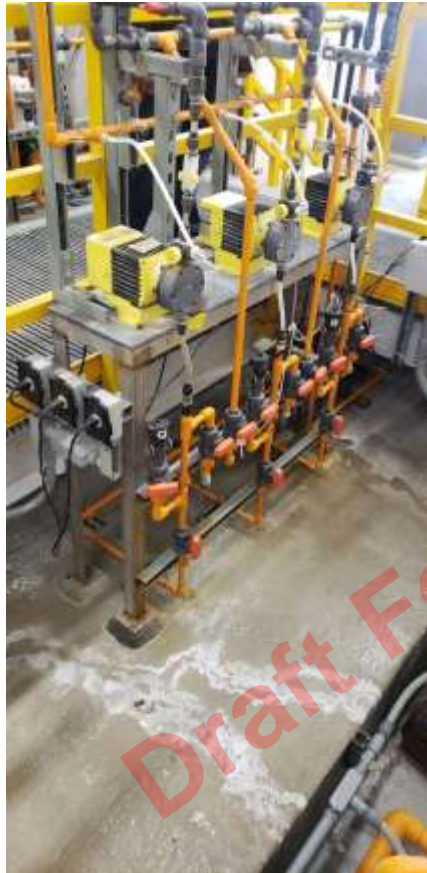
**FIGURE 2-17**  
**Coagulant Chemical Feed System**

primary sedimentation basins and utilized for the coagulation and flocculation processes. Chlorine is added after the primary sedimentation basins and ammonia and caustic are added after the secondary sedimentation basins to achieve chloramine disinfection and pH adjustments. Caustic is injected into the water prior to entering the filters to remove carbonate and non-carbonate hardness. PAC may be added as an emergency absorbent during spill events on the Ohio River. The existing condition of the Hyper+ Ion and caustic chemical feed system are shown in Figures 2-17 through 2-19.

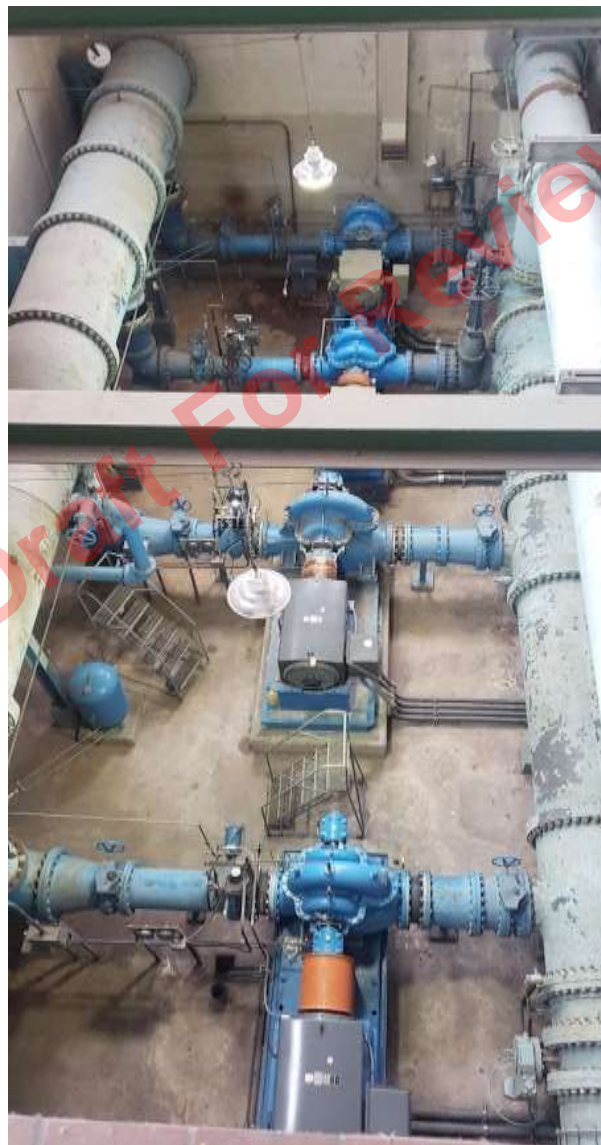
**FIGURE 2-26**  
**High Service Pump Station No. 2**

High Service Pump (HSP) Nos. 4 through 7 are located in High Service Pump Station (HSPS) No. 2 and are shown on **Figure 1-1, Area 14** and shown in **Figure 2-26**. HSP No. 6, shown in **Figure 2-27**, and No. 7 were rebuilt in 2015 and HSP No. 4 was rebuilt in 2018.

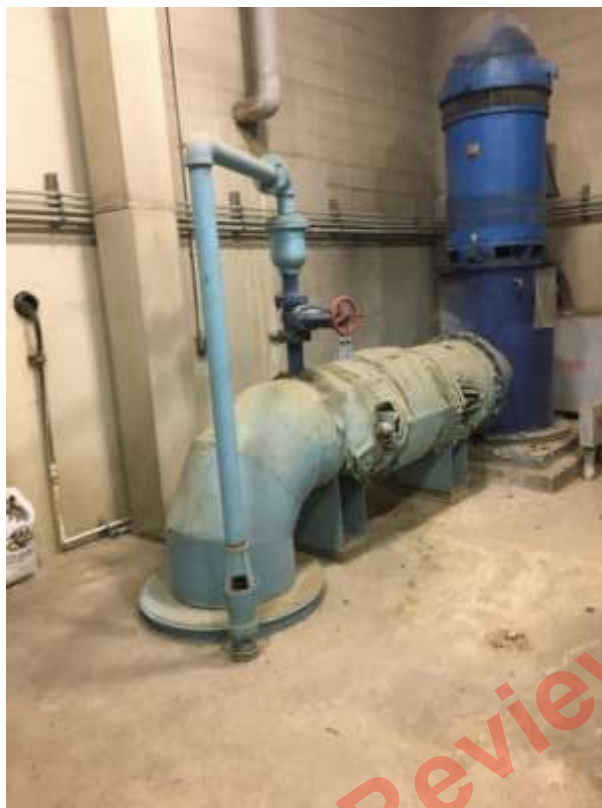
**FIGURE 2-28**  
**High Service Pump Station No. 3**

Additional improvements to HSPS No. 3 include recoating of the corroded process piping, and equipment as needed, recoating the stairs and handrails, and upgrading or replacing the flow meters on the discharge piping.

It is recommended that the pump and motor rebuild of HSP No. 10 be completed within the next five (5) years. Currently, there is an across-the-line starter for HSP No. 10. It is recommended to replace the current motor starter with a variable frequency drive or eddy current drive as space permits.

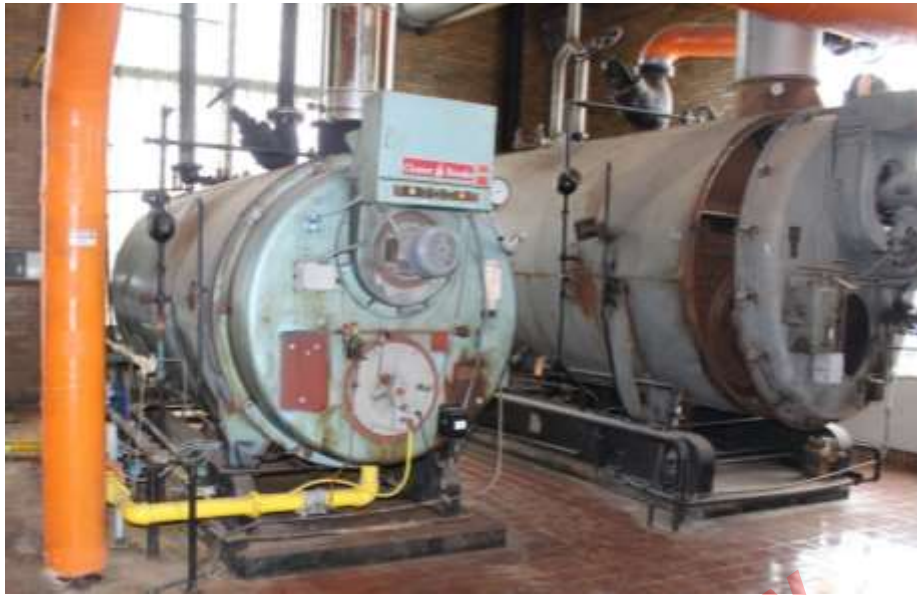
**FIGURE 2-30**  
**Boilers**

The plant heating is comprised of a converted natural gas-fired centralized boiler system located in the head house and electric unit heaters. The boiler/steam heating system consists of two (2) boilers, five (5) condensate pumps, an estimated 36-unit heaters, and all associated piping and valves required for operation. The boilers, as shown in **Figure 2-30**, are manufactured by Cleaver Brooks with one being manufactured in 1963 and the other in 1976. The larger boiler is out of service and no longer used.

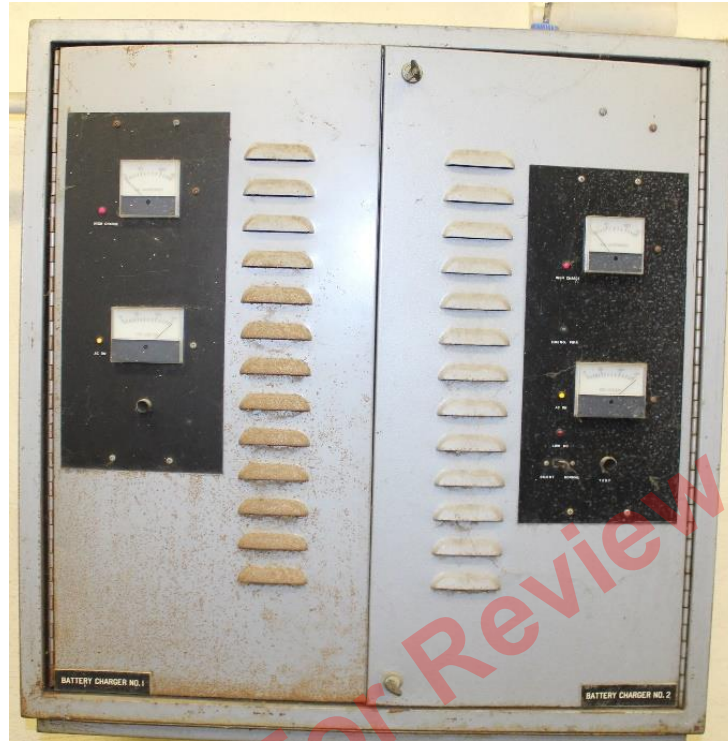
**FIGURE 2-3**  
**HSPS No. 3's Battery Backup Charging Station**

The backup battery systems should be individually tested, evaluated for deficiencies, and repaired or replaced as needed. It is recommended to begin with the systems that directly affect critical plant production processes such as the Supervisory Control and Data Acquisition (SCADA) and RTU backup power supplies. The WTP's RTUs, programmable logic controllers (PLCs), human machine interfaces (HMIs), and analyzer equipment should be provided with enough capacity for a least 6-hours to mitigate the risk of an outage during a catastrophic power systems failure.

The inspections on the backup power supply systems should be completed every six (6) months on backup power supply systems that are five (5) years old or older. Systems that are less than five (5) years old (unless otherwise directed by the manufacturer) should be inspected annually.
