CERTIFICATE OF SERVICE

**TESTIMONY OF OUCC WITNESS JAMES T. PARKS
CAUSE NO. 45132-U
HILLVIEW ESTATES SUBDIVISION UTILITIES, INC.**

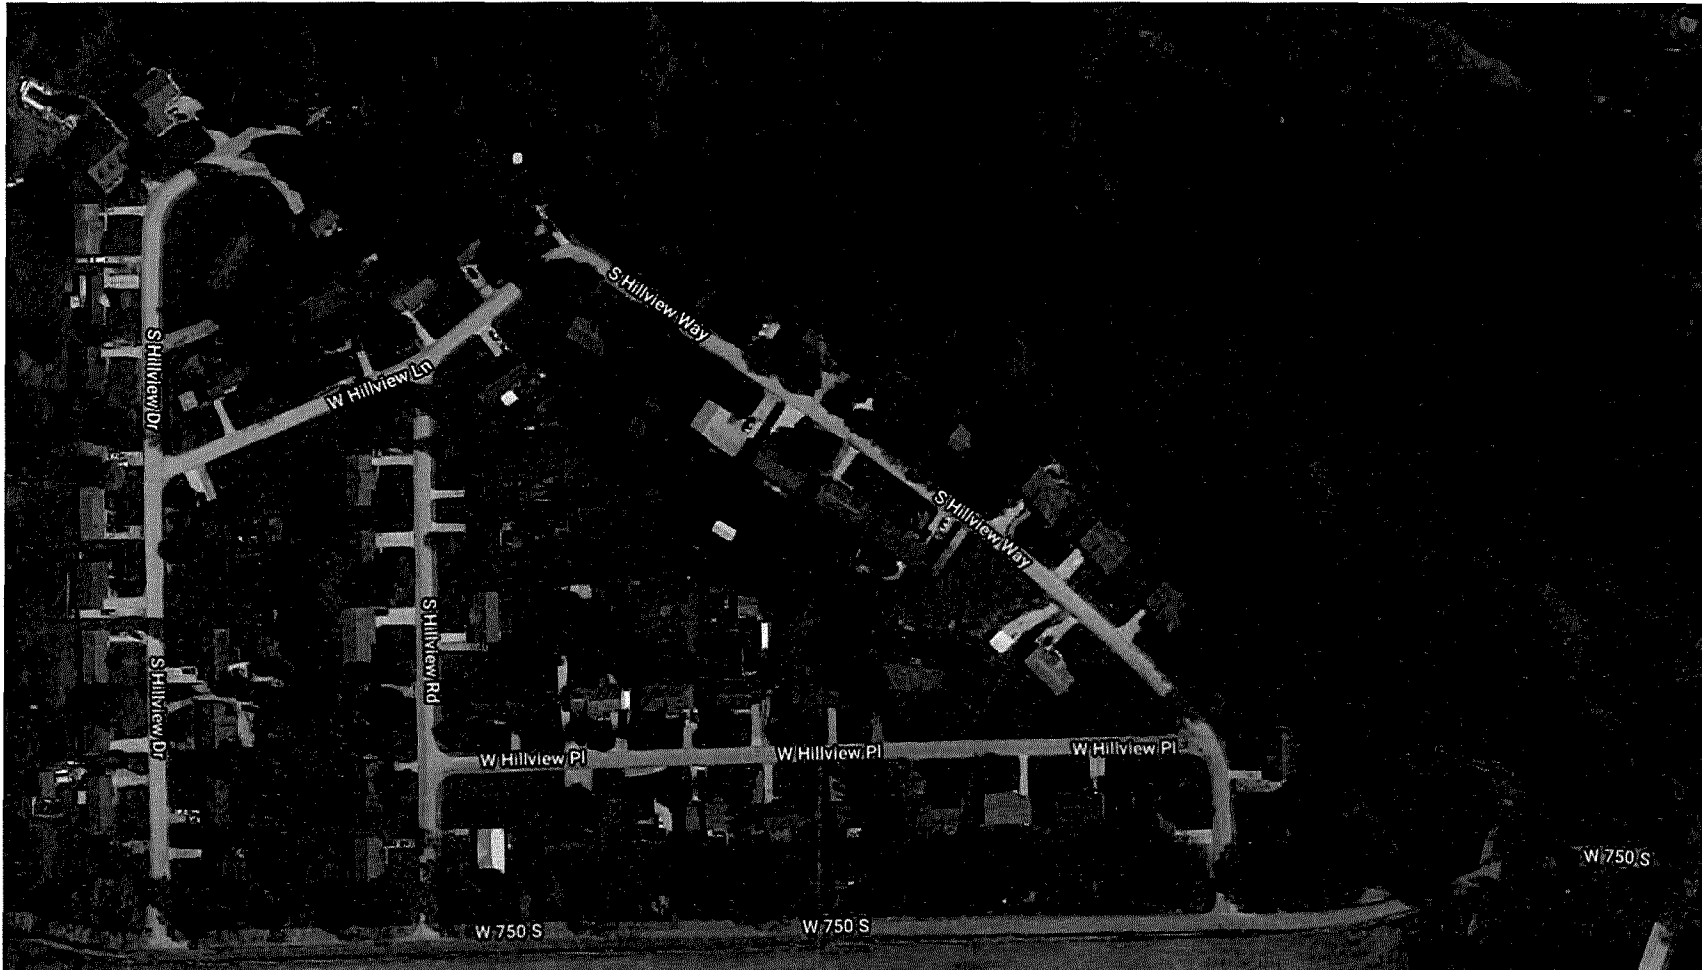
Hillview Estates Subdivision showing 67 residences on 74 platted lots and the wastewater treatment (package) plant (lower right corner - north of W 750 S and west of State Rd. 58 (not marked)).

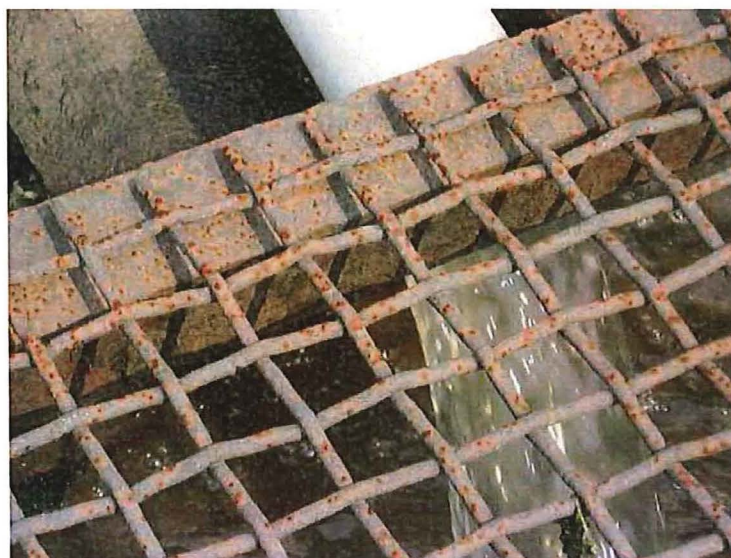
Facility:	
Hillview Estates Subdivision	
Photographer:	
Kevin Hotz	
Date: 6/30/2015	Time:
Others Present:	
Location/Description: Clear influent wastewater
