**PETITION OF COMMUNITY UTILITIES OF)
INDIANA, INC. FOR: AUTHORITY TO)
INCREASE ITS RATES AND CHARGES FOR)
WATER AND WASTEWATER UTILITY)
SERVICE; APPROVAL OF NEW SCHEDULES)
OF RATES AND CHARGES APPLICABLE)
THERE TO; AUTHORITY TO RECOVER)
CERTAIN COSTS INCURRED IN)
CONNECTION WITH CAUSE NOS. 44724,)
45342 AND 45389; AUTHORITY TO RECOVER)
COSTS INCURRED AND DEFERRED IN)
CONNECTION WITH THE COVID-19)
PANDEMIC; APPROVAL OF A NEW)
RESIDENTIAL LOW-INCOME RATE FOR)
WATER AND WASTEWATER SERVICE; AND)
OTHER APPROPRIATE RELIEF)**

CAUSE NO. 45651

DIRECT TESTIMONY

LOREN GROSVENOR

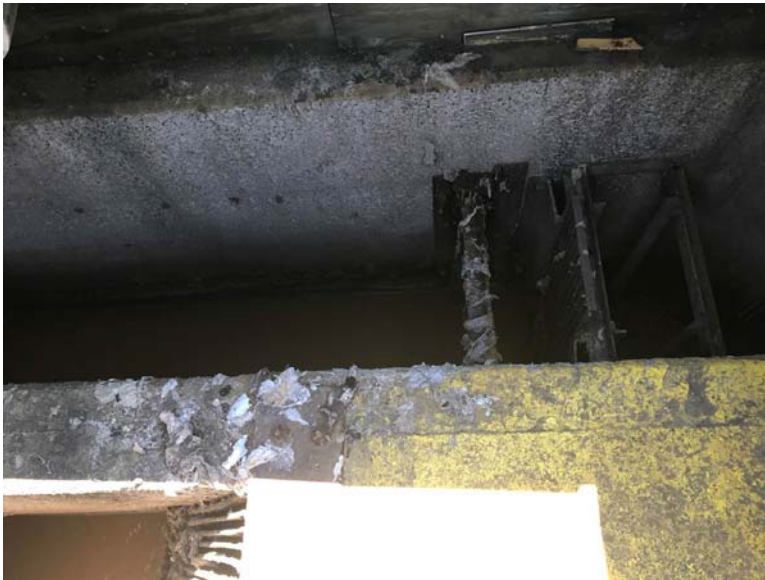
Facility: Community Utilities WWTP
Photographer: Nicholas Ream
Date: 7/9/2018 Time: 12:40:00 PM
Others Present: Kim Rohr, Loren Grosvenor
Location/Description: East and down view of the parshall flume.

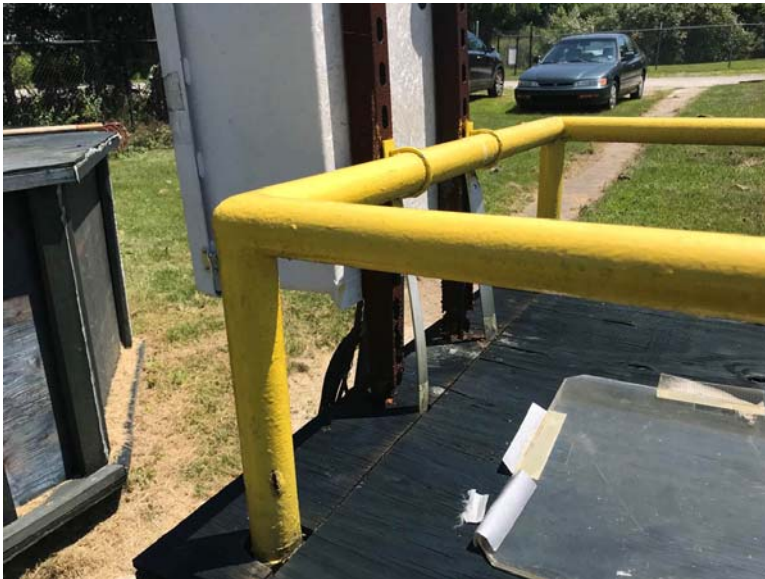
Facility: Community Utilities WWTP
Photographer: Nicholas Ream
Date: 7/9/2018 Time: 12:45:00 PM
Others Present: Kim Rohr, Loren Grosvenor
Location/Description: East view of the influent meter box. Through difficult to see in the picture, the steel has nearly rusted through.

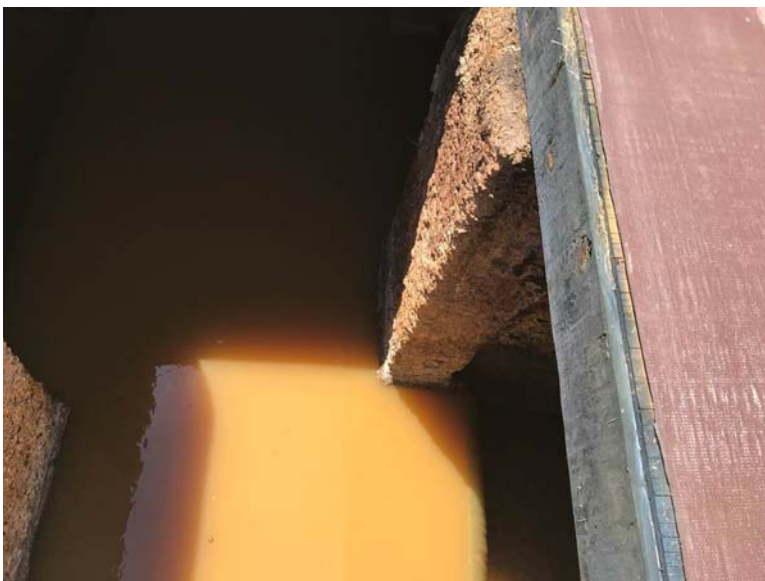
Facility: Community Utilities WWTP
Photographer: Nicholas Ream
Date: 7/9/2018 Time: 12:45:00 PM
Others Present: Kim Rohr, Loren Grosvenor
Location/Description: South view of the splitter box. Heavy pitting was visible in the splitter box, likely due to hydrogen sulfide.
