INDIANA UTILITY REGULATORY COMMISSION

PETITION OF COMMUNITY UTILITIES OF)
INDIANA, INC. FOR APPROVAL OF (1))
EXPENDITURES FOR CONSTRUCTION OF)
ADDITIONS AND IMPROVEMENTS TO)
PETITIONER'S WASTEWATER UTILITY) CAUSE NO. 45389
PROPERTIES, AND (2) THE INCLUSION OF THE)
VALUE OF SUCH NEW FACILITIES, INCLUDING)
PLAN DEVELOPMENT AND IMPLEMENTATION)
COSTS, IN PETITIONER'S RATE BASE IN FUTURE)
CASES.)

PETITIONER'S RESPONSE TO COMMISSION DOCKET ENTRY
QUESTIONS DATED OCTOBER 28, 2020

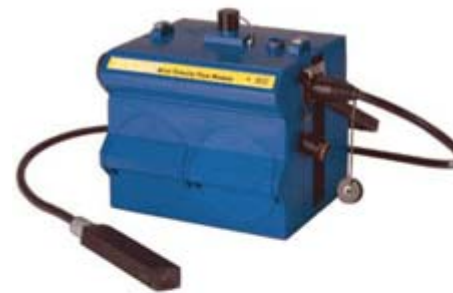
**Above: 2150 with
AV sensor and
Battery Module**

**Right: up to 4
Modules stack
together for
multi-stream or
redundant
measurements**

The 2150's "smart" area velocity probe is built on digital electronics, so the analog level is digitized in the sensor itself to overcome electromagnetic interference. The probe is also factory-calibrated for 10-foot (3 meter) span at different temperatures. This built-in calibration eliminates drift in the level signal, providing long-term level stability that reduces recalibration frequency and completely eliminates span recalibration.

In field use, the 2150 is typically powered either by two alkaline, or Teledyne ISCO Rechargeable Lead-acid batteries, within a 2191 Battery Module. Highly efficient power management extends battery life up to 15 months at 15-minute data storage intervals. Other power options (including solar) are available.
